ELECTRICAL TRANSMISSION

PROBLEM OVERVIEW

CUES was contracted by an electricity provider in western Canada to perform an in-pipe video inspection/assessment and internal pipeline mapping project for approximately 41,338 ft. of buried electrical pipeline. The client was concerned that the age of the system and material of construction would prohibit proper installation of newer electrical cabling into the pipeline. The objective of the project was twofold: 1) to provide the client with video documentation detailing the internal condition and perform a condition assessment of any defects present within the pipeline structures, and 2) to provide 3D positional measurements for development of plan and profile depictions with bending radius analysis.

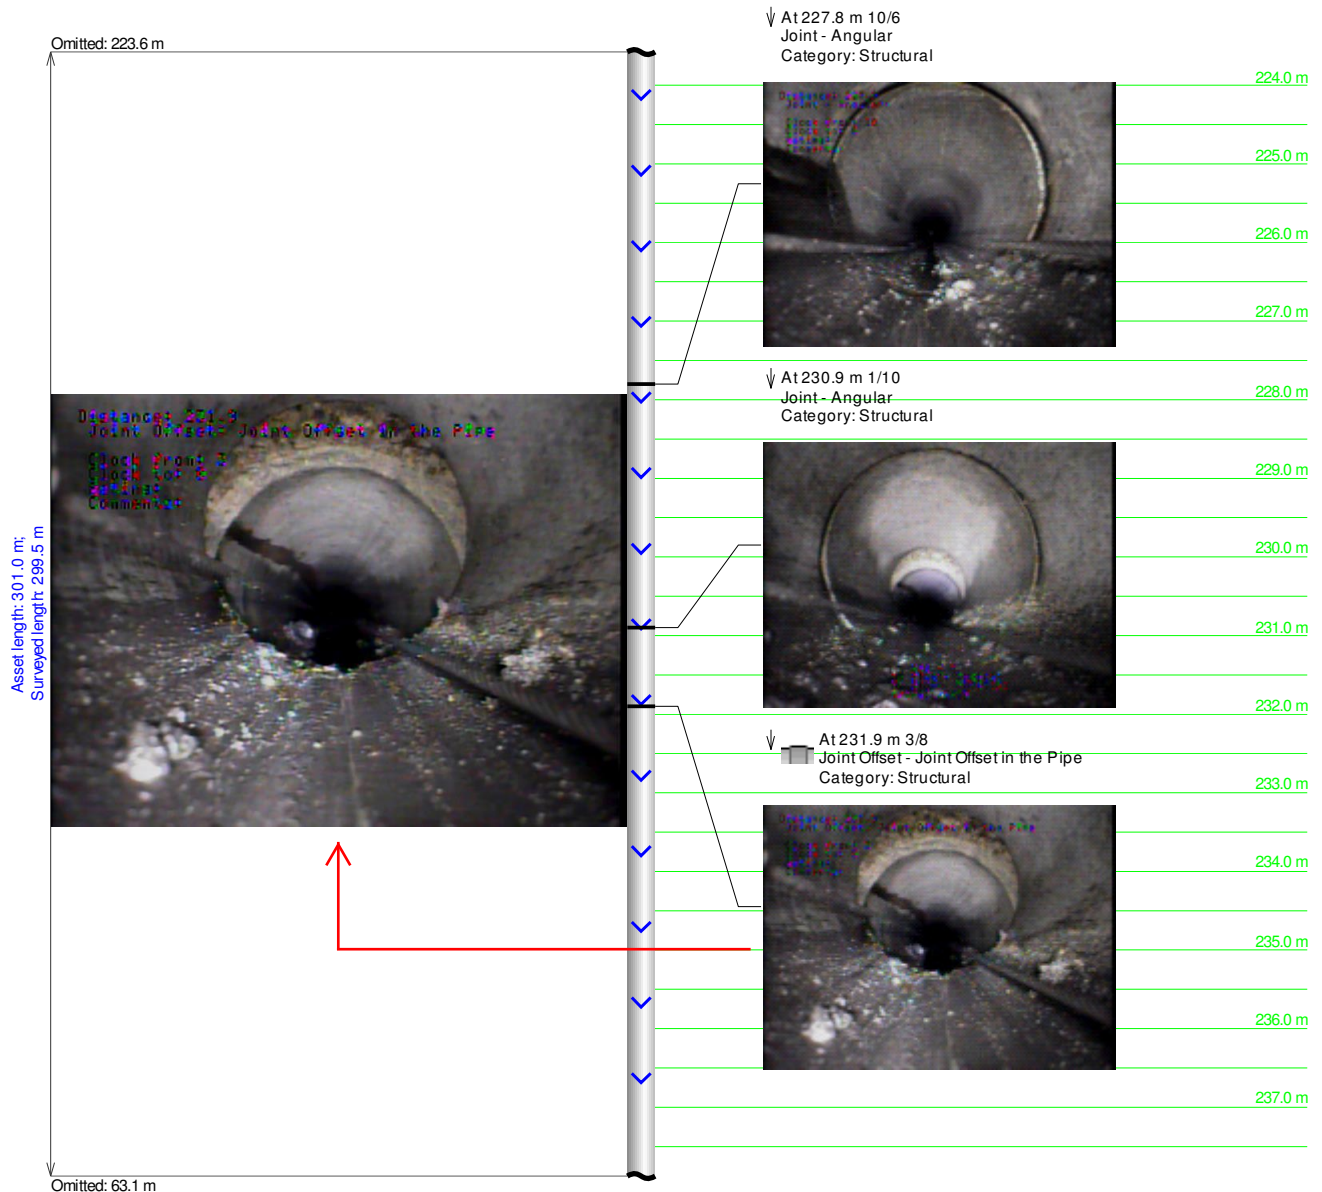
Figure 2

Project Name: Cable Duct Survey From GTP-HSS		Mainline ID: MHKB(2)-767(2)		City: Victoria	Address: Borden St. and McKenzie Ave.	
Start date/time: 04/04/2013	Pipe width: 	Pipe height: 125	Pipe type: Cement	Surface condition: Other	Weather: Heavy Rain	
Direction: Downstream	Surveyed footage: 299.5	Operator: Thomas		Comments 4/APRIL/2013

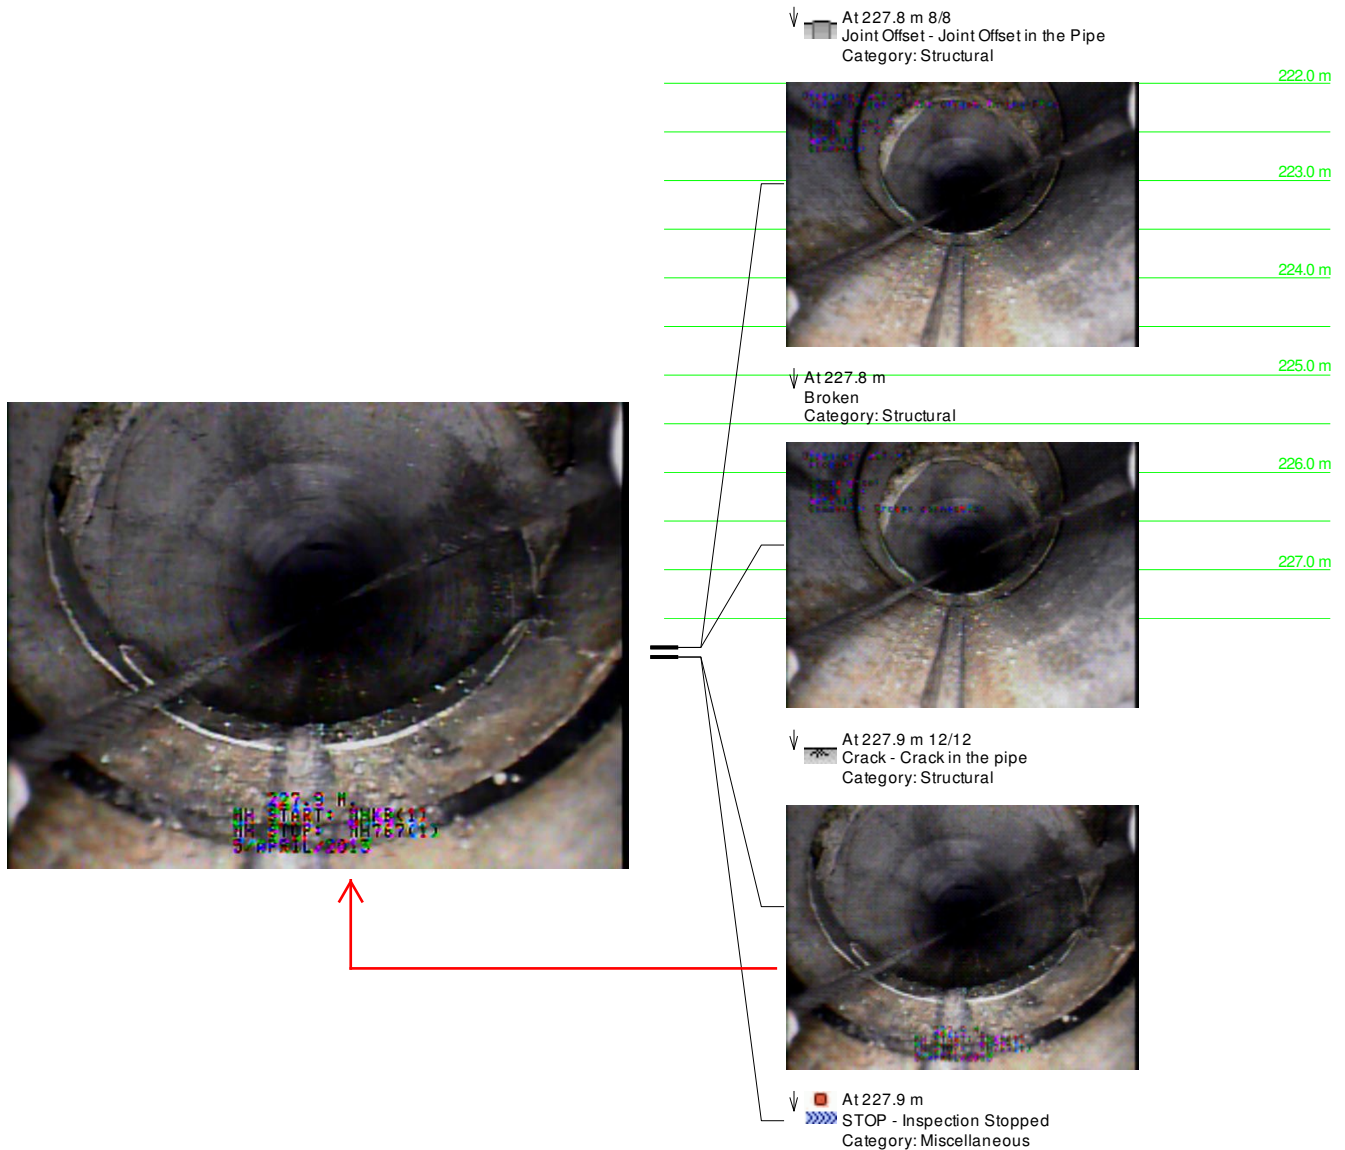
Figure 3

Project Name: Cable Duct Survey From GTP-HSS		Mainline ID: MHKB(1)-767(1)*		City: Victoria	Address: Borden St	
Start date/time: 05/04/2013	Pipe width: 	Pipe height: 125	Pipe type: Cement	Surface condition: Other	Weather: Dry	
Direction: Downstream	Surveyed footage: 227.9	Operator: Thomas		Comments: 5/APRIL/2013

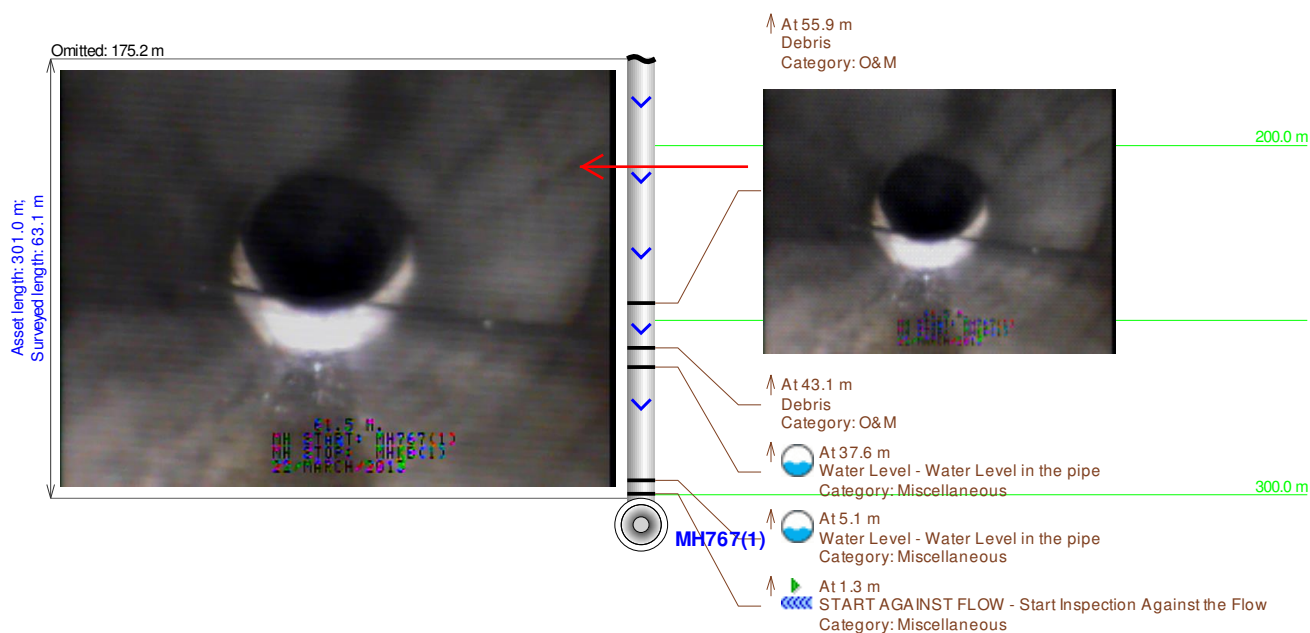
Figure 4

Project Name: Cable Duct Survey From GTP-HSS		Mainline ID: MHKB(1)-767(1)		City: Victoria	Address: Borden St. and McKenzie Ave.	
Start date/time: 22/03/2013	Pipe width: 	Pipe height: 125	Pipe type: Cement	Surface condition: Asphalt	Weather: Dry	
Direction: UPSTREAM	Surveyed footage: 63.1	Operator: Thomas		Comments: 22/MARCH/2013

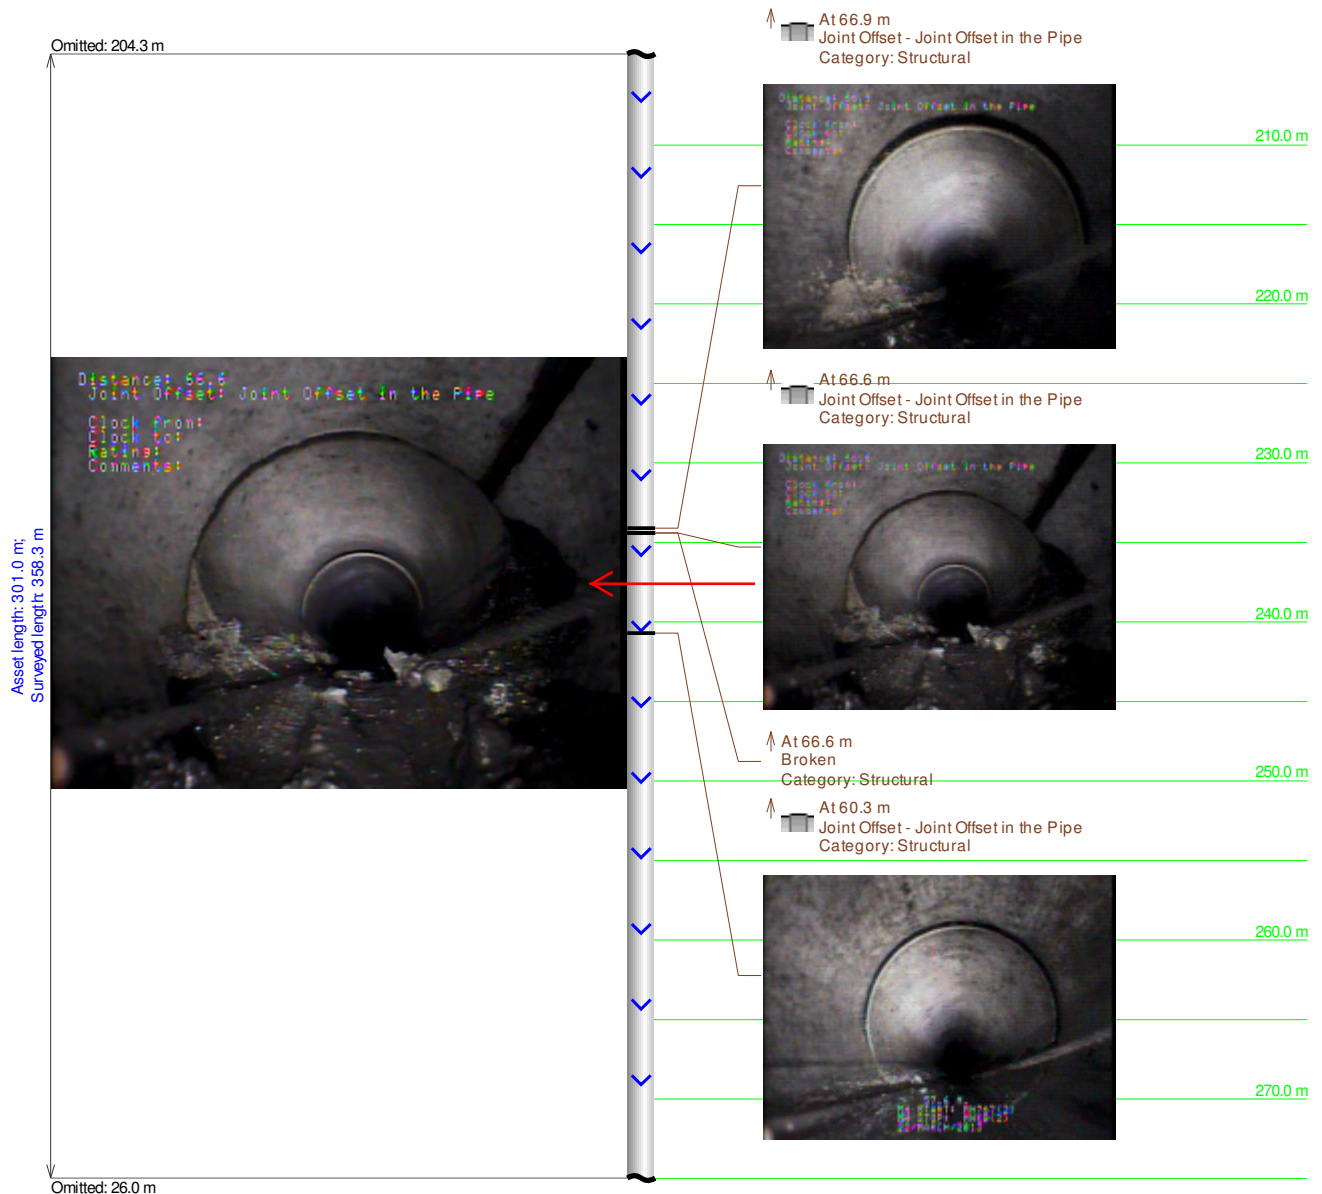
Figure 5

Project Name: Cable Duct Survey From GTP-HSS		Mainline ID: MHKB(2)-767(2)		City: Victoria	Address: Borden St. and McKenzie Ave.	
Start date/time: 22/03/2013	Pipe width: 	Pipe height: 125	Pipe type: Cement	Surface condition: Other	Weather: Dry	
Direction: UPSTREAM	Surveyed footage: 358.3	Operator: Thomas	Comments 22/MARCH/2013

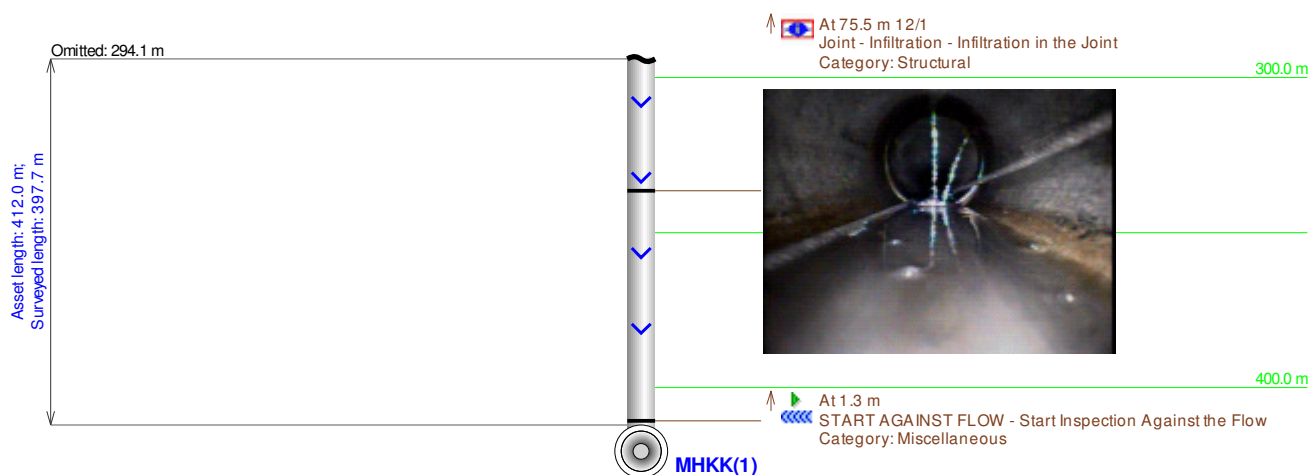
Figure 6

Project Name: Cable Duct Survey From GTP-HSS		Mainline ID: MHKJ(1)-KK(1)		City: Victoria	Address: Nanaimo St. (Victoria Real Estate Board Parking lot)	
Start date/time: 23/03/2013	Pipe width: 	Pipe height: 125	Pipe type: Cement	Surface condition: Asphalt	Weather: Dry	
Direction: UPSTREAM	Surveyed footage: 397.7	Operator: Thomas		Comments 23/MARCH/2013
