## ELECTRICAL TRANSMISSION

### PROBLEM OVERVIEW

CUES was contracted by an electricity provider in western Canada to perform an in-pipe video inspection/assessment and internal pipeline mapping project for approximately 41,338 ft. of buried electrical pipeline. The client was concerned that the age of the system and material of construction would prohibit proper installation of newer electrical cabling into the pipeline. The objective of the project was twofold: 1) to provide the client with video documentation detailing the internal condition and perform a condition assessment of any defects present within the pipeline structures, and 2) to provide 3D positional measurements for development of plan and profile depictions with bending radius analysis.

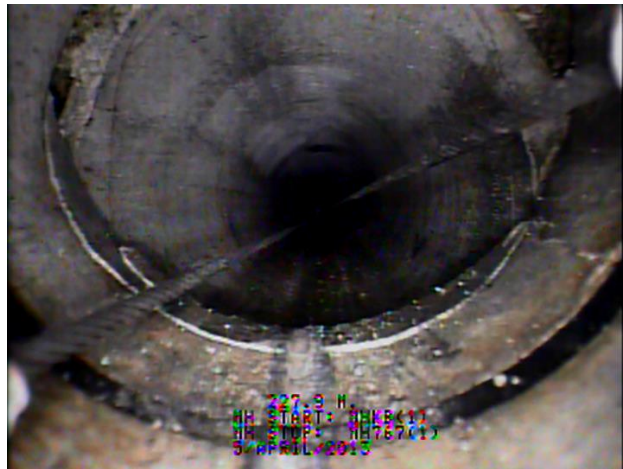
↓ At 227.8 m 8/8  
 Joint Offset - Joint Offset in the Pipe  
 Category: Structural

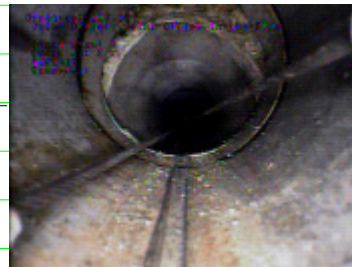
↓ At 227.8 m

Broken  
 Category: Structural

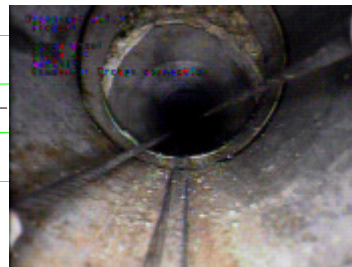
↓ At 227.9 m 12/12  
 Crack - Crack in the pipe  
 Category: Structural

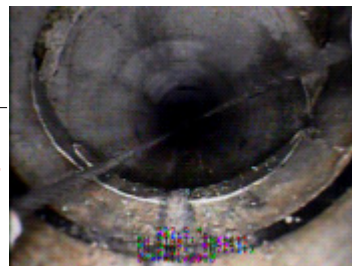
Figure 3

↓ At 227.9 m  
 STOP - Inspection Stopped  
 Category: Miscellaneous
