SolidFX

Inspection Report

Anytown, USA

Inspected November 16, 2018

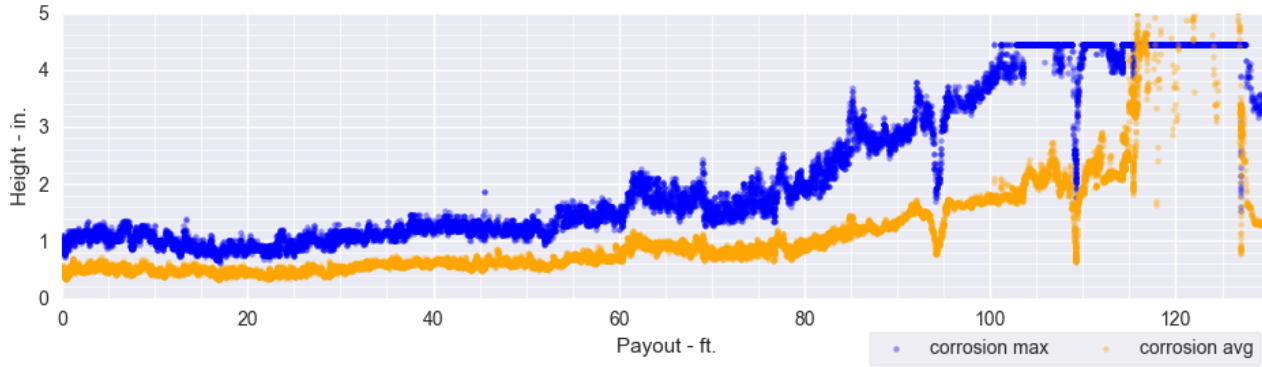
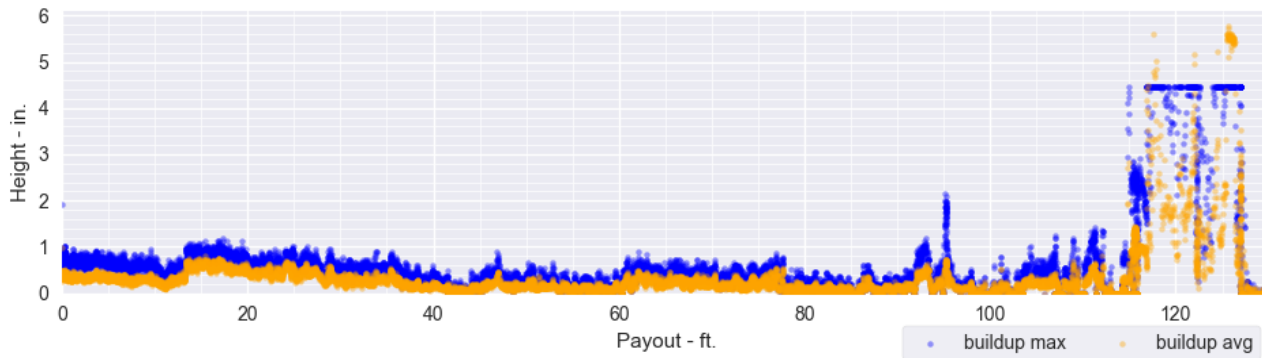
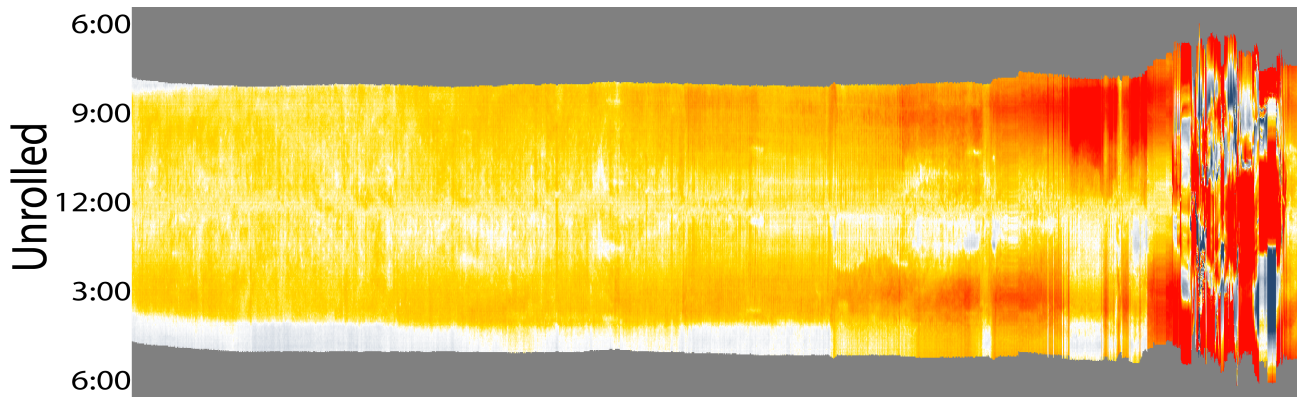
Sediment and Corrosion Graphs(0'-130')

Corroded Volume (cubic in):	143948.4
Wall/As-built (%):	85.9
Average Wall Loss (%):	14.1
