TELECOMMUNICATIONS

PROBLEM OVERVIEW

CUES was requested to map/locate three communication conduits that run under a canal and parallel to a bridge that is planned to be extended ([ref Figure 1](#)). Locating these pipes is necessary in order to avoid driving pilings through the structure during the construction phase of the bridge extension. The three conduits are within a structure that was dug as an open trench in the 1960's and per the drawings, it is impossible to know exactly where the pipes are located. Many attempts were made to locate this structure (sonde, divers) but were unsuccessful.

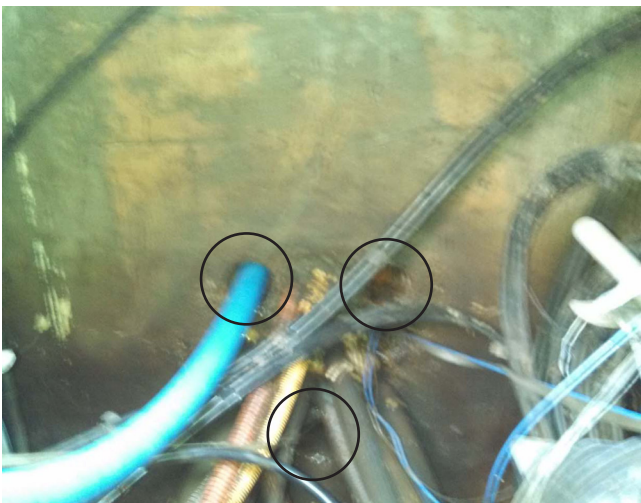
Figure 2: Bulkhead of Structure Containing Conduits

The main issue for this job was verifying the inside diameter (ID) of the three conduits ([ref Figure 2](#)). The contractor requesting the mapping job originally thought the pipes were 3in ID. CUES required the contractor to verify using a pig, which could not be done. In this particular case, having a 3in ID, it was important for CUES to have verification of the exact pipe size before traveling to the site. The reason being a pipe size range of 1.5-3in ID requires a different probe than a pipe size range of 3in and larger (DR2 articulated probe vs DR4.2XS probe). Since a 2.5in pig was unable to transverse the pipes, CUES recommended the contractor install clean pipes through the host pipes. This would give CUES a known ID and clean pipe to map/locate. In two out of the three pipes, they were able to push through a HDPE 2in OD, 1 5/8in ID line, with no joints ([ref Figure 3](#)). With the third conduit, they pushed through a 2 3/8in OD, 2in ID PVC line with 2 ft sections. The two HDPE and one PVC lines were cut to be flush with the bulkhead walls before the mapping was performed. This was a success and CUES was able to run the articulated AMP™ through each conduit multiple times.

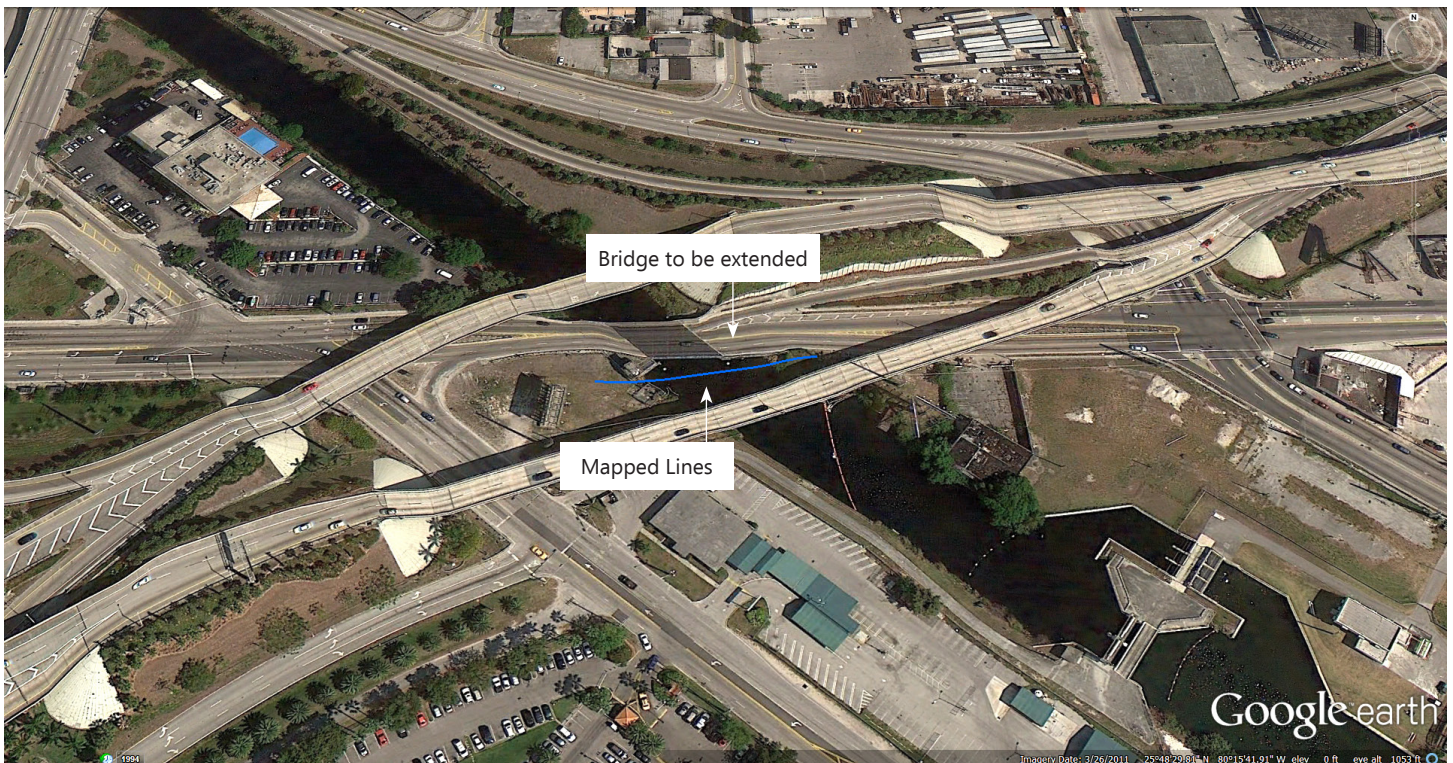
Figure 4: Site Location with Results

The individual plan and profile for each conduit were generated along with a plan and profile that shows all three conduits together ([ref Appendix A](#)). [Figures 4 and 5](#) are the Google Earth images containing the results.

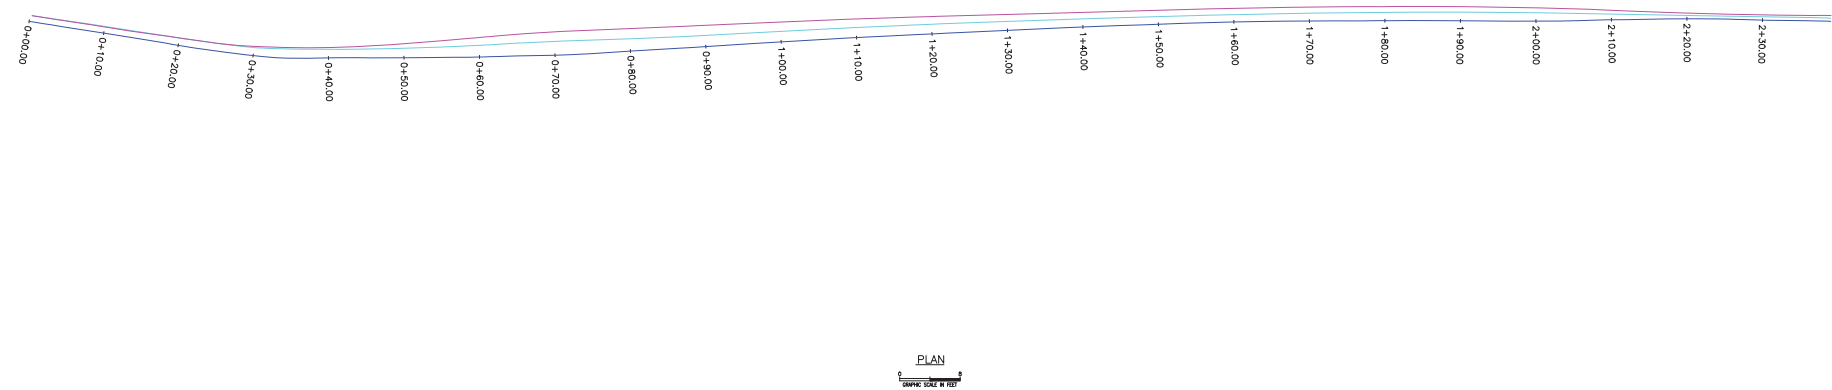
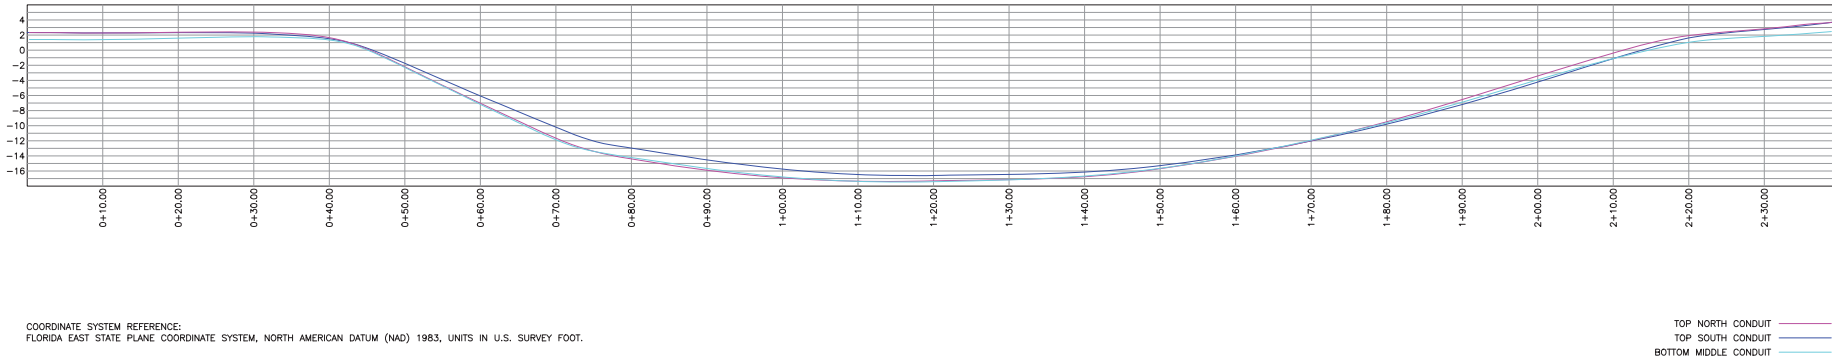
Appendix A: Combined Plan and Profile of 3 Mapped Conduits

TOP NORTH CONDUIT
TOP SOUTH CONDUIT
BOTTOM MIDDLE CONDUIT

DATE VUE		DATE PM	
PROJECT NO.		FILENAME	
SCALE: AS SHOWN		DATE: JAN 2014	
SHEET 1 OF 1		ALL CONDUITS LOCATION MAPPED WITH CUES ACCURATE MAPPING PROBE
