TELECOMMUNICATIONS

PROBLEM OVERVIEW

Appendix A: Combined Plan and Profile of 3 Mapped Conduits

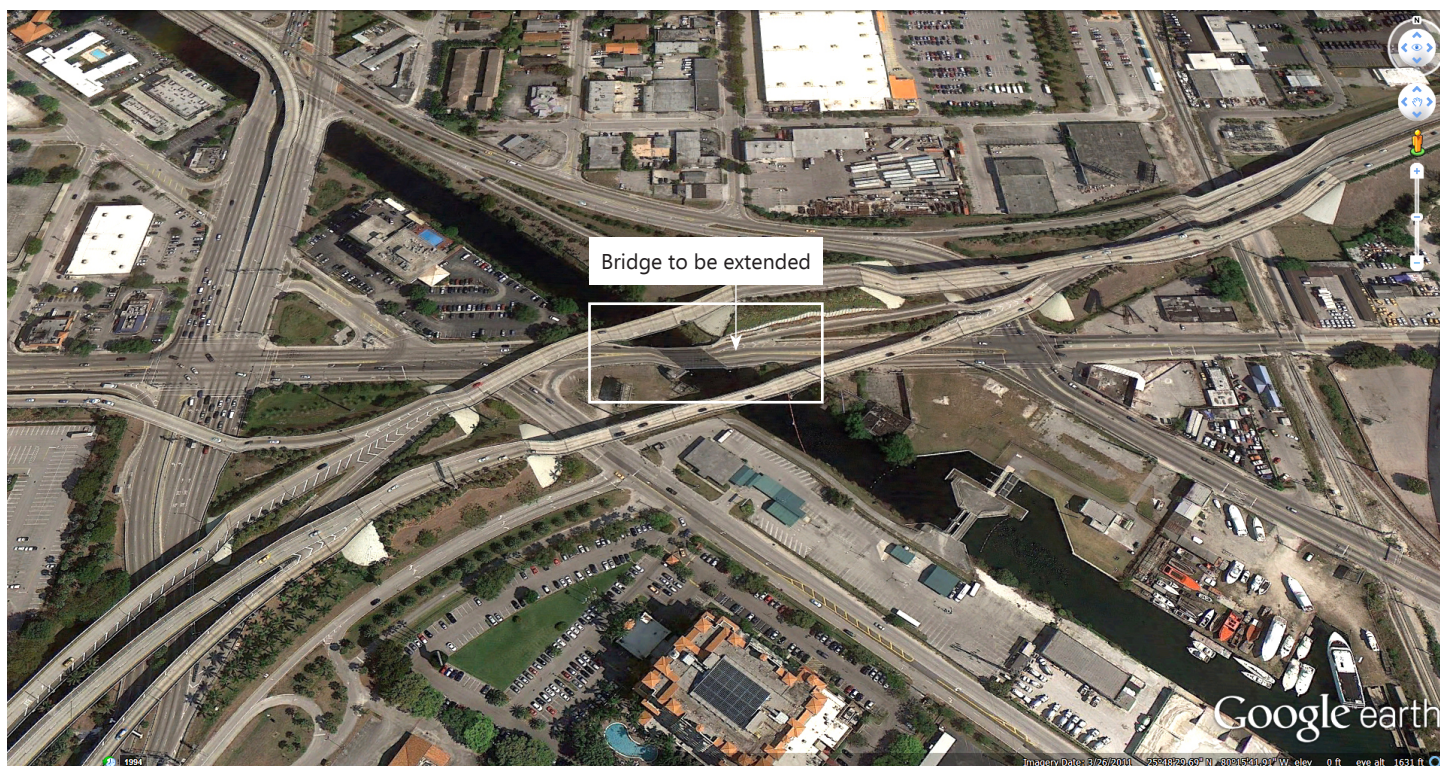
Figure 1: Site Location

CUES was requested to map/locate three communication conduits that run under a canal and parallel to a bridge that is planned to be extended (ref Figure 1). Locating these pipes is necessary in order to avoid driving pilings through the structure during the construction phase of the bridge extension. The three conduits are within a structure that was dug as an open trench in the 1960's and per the drawings, it is impossible to know exactly where the pipes are located. Many attempts were made to locate this structure (sonde, divers) but were unsuccessful.

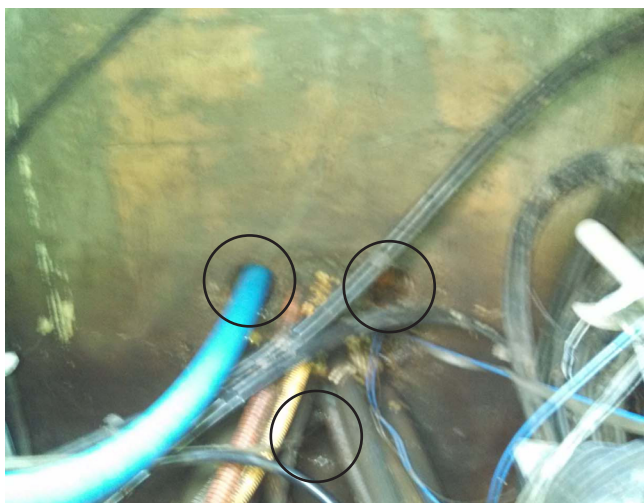
Figure 2: Bulkhead of Structure Containing Conduits

The main issue for this job was verifying the inside diameter (ID) of the three conduits (ref Figure 2). The contractor requesting the mapping job originally thought the pipes were 3in ID. CUES required the contractor to verify using a pig, which could not be done. In this particular case, having a 3in ID, it was important for CUES to have verification of the exact pipe size before traveling to the site. The reason being a pipe size range of 1.5-3in ID requires a different probe than a pipe size range of 3in and larger (DR2 articulated probe vs DR4.2XS probe). Since a 2.5in pig was unable to transverse the pipes, CUES recommended the contractor install clean pipes through the host pipes. This would give CUES a known ID and clean pipe to map/locate. In two out of the three pipes, they were able to push through a HDPE 2in OD, 1 5/8in ID line, with no joints (ref Figure 3). With the third conduit, they pushed through a 2 3/8in OD, 2in ID PVC line with 2 ft sections. The two HDPE and one PVC lines were cut to be flush with the bulkhead walls before the mapping was performed. This was a success and CUES was able to run the articulated AMP™ through each conduit multiple times.

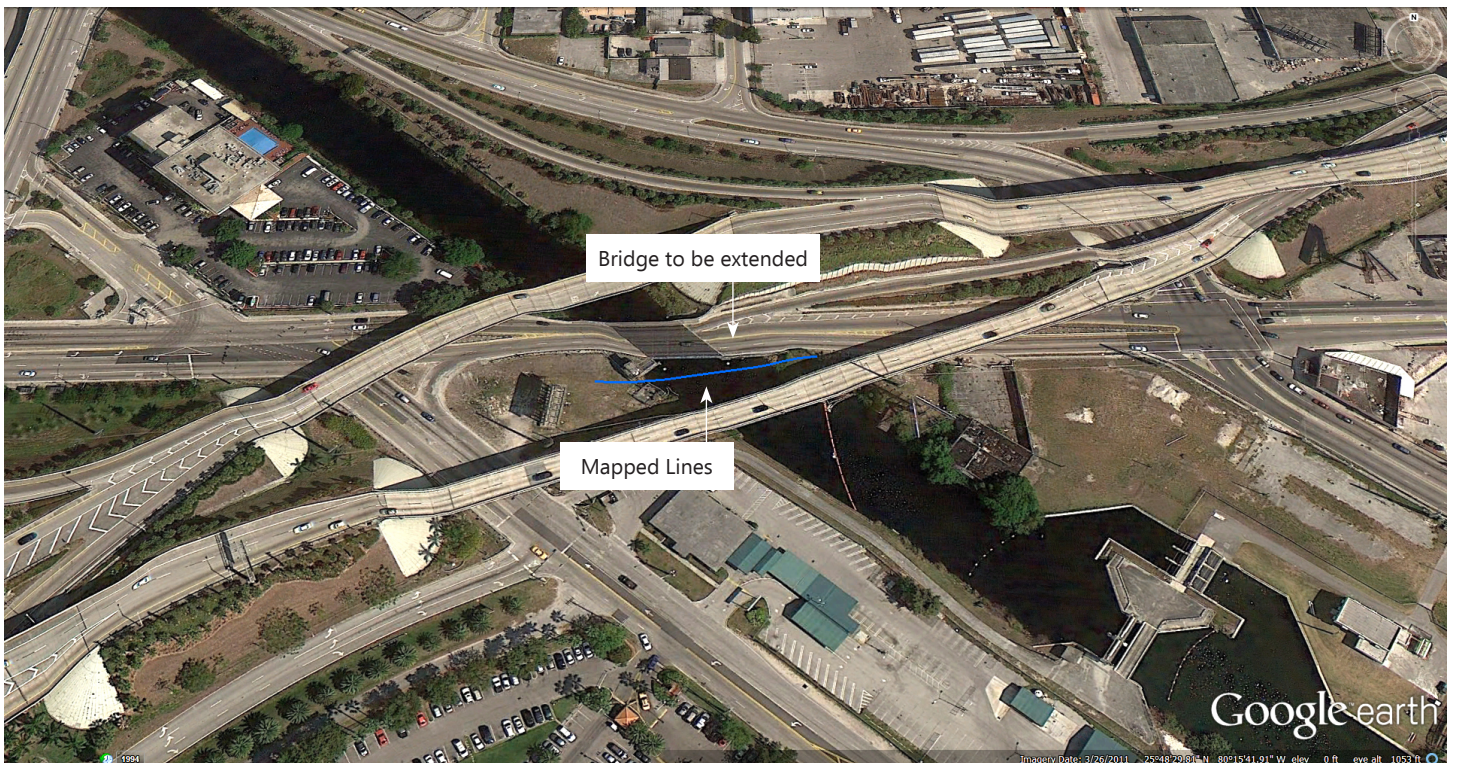
Figure 4: Site Location with Results

The individual plan and profile for each conduit were generated along with a plan and profile that shows all three conduits together (ref Appendix A). Figures 4 and 5 are the Google Earth images containing the results.
