SolidFX

Inspection Report

Anytown, USA

Inspected November 16, 2018

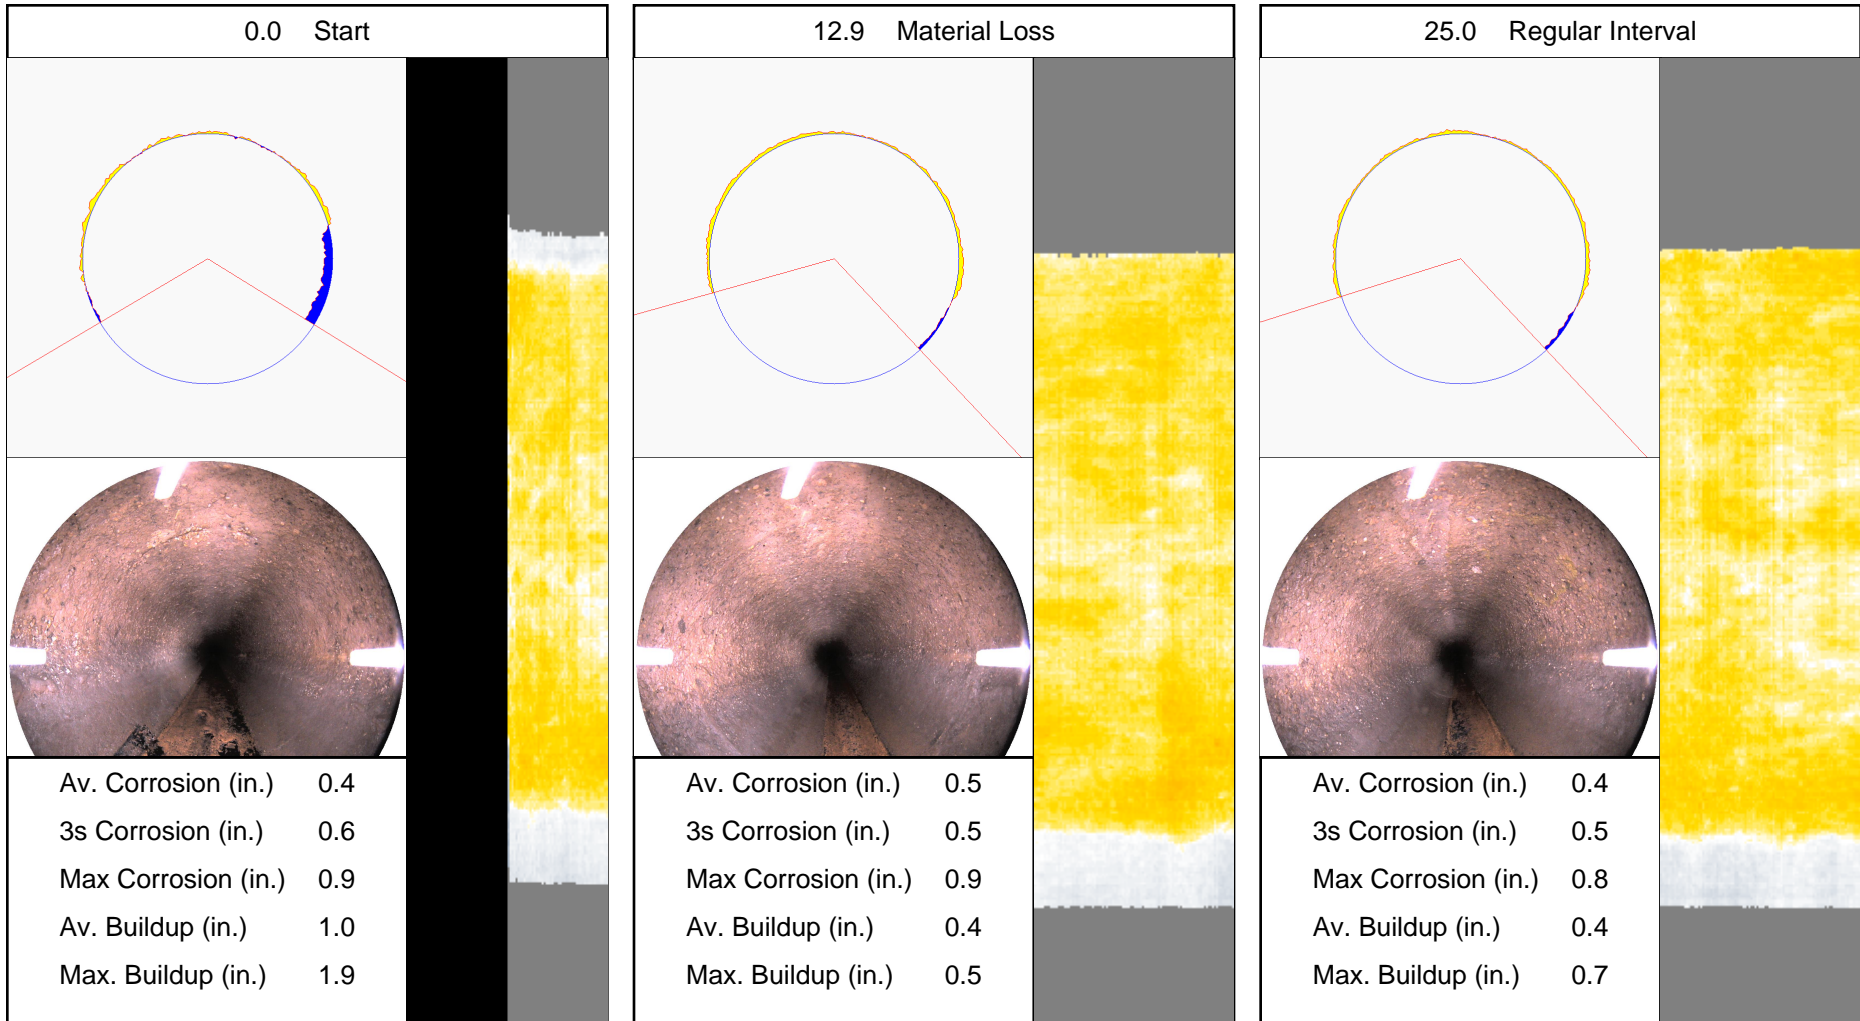
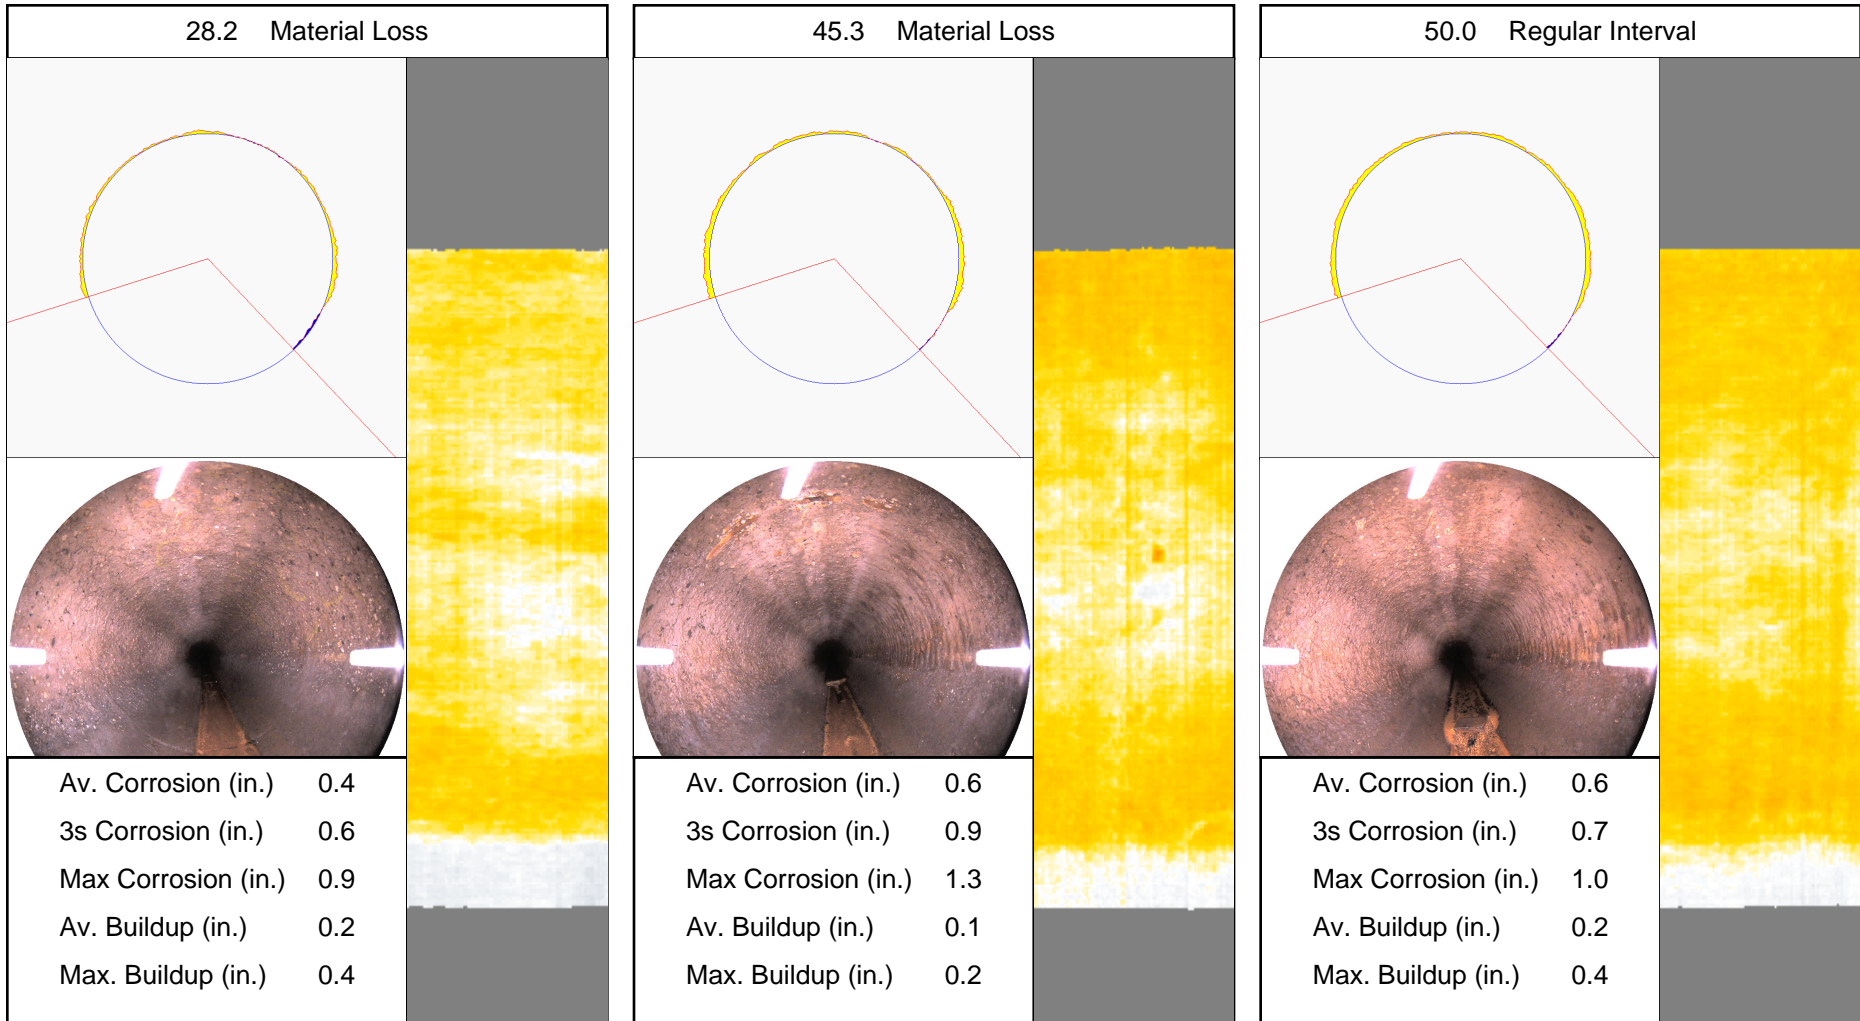
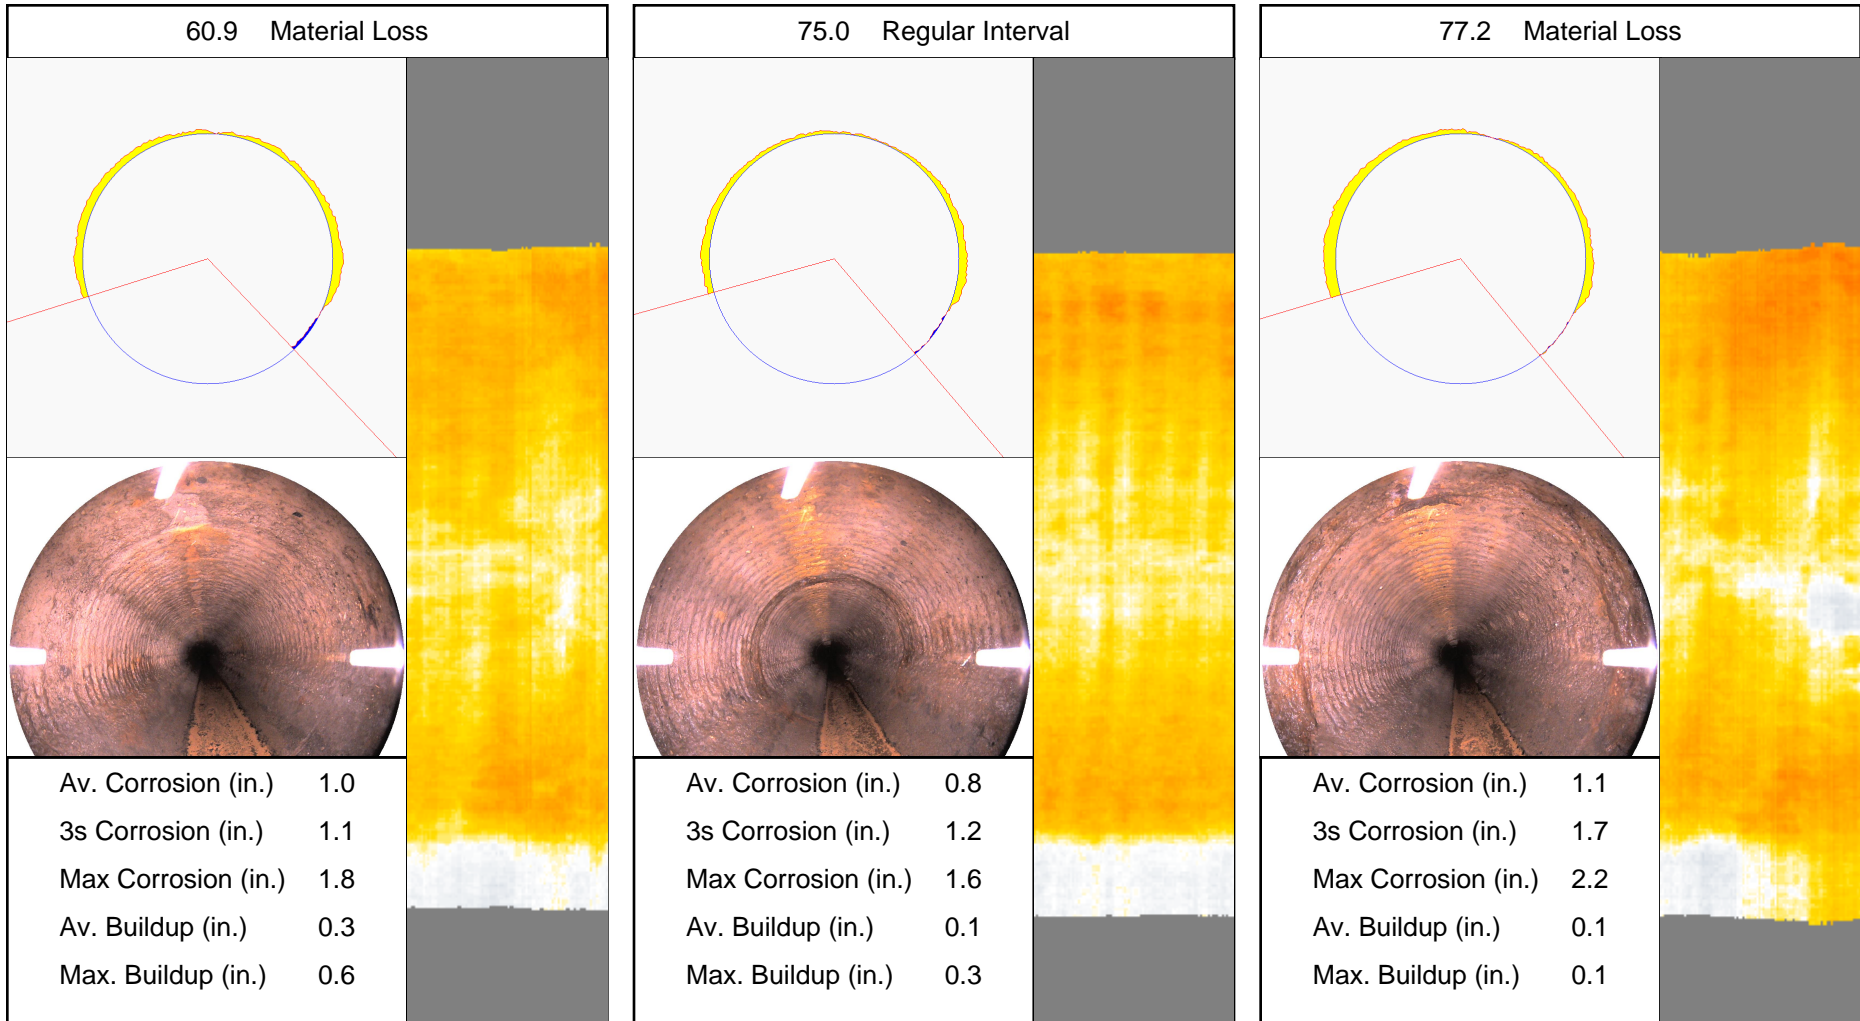
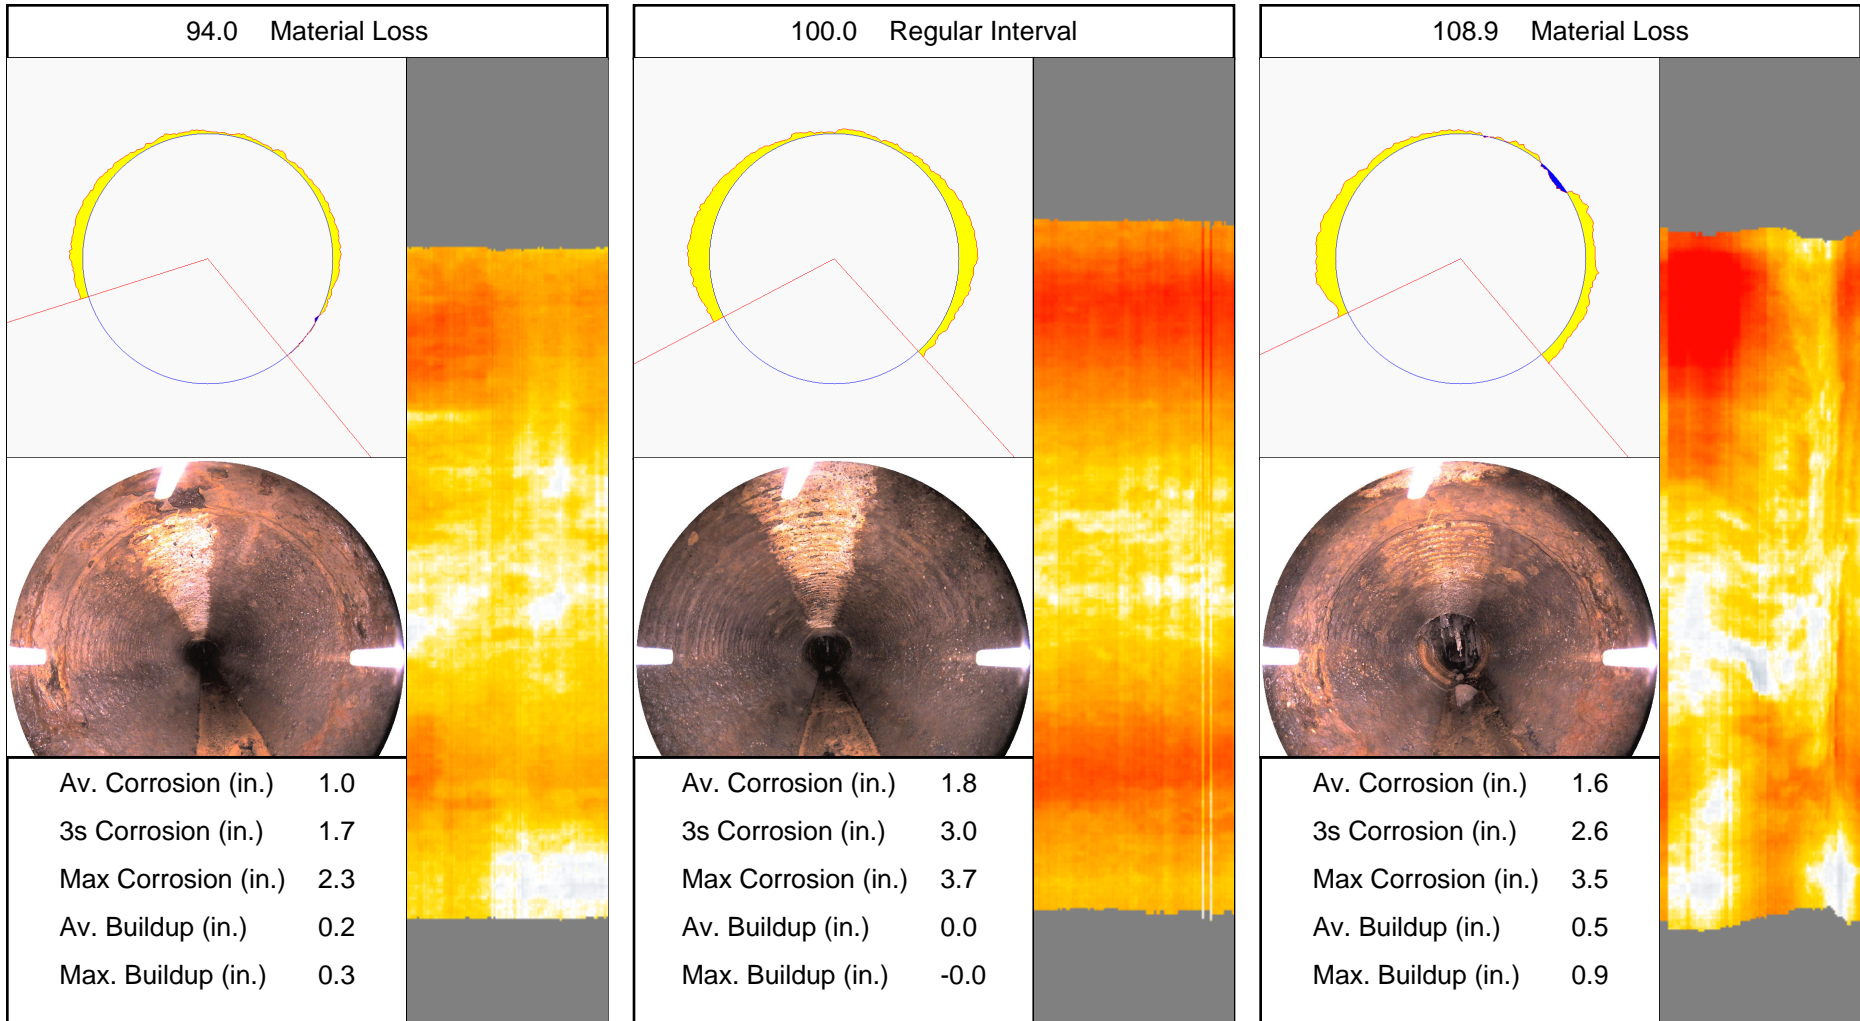
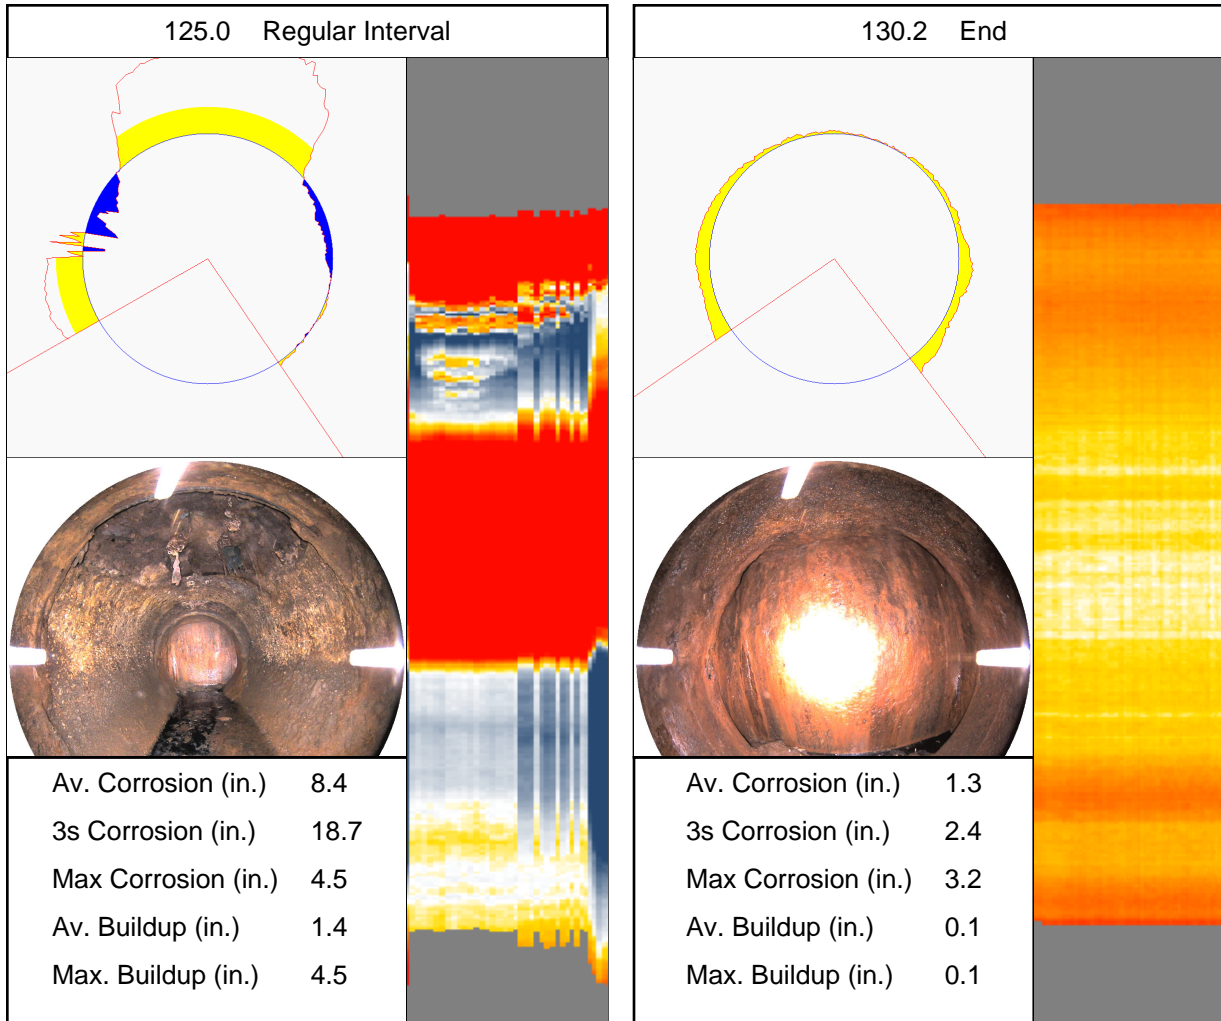
Distributed Cross-Sections

Service Area:	ITO1
Segment Reference:	SMH-11L901 - SMH-11L092
Upstream Manhole:	SMH-11L901
Downstream Manhole:	SMH-11L092
Direction:	Upstream
Distance:	130.2
Scan Date:	November 16, 2018
Operator Notes:	None
Processing Notes:	Advanced corrosion present throughout the inspection
