Multi-Sensor Inspection: 2D LIDAR & 3D LIDAR

SolidFX MSI Equipment

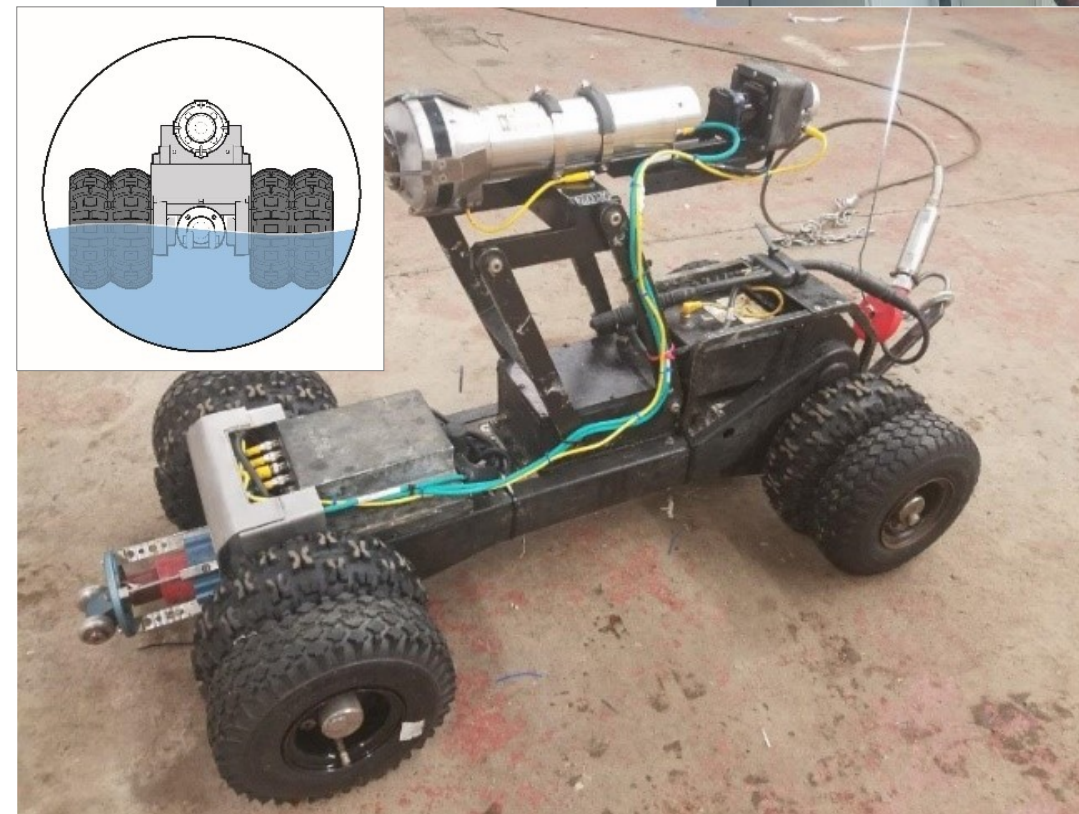
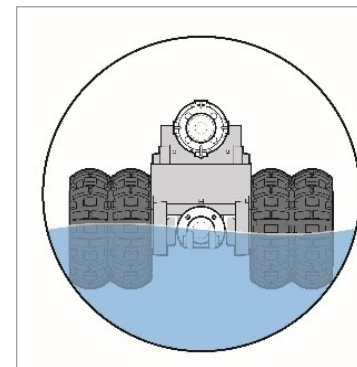
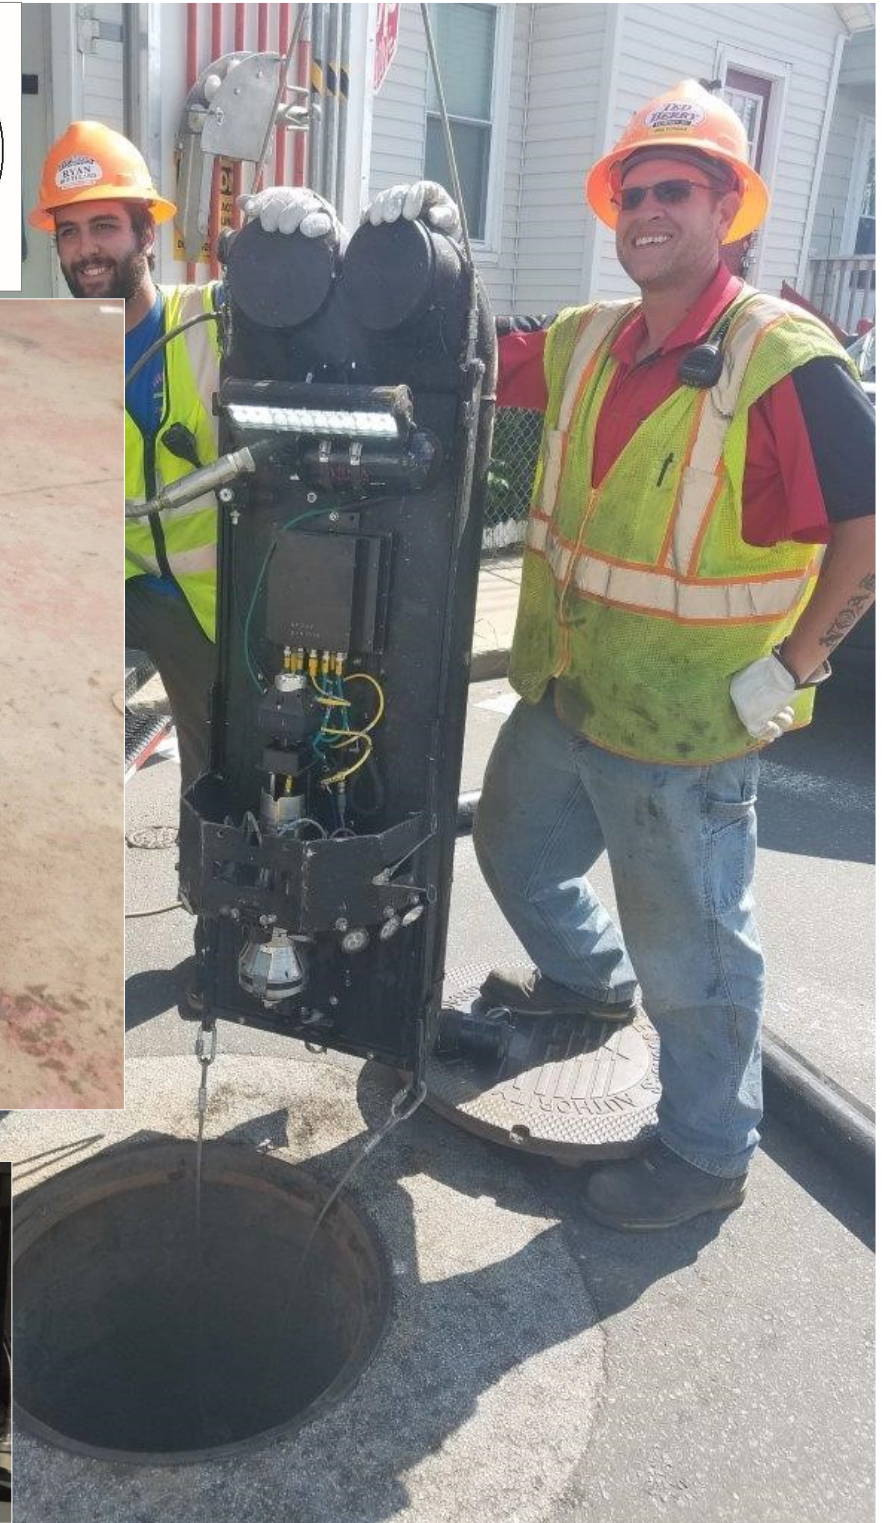
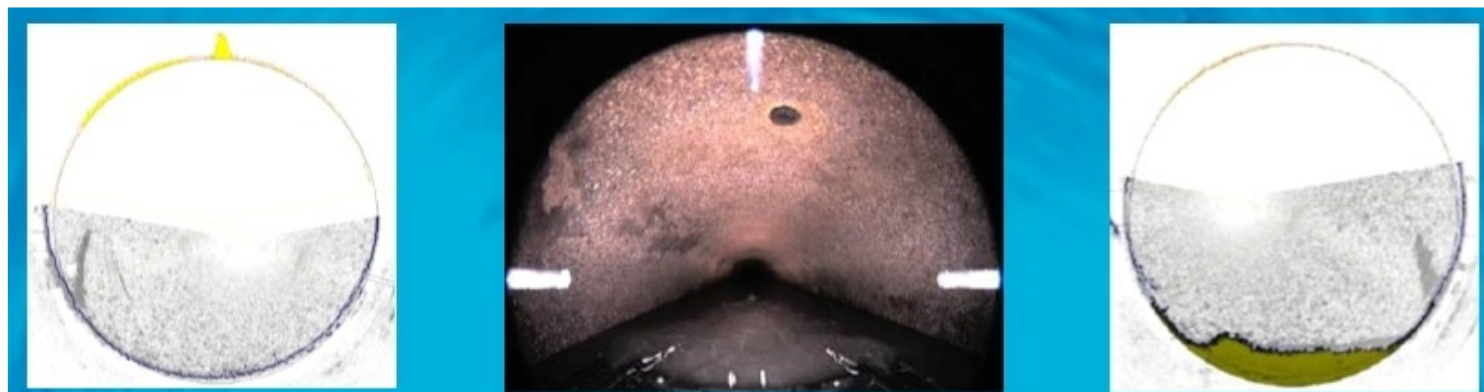
- State-of-the-Art 2D LIDAR Inspection
- FLOAT for 36" and larger pipe
 - Up to 5400 LF
- SMM for 24" and larger pipe
 - Up to 3000 LF
- View and verify data quality in real time
- Code in back office for QA/QC
- Lens cleaning for I&I

LIDAR view

DUC view

SONAR view

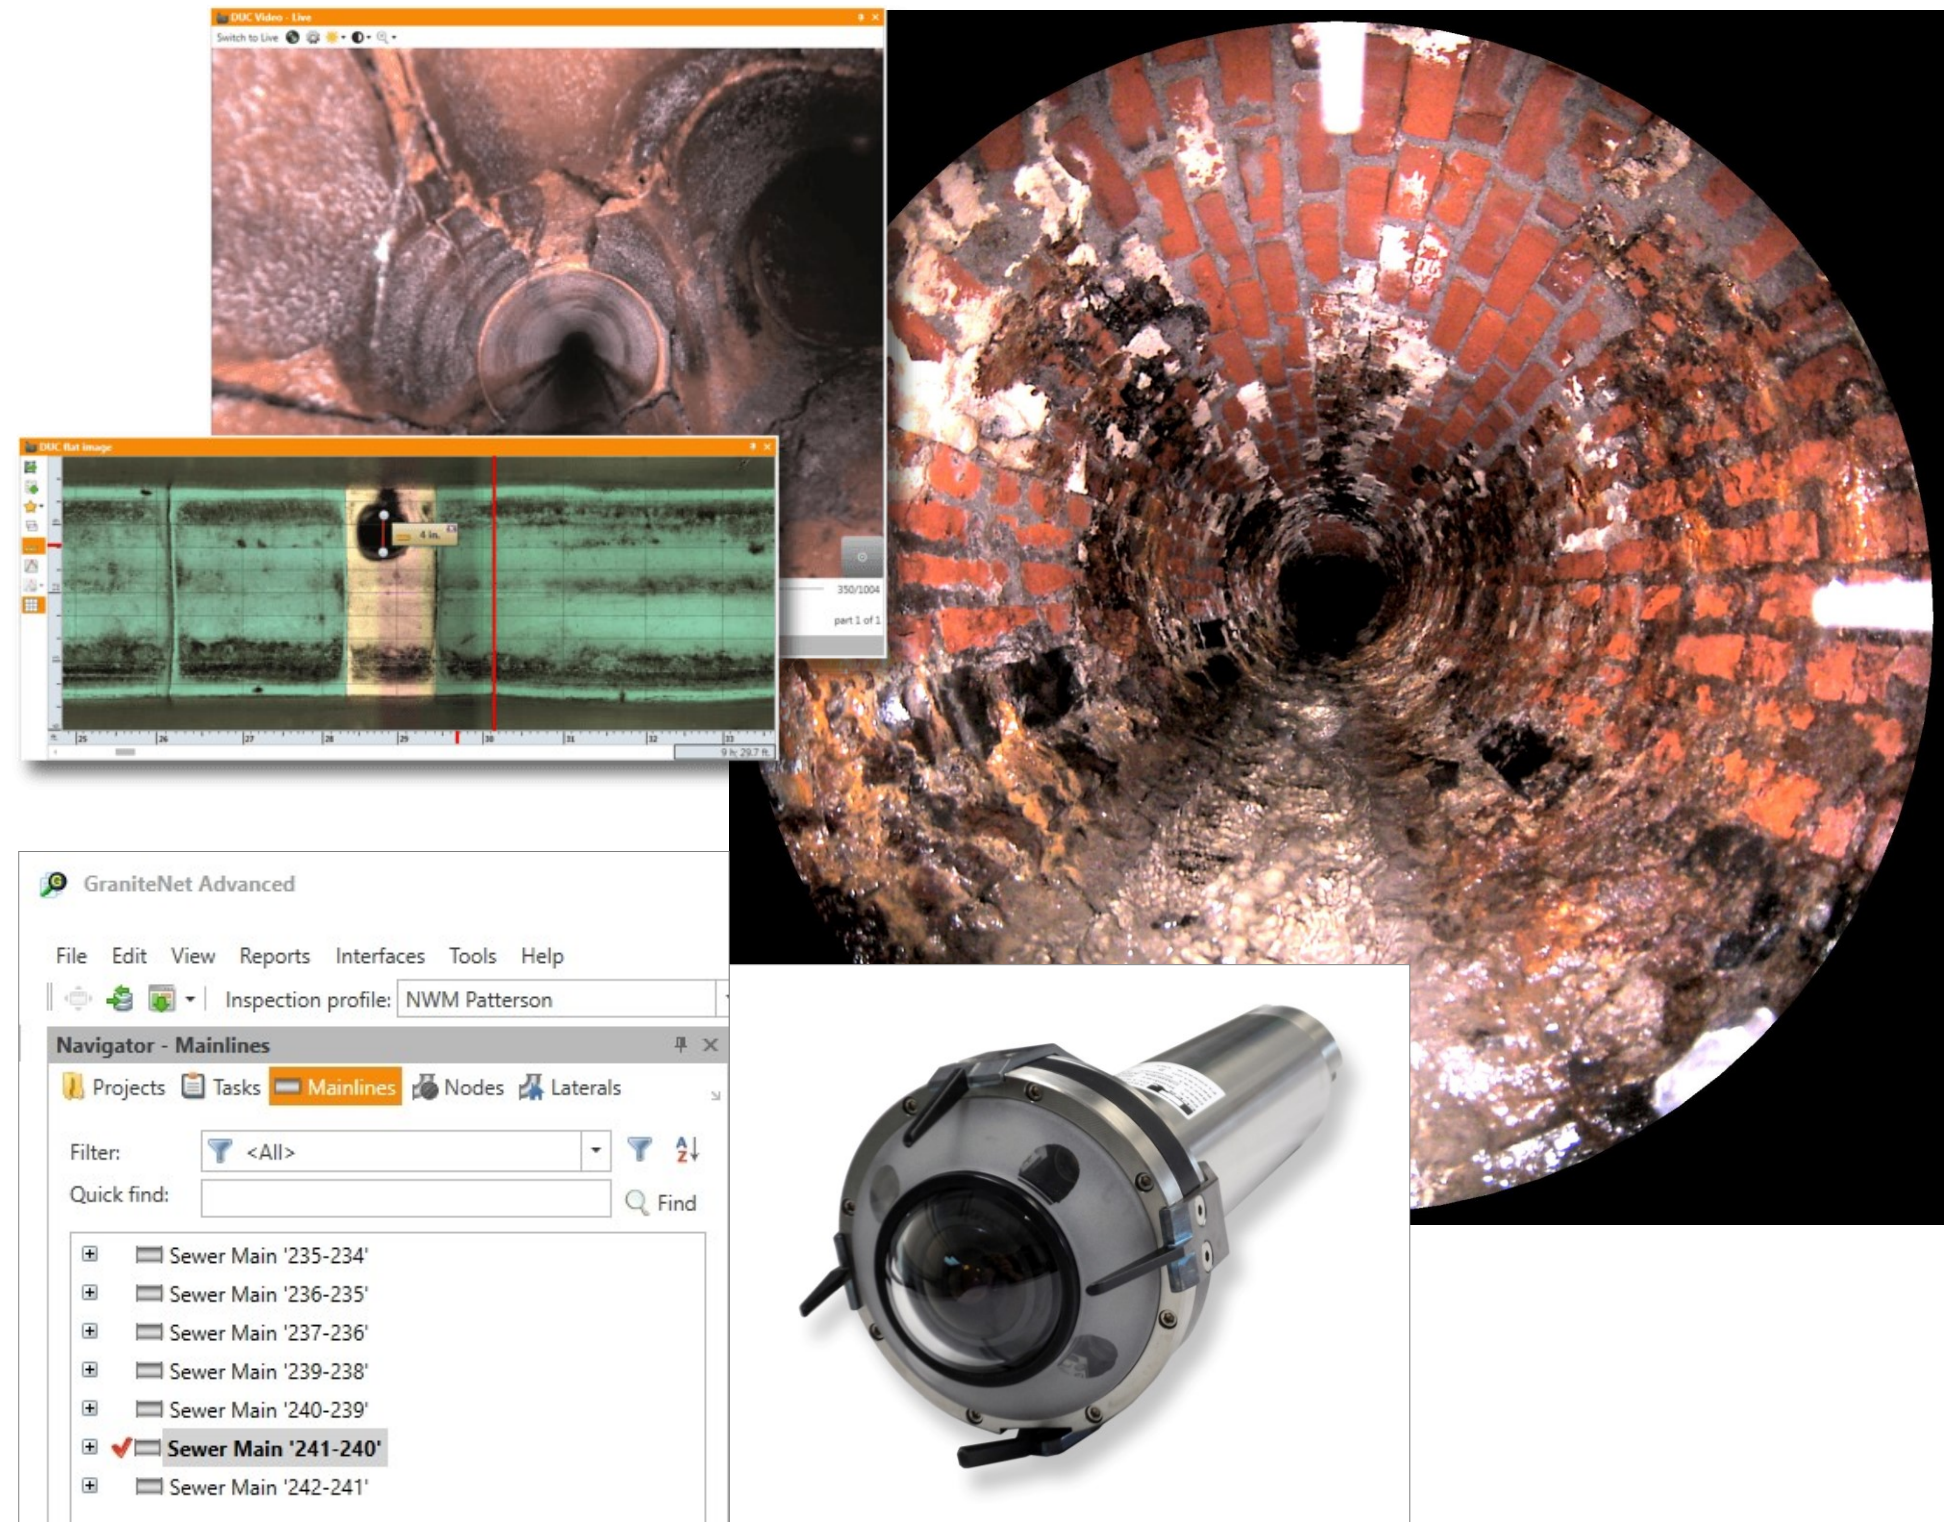
SFX-SONAR

Profiling SONAR

- Frequency = 2.25 MHz
- Beam = 1.4-deg conical
- RPM = 1 rev/sec
- Range = 6" - 180" (15 ft.)
- Pitch & Roll
- Debris level
- Water level
- Capacity Analysis
- On-screen measurements

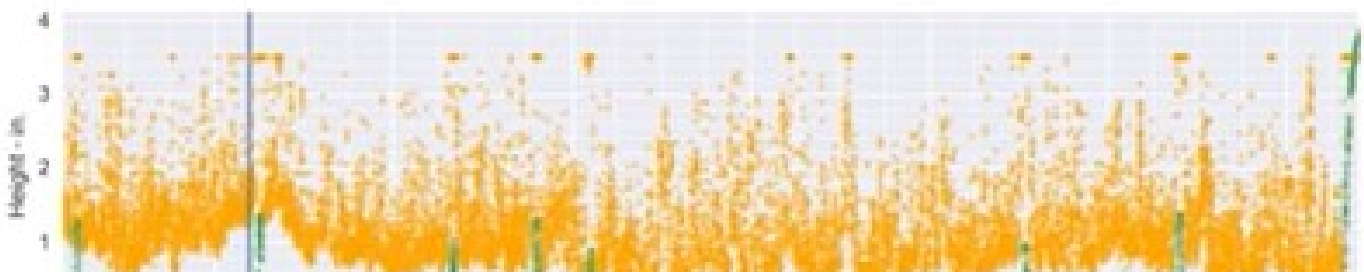
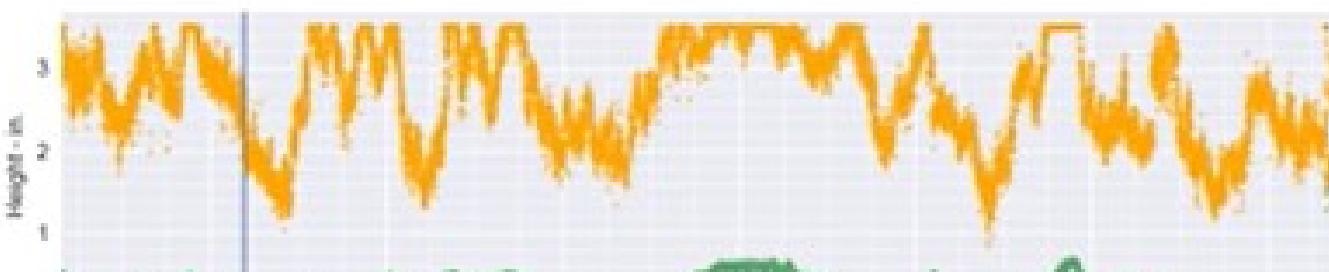
SFX-4:1 Viewer

PIPC
Upstream Manhole: GIS123
Downstream Manhole: GIS456

Payout: 29.7 Corrosion avg in: 0.27 Buildup avg in: 0.33
 2016-02-29 10:56:02 Corrosion max in: 1.27 Buildup max in: 2.53

HD Video

Rollout View

Cross Section View

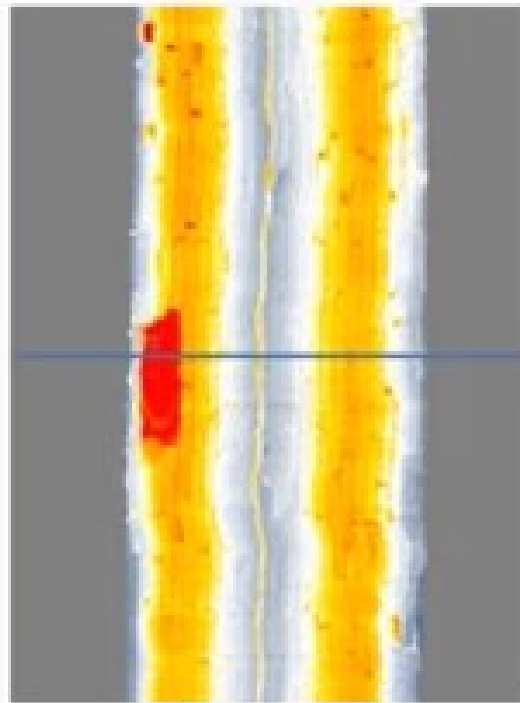
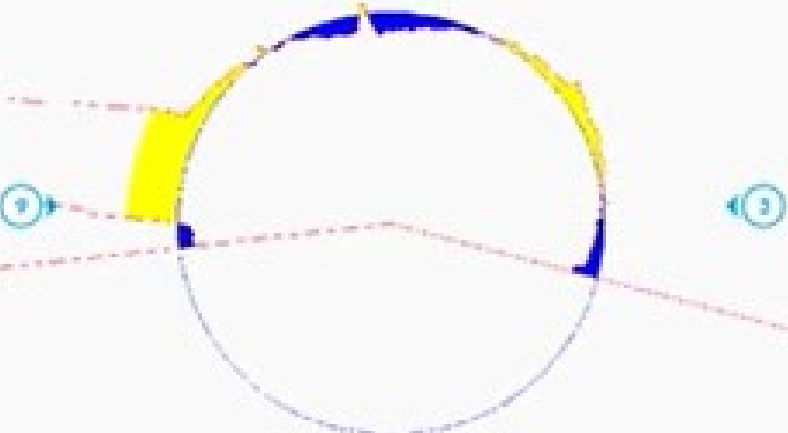
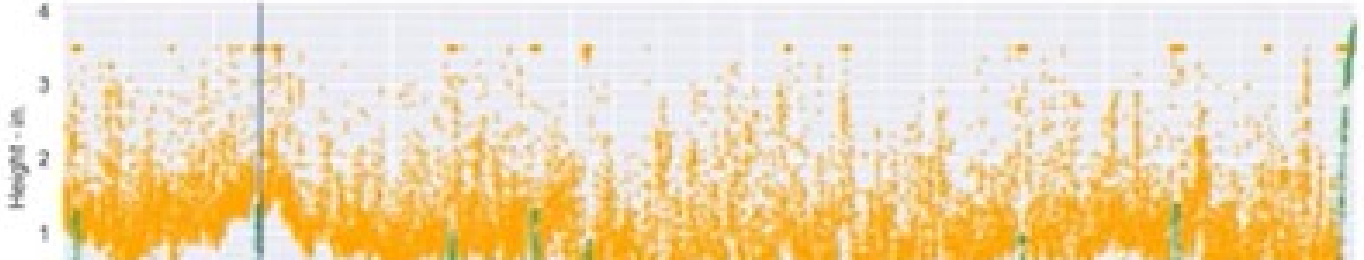
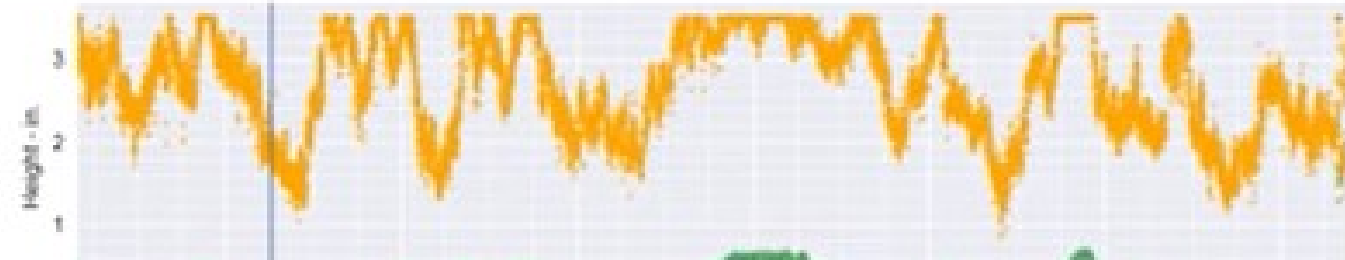
SFX-4:1 Viewer (cont.)

**PIP**
Upstream Manhole: GIS123
Downstream Manhole: GIS456

Payout: 31.4
2016-02-29 10:56:08

Corrosion avg in: 1.33
Corrosion max in: 3.5

Buildup avg in: 0.27
Buildup max in: 1.98

HD Video

Rollout View

Cross Section View

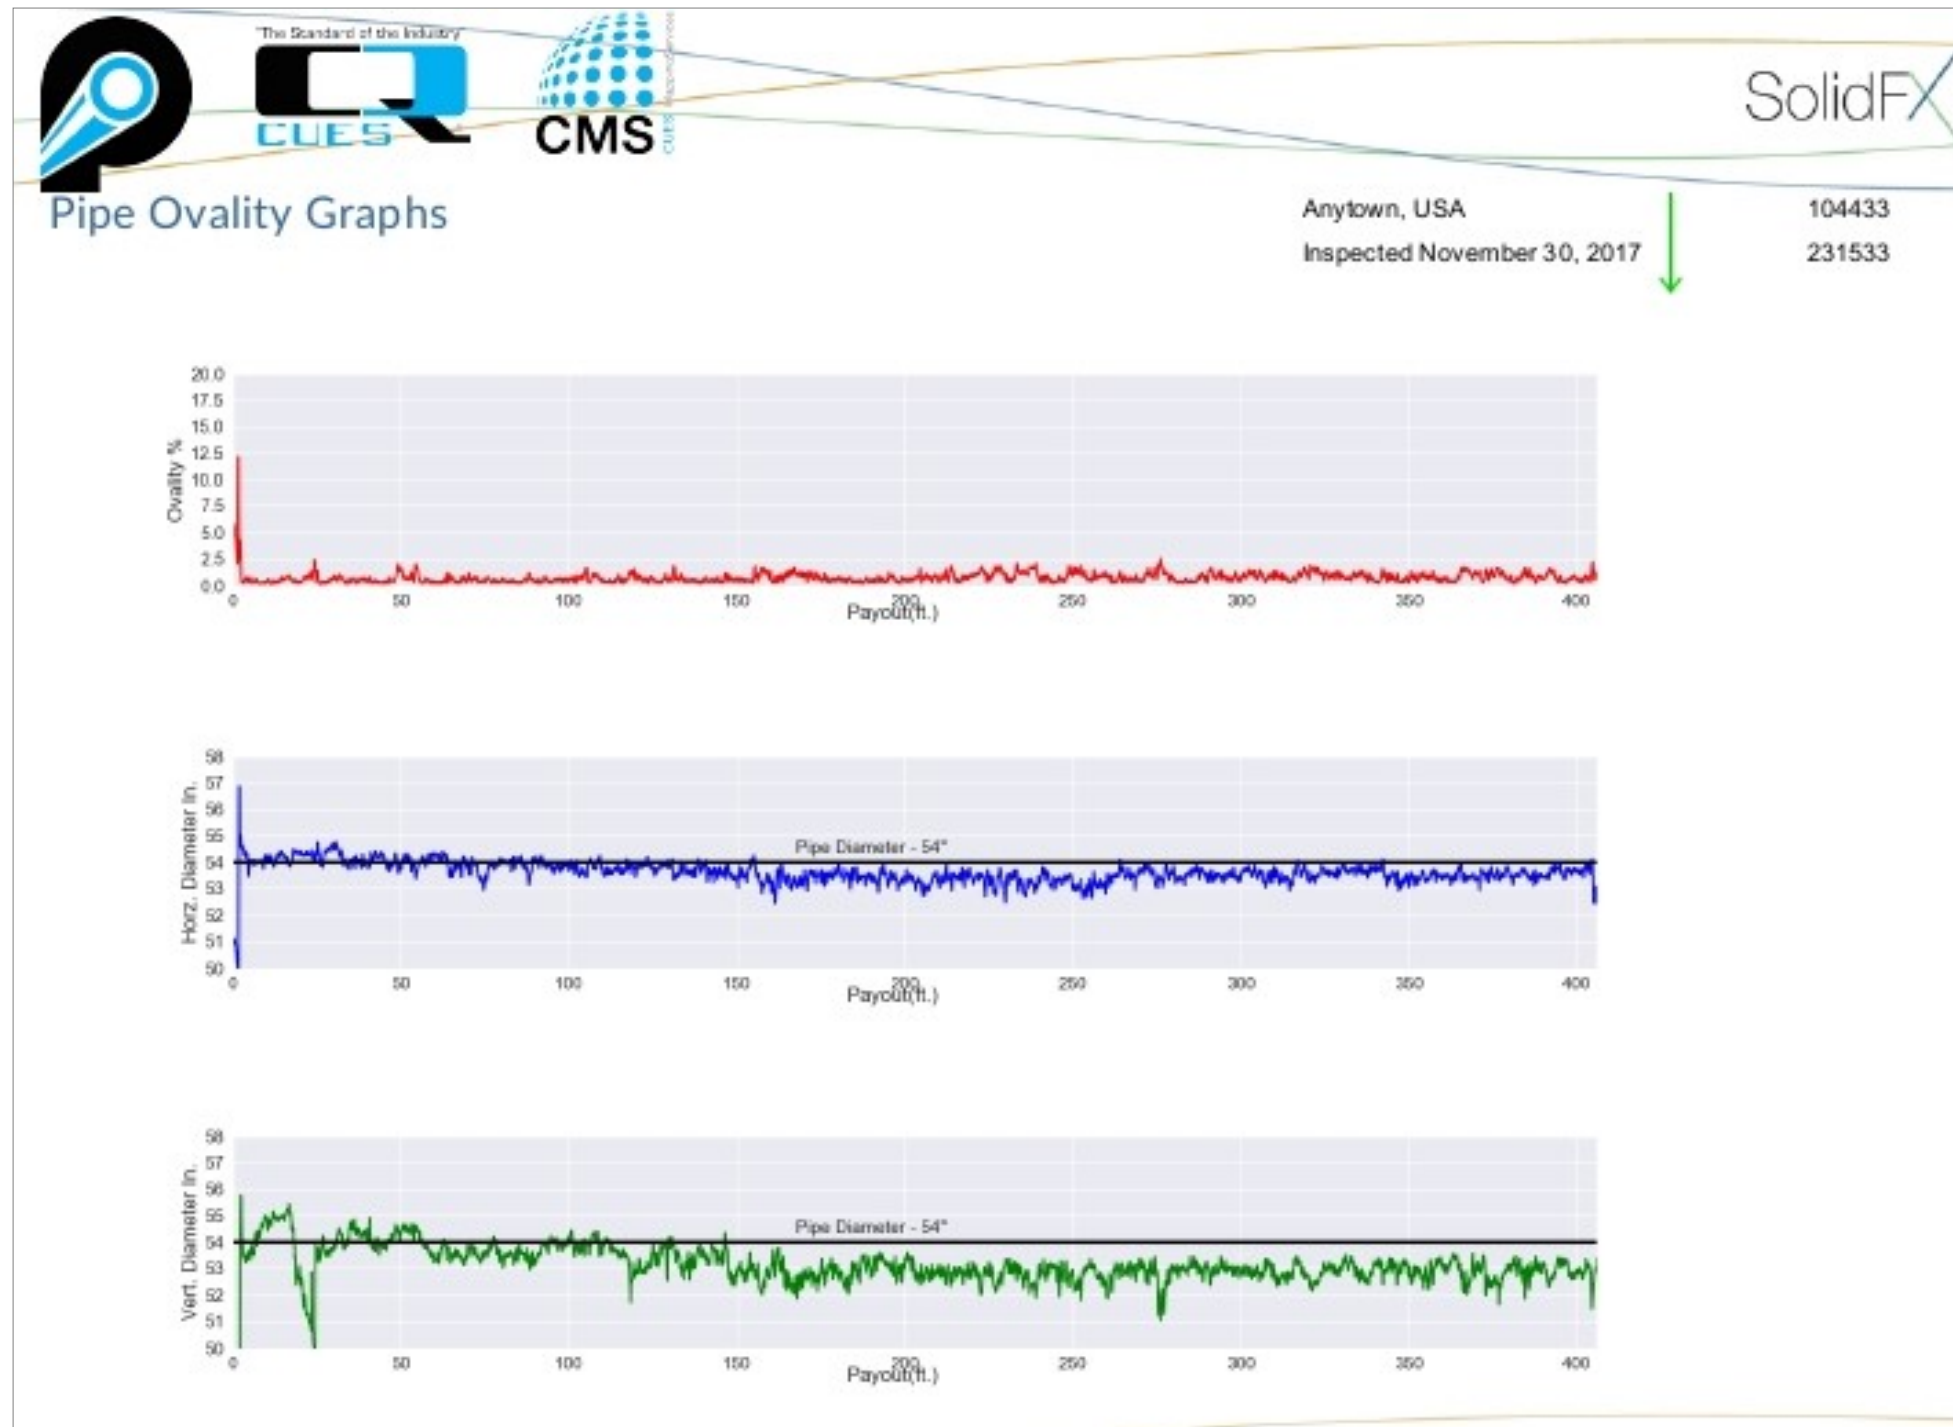
SFX-Condition Assessment Report *(cont.)*

$$\text{Ovality} = \frac{(\text{Horizontal Diameter} - \text{Vertical Diameter})}{(\text{Horizontal Diameter} + \text{Vertical Diameter})}$$

Horizontal Diameter is width at maximum.
Vertical Diameter is 2 * Vertical Radius.
Vertical Radius is vertical distance from center of Horizontal Diameter to peak of circle

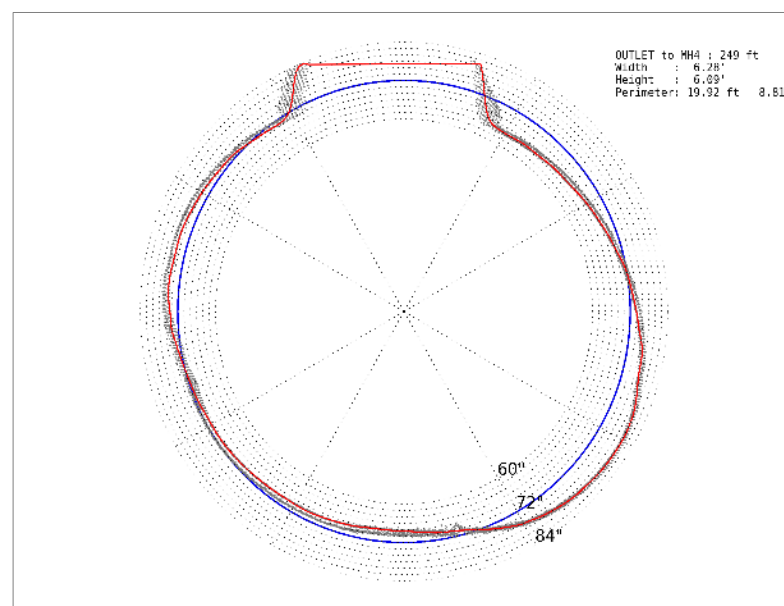
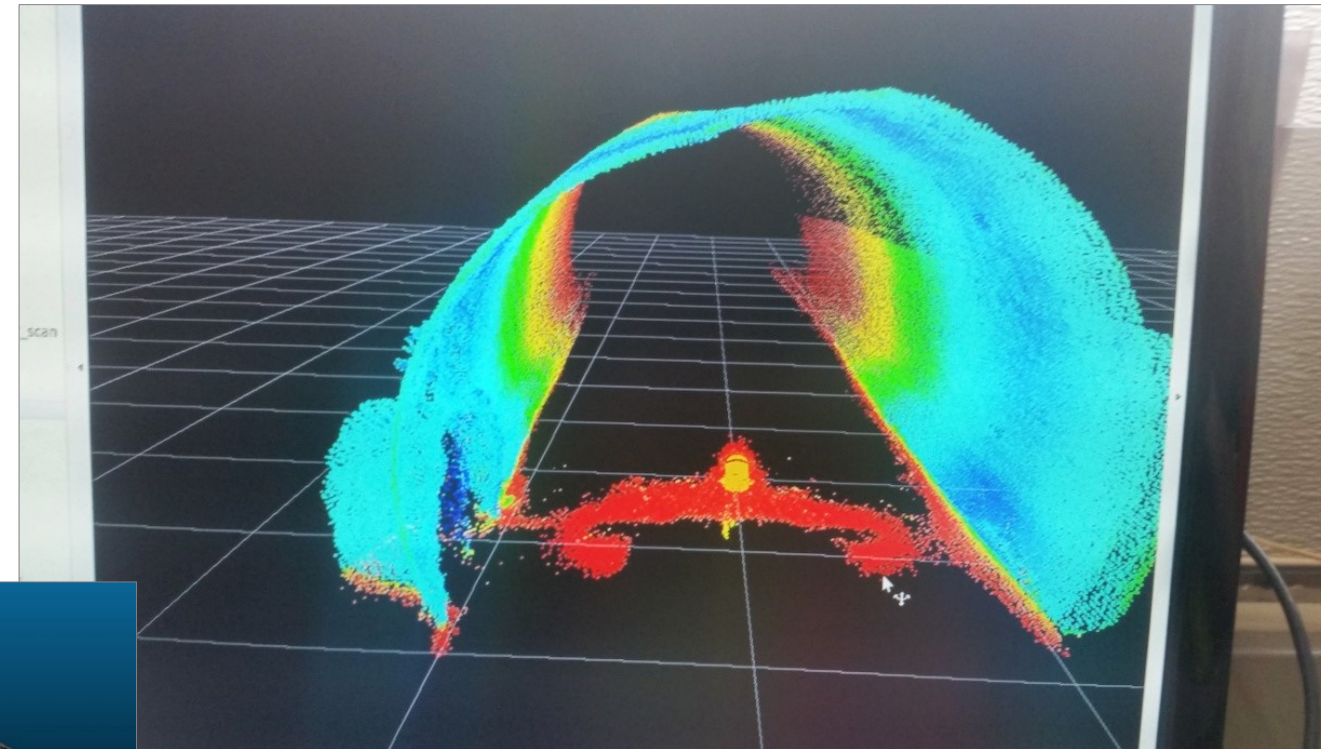
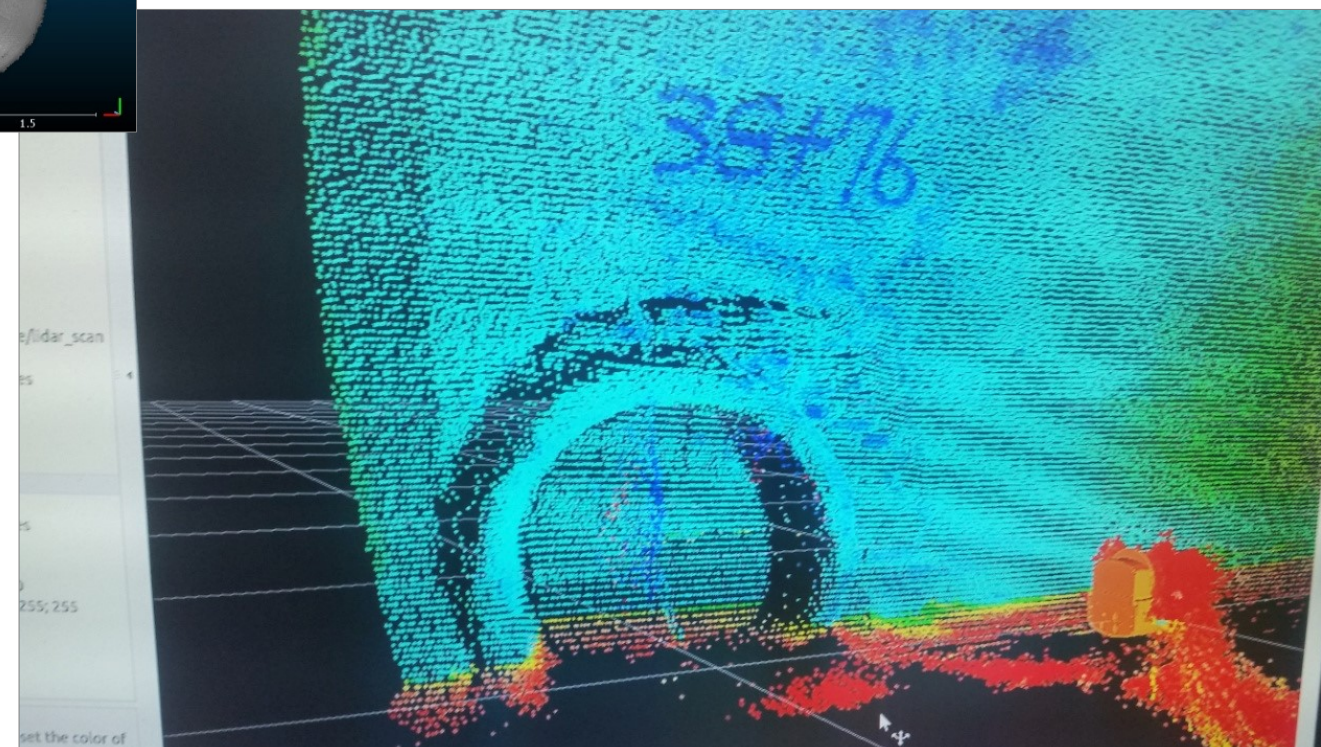
THE CUES SOLIDFX 3D MULTI-SENSOR PLATFORM

Used for condition assessment, rehabilitation planning, and geo-location mapping.

- Deployed from a stable skid or tractor
- Never miss a defect with the DUC camera
- Suitable for pipelines ranging from 36" to 240"
- The digital SONAR and DUC are complimented by 3D LiDAR
- LiDAR accurately measures cross sections & bends in the pipe
- Use LiDAR data and detailed scans to determine pipe centerline
- Collect high-density point clouds to accurately determine pipe size

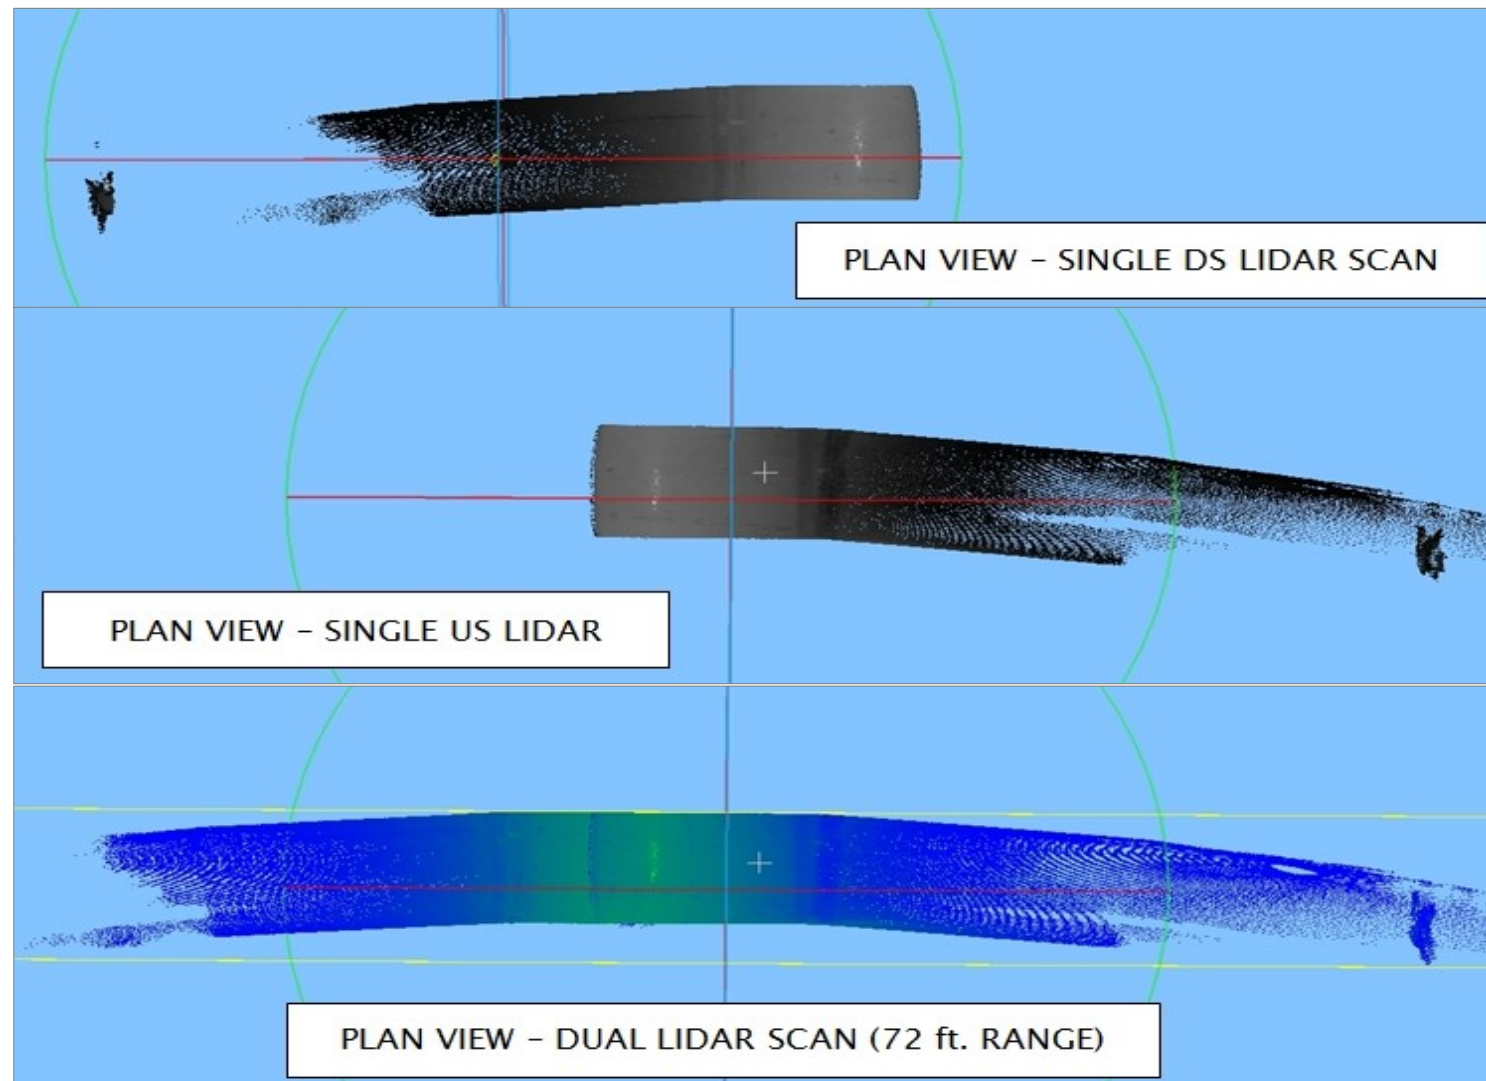
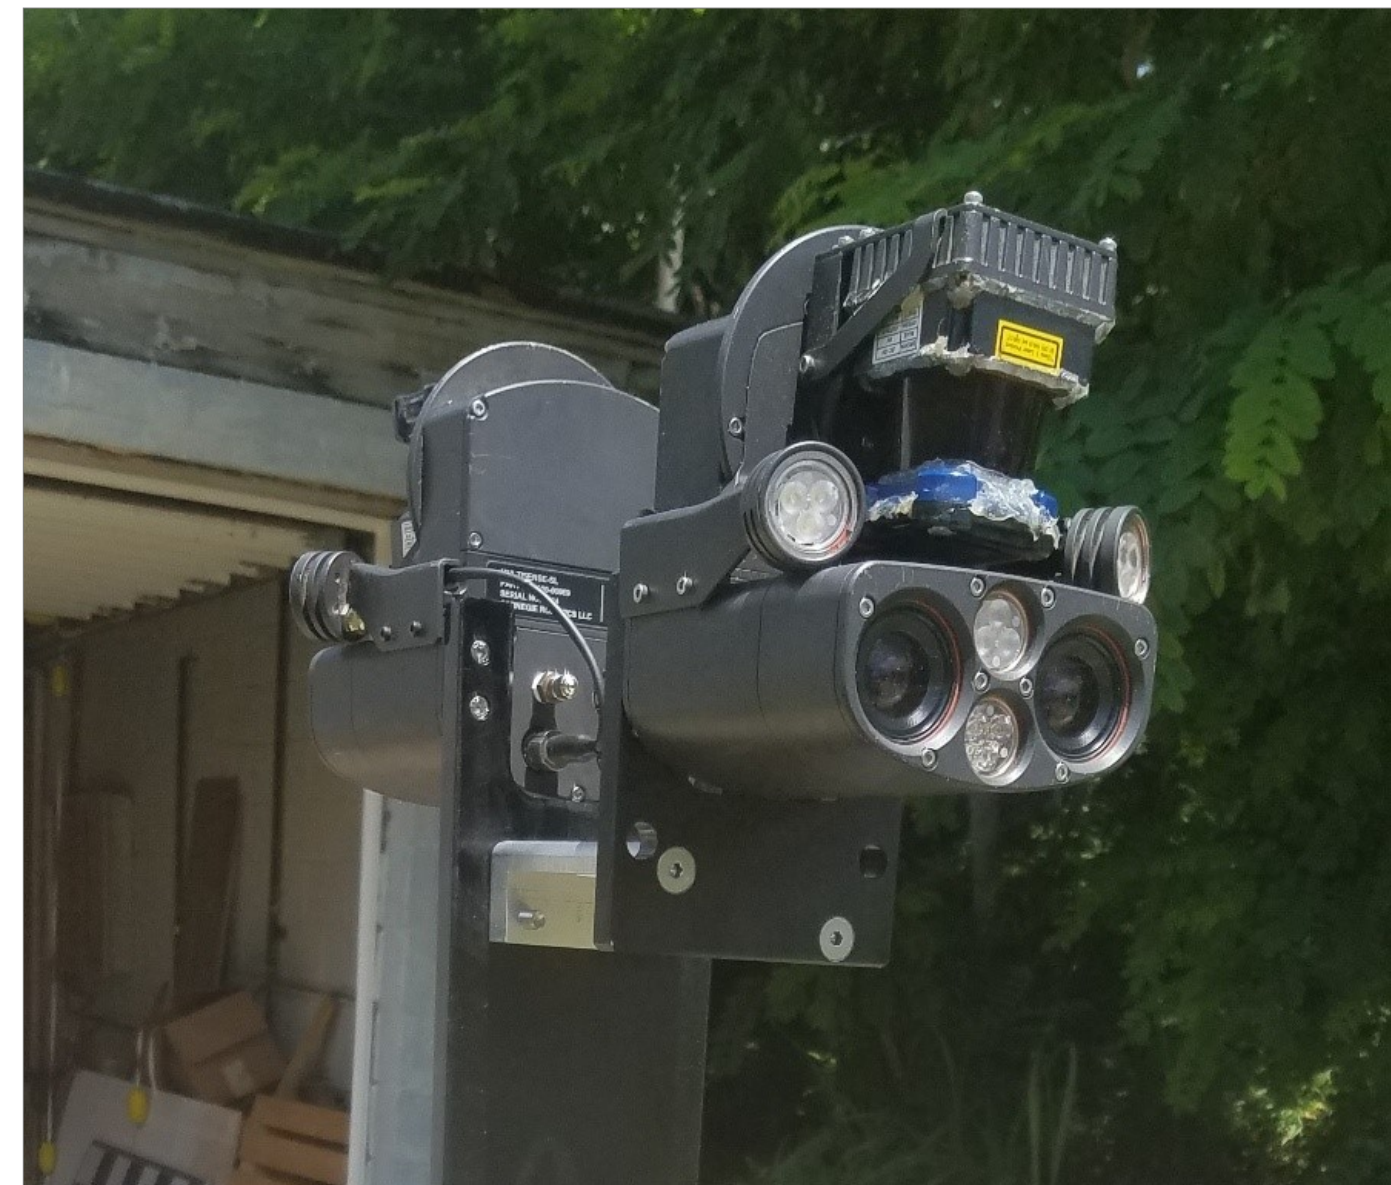
Dual LIDAR Technology

Combine Data From Two Sensors

One SCAN Covers 40-70 Feet

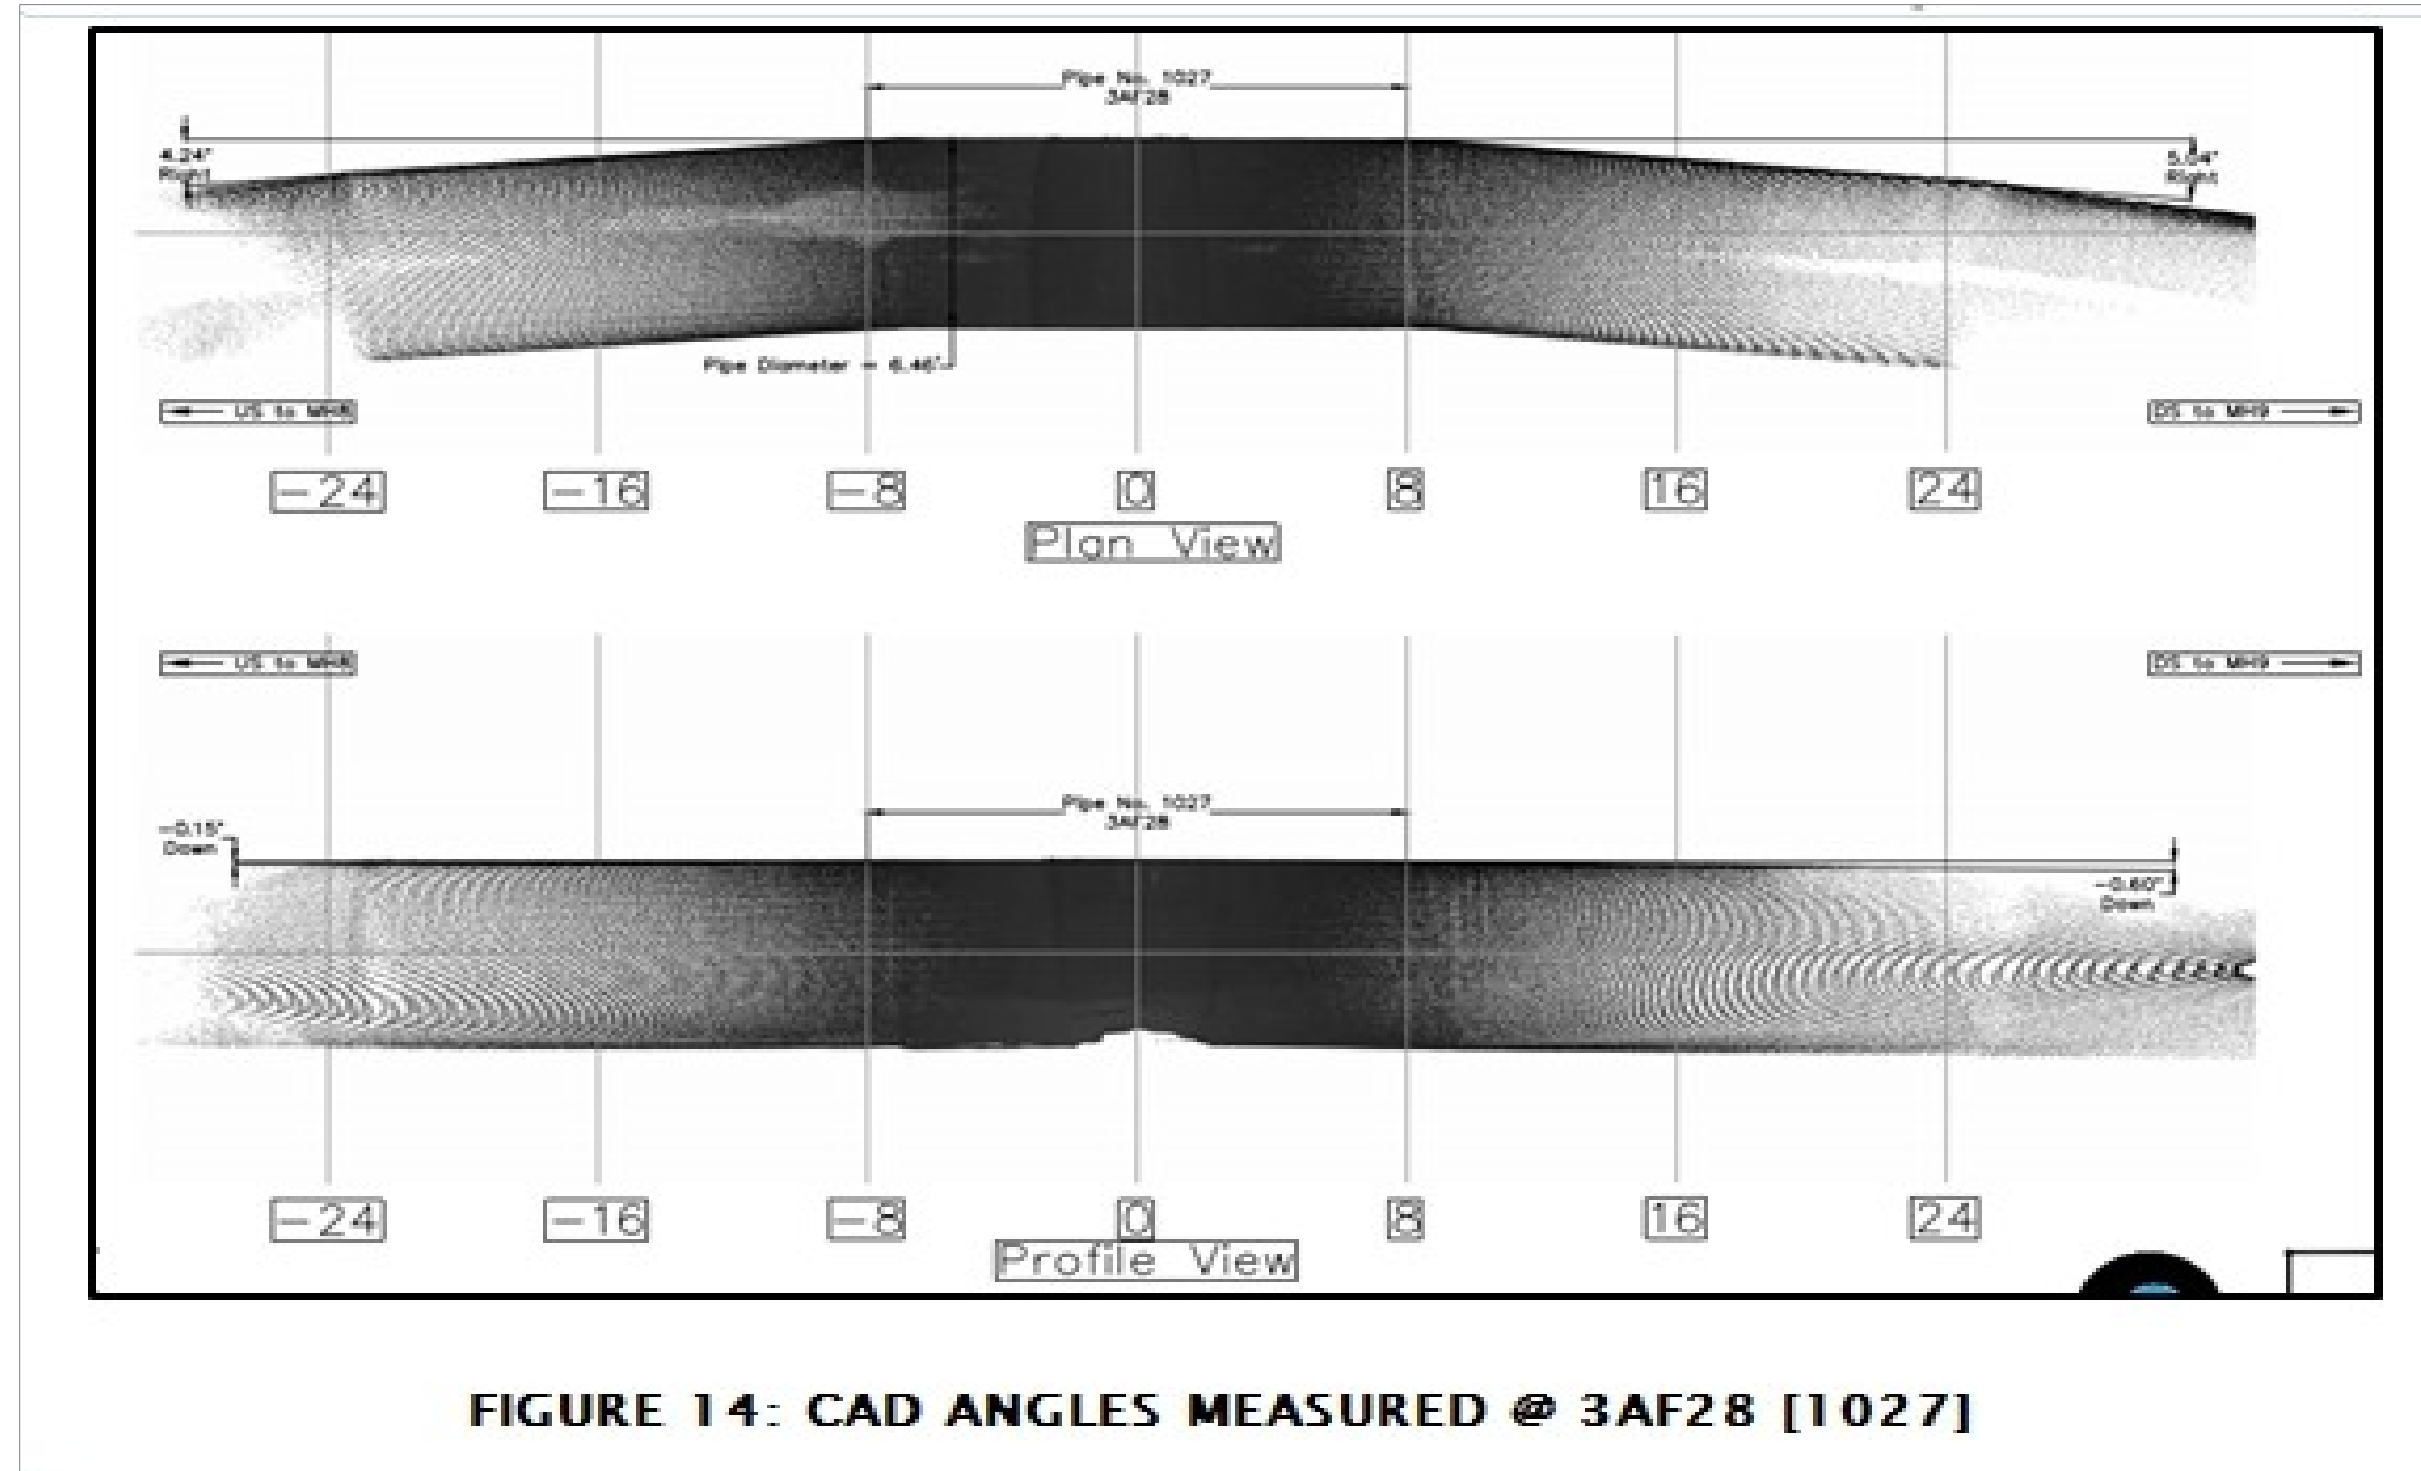
FIGURE 14: CAD ANGLES MEASURED @ 3AF28 [1027]

DUAL LIDAR Technology

Longer Point Cloud
More Accurate
Measurements
