Multi-Sensor Inspection: 2D LIDAR & 3D LIDAR

SolidFX MSI Equipment

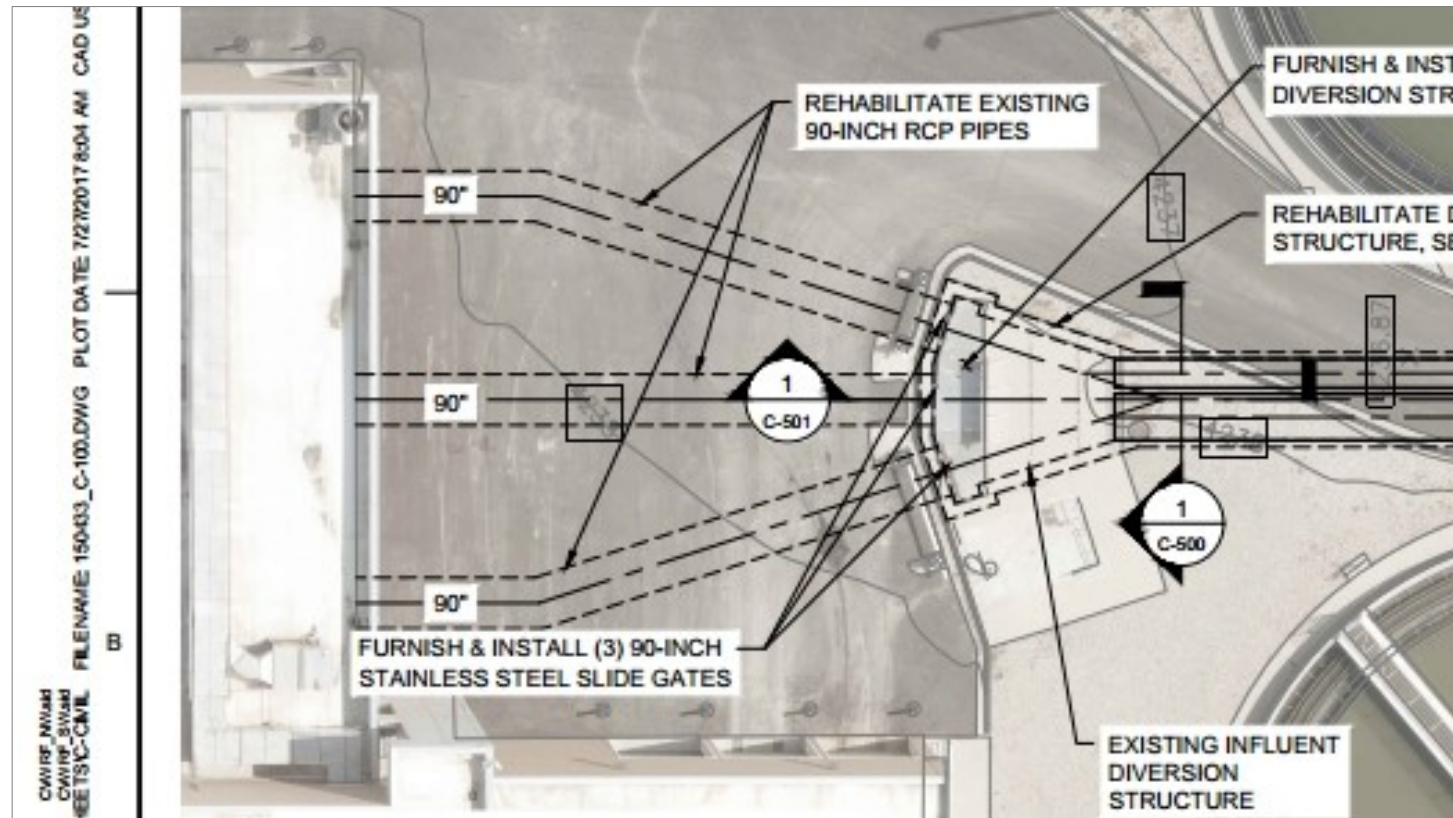
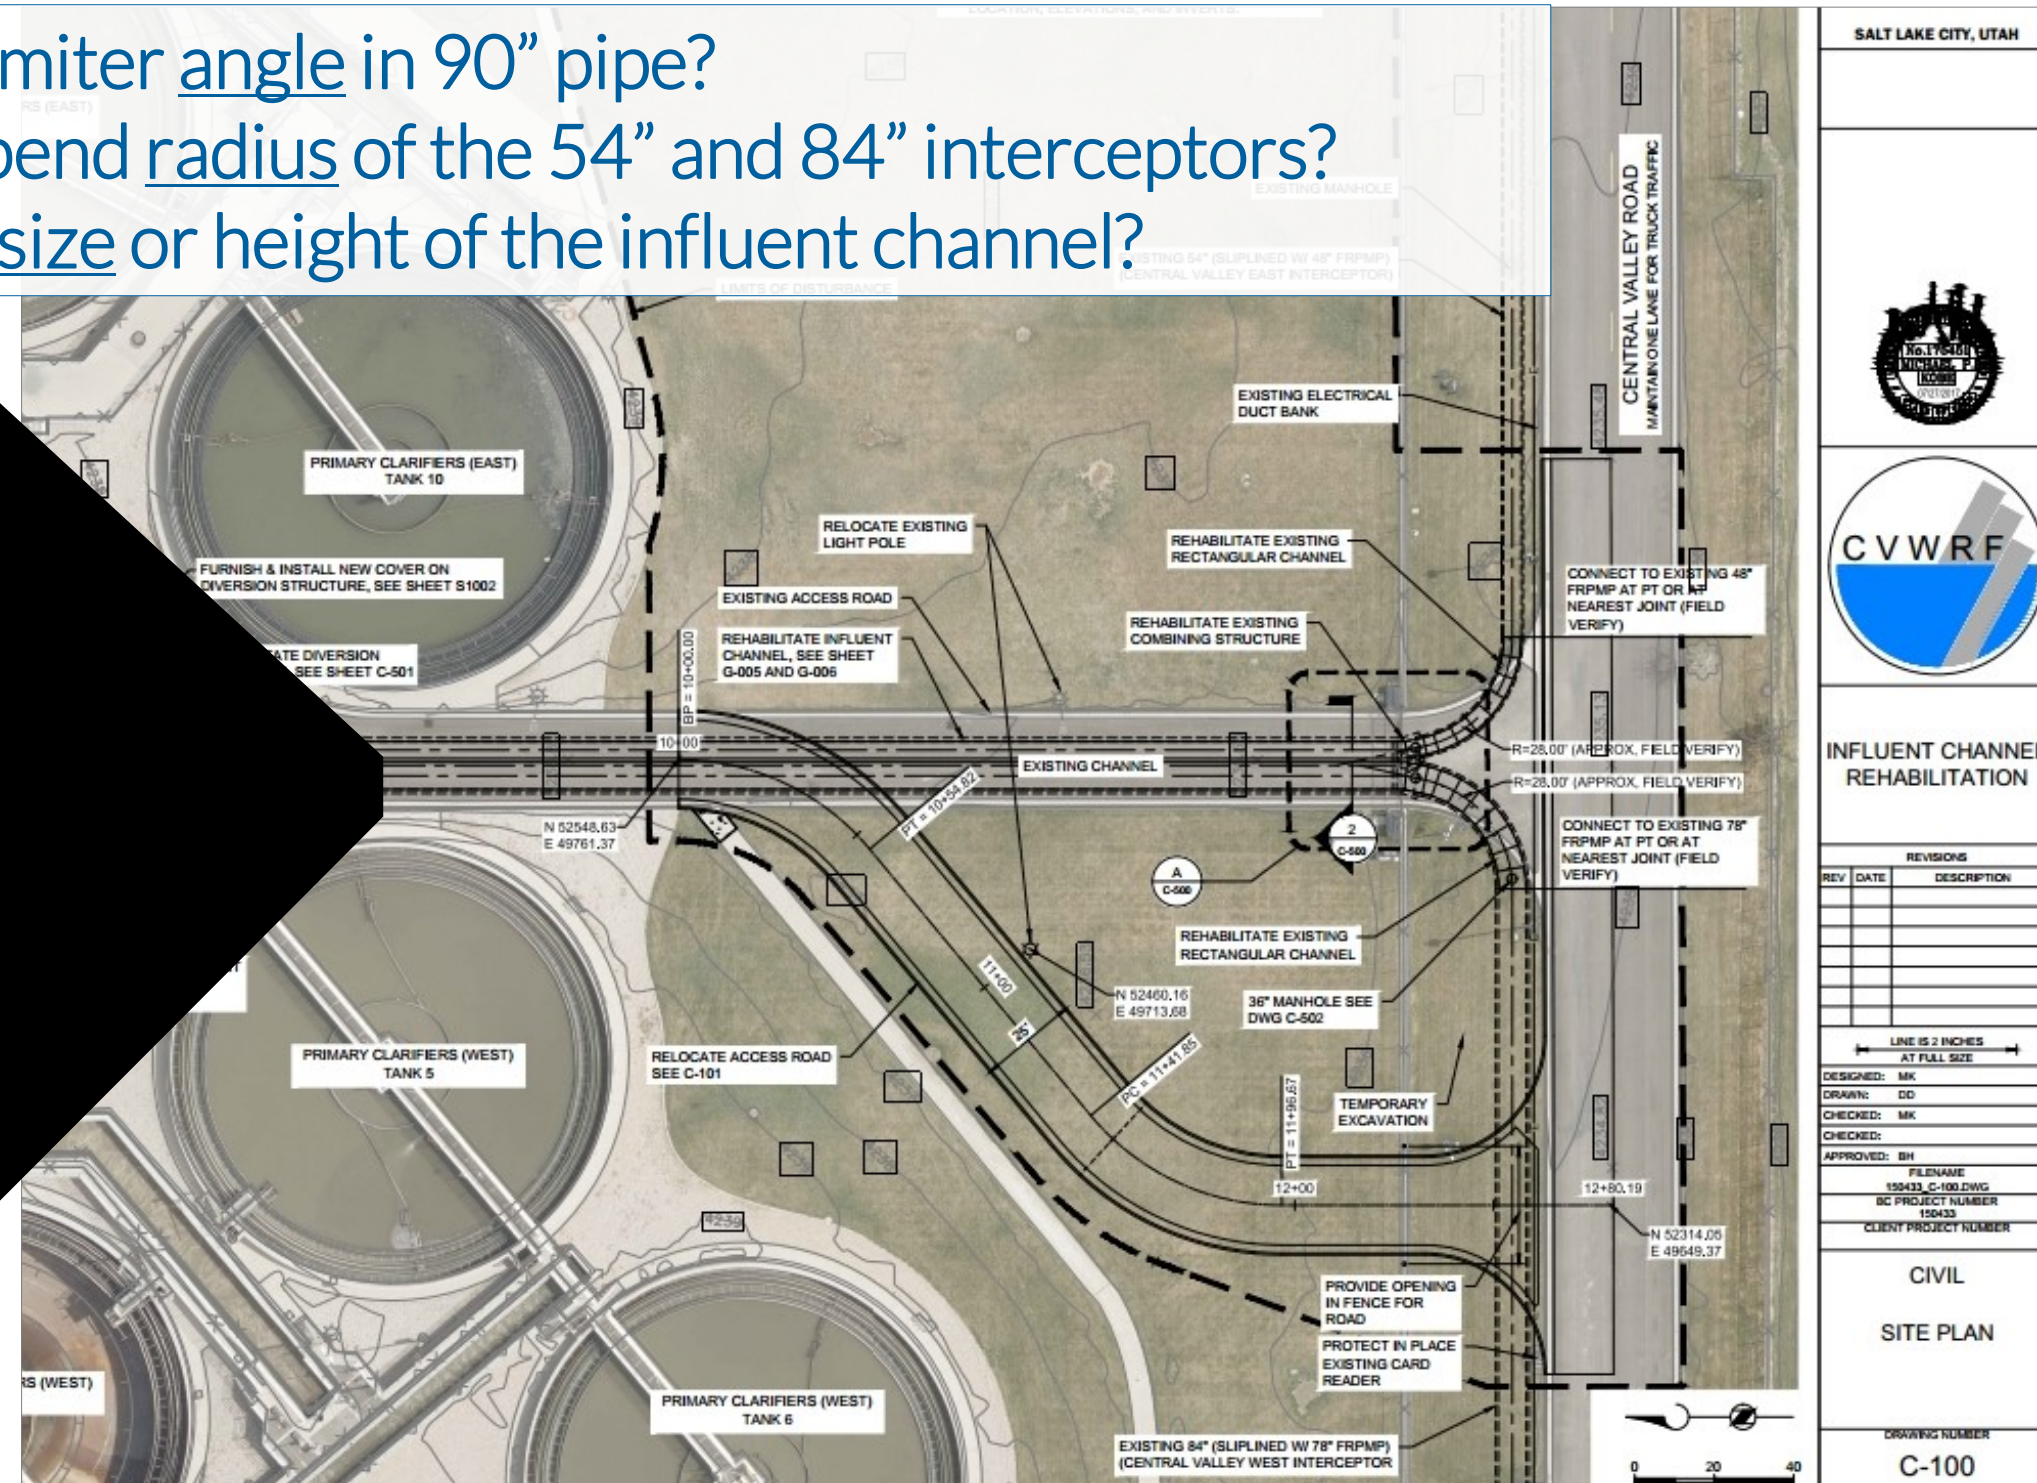
CIVIL
 SITE PLAN

Influent Structure Rehab Size and Bend Analysis

What is the miter angle in 90" pipe?
 What is the bend radius of the 54" and 84" interceptors?
 What is the size or height of the influent channel?

INFLUENT CHANNEL REHABILITATION

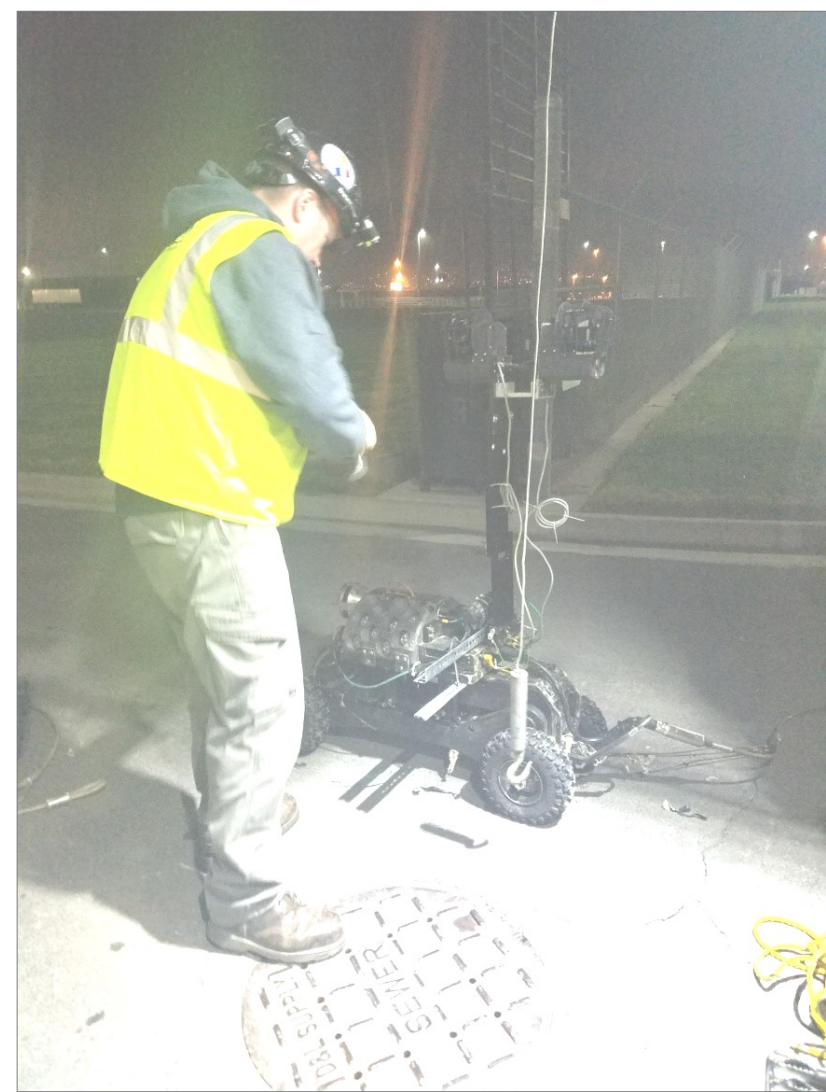
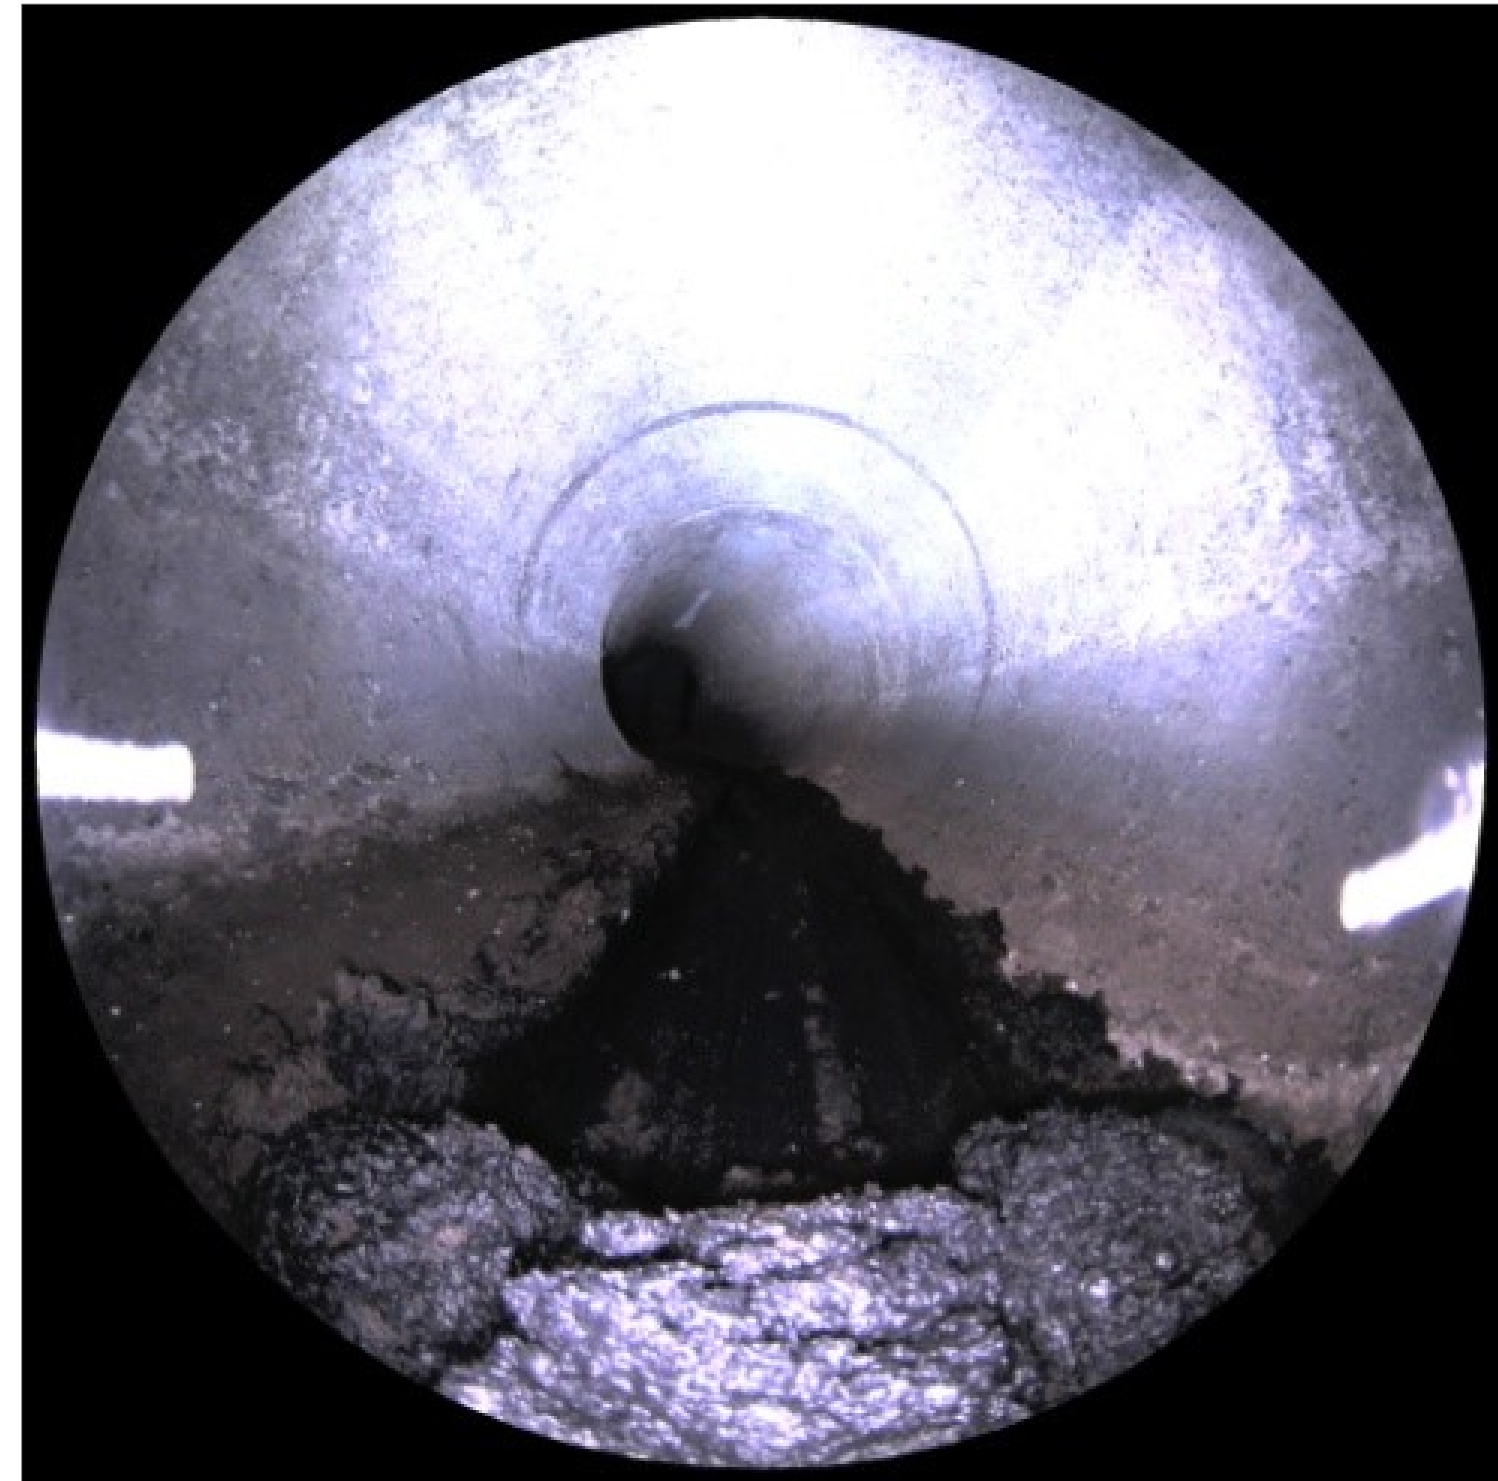
Influent Structure Rehab

SMM Setup

90" Diversion Pipe

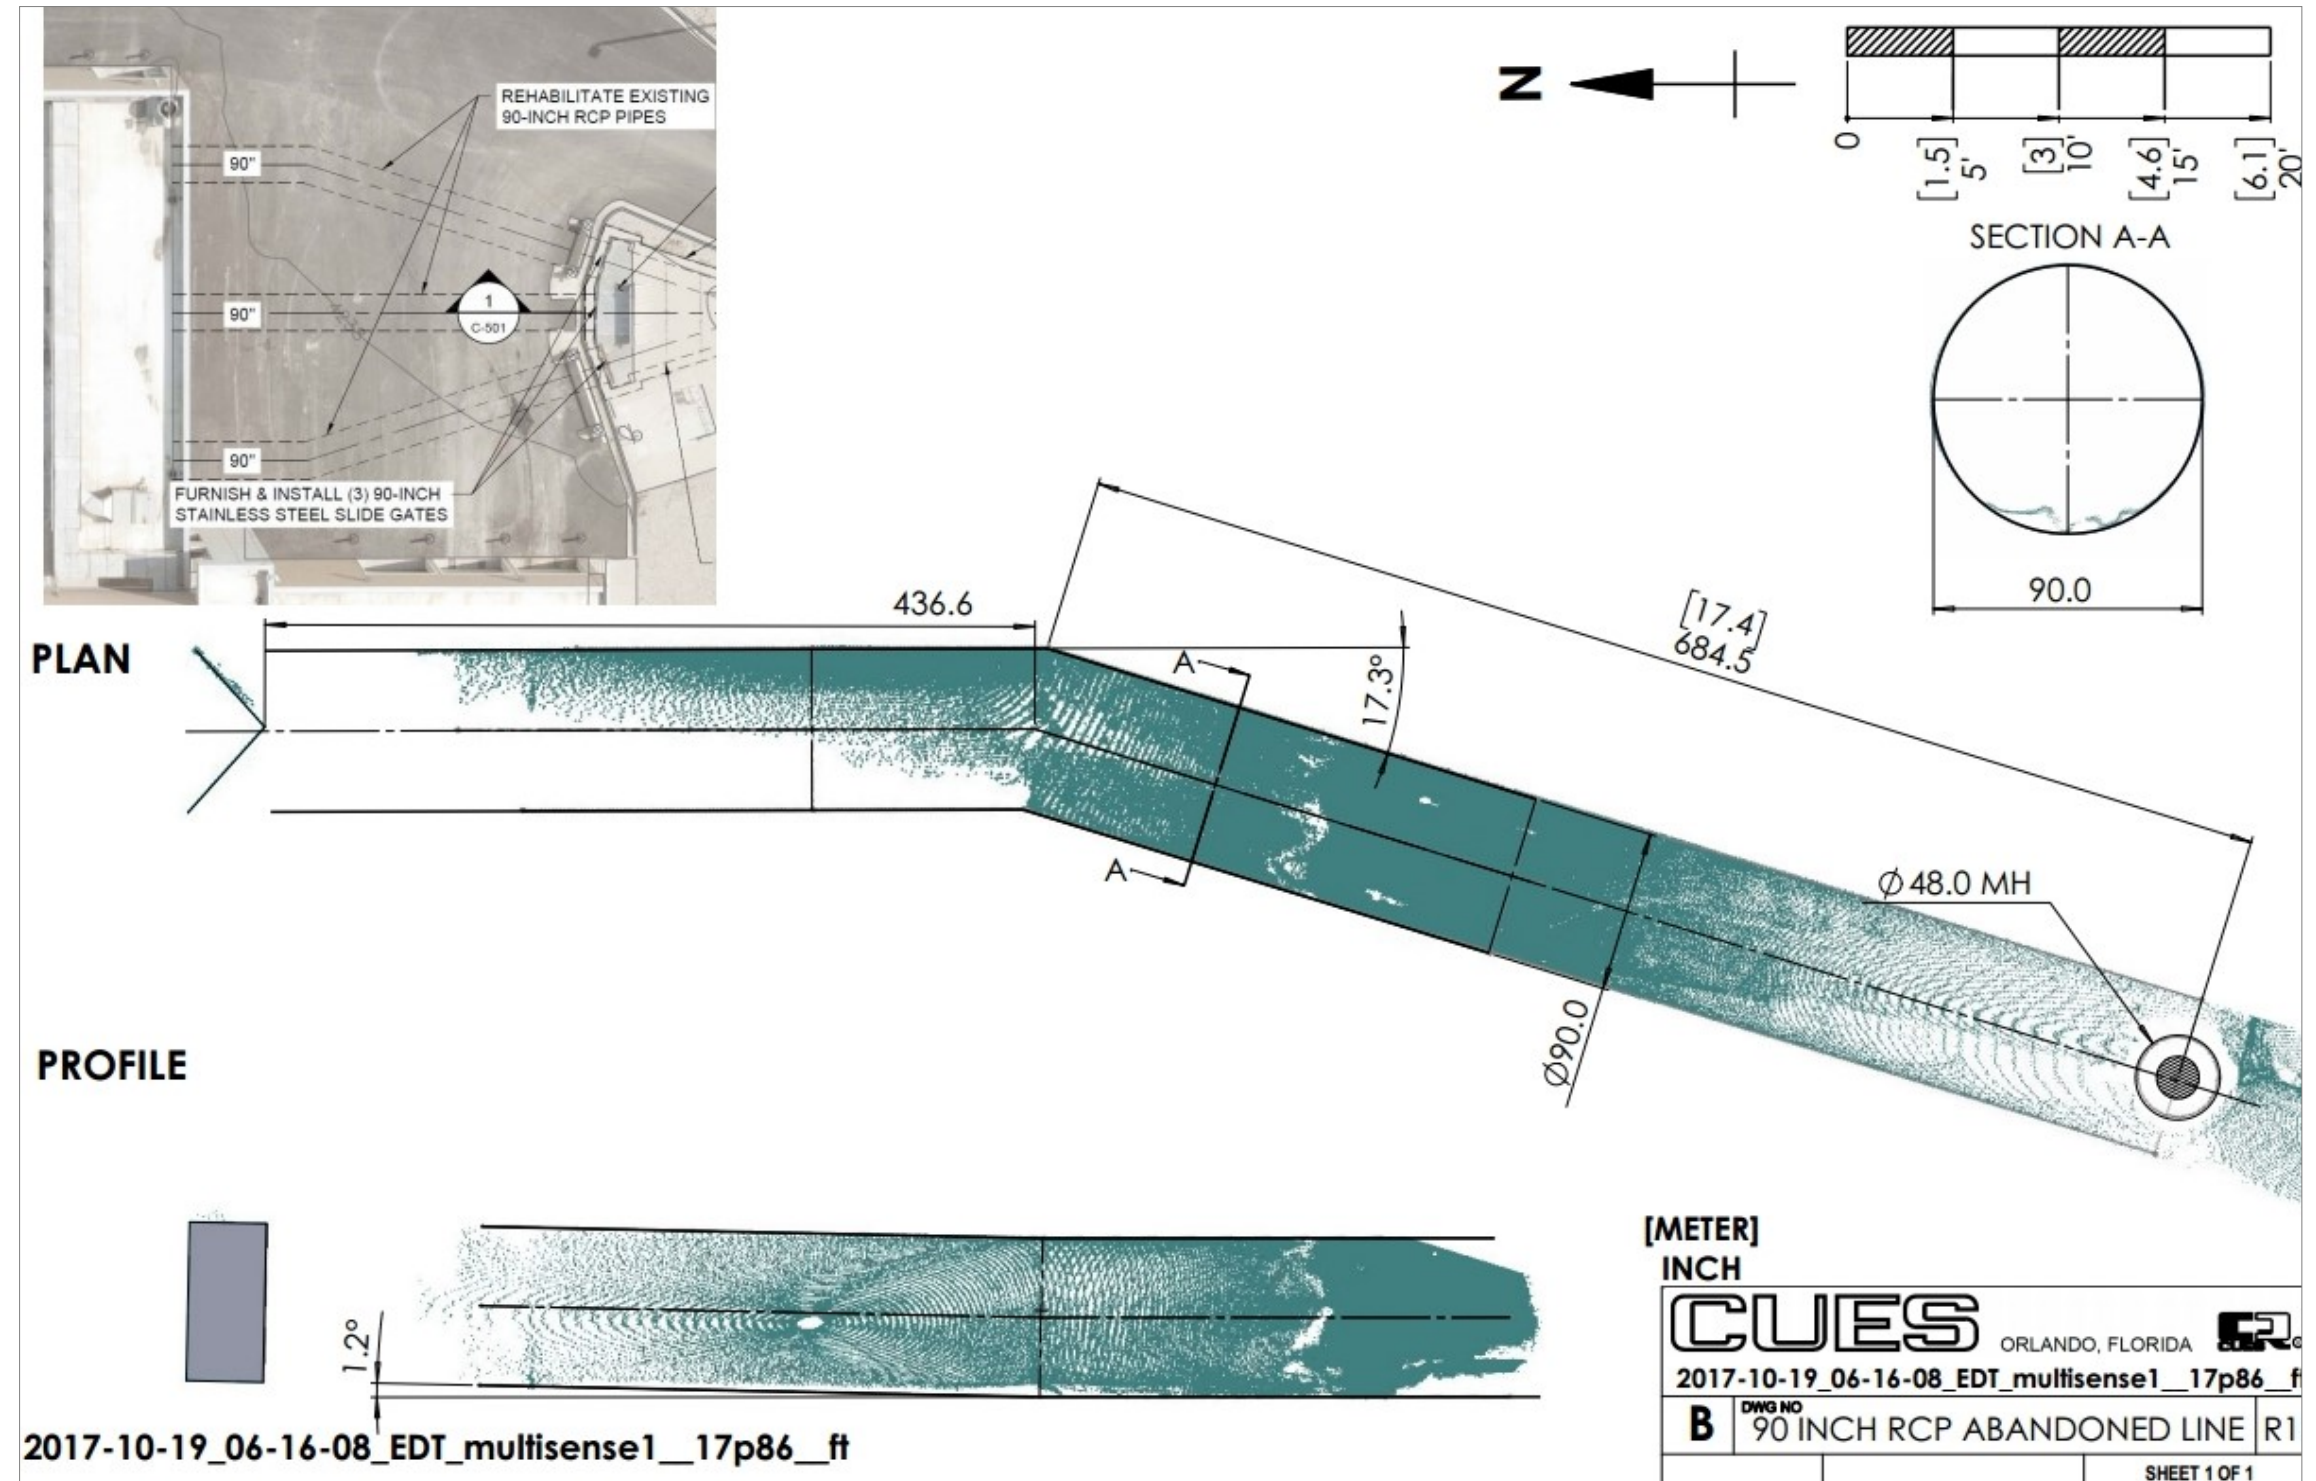
Influent Structure Rehab 90" Diversion Pipe CAD Drawing

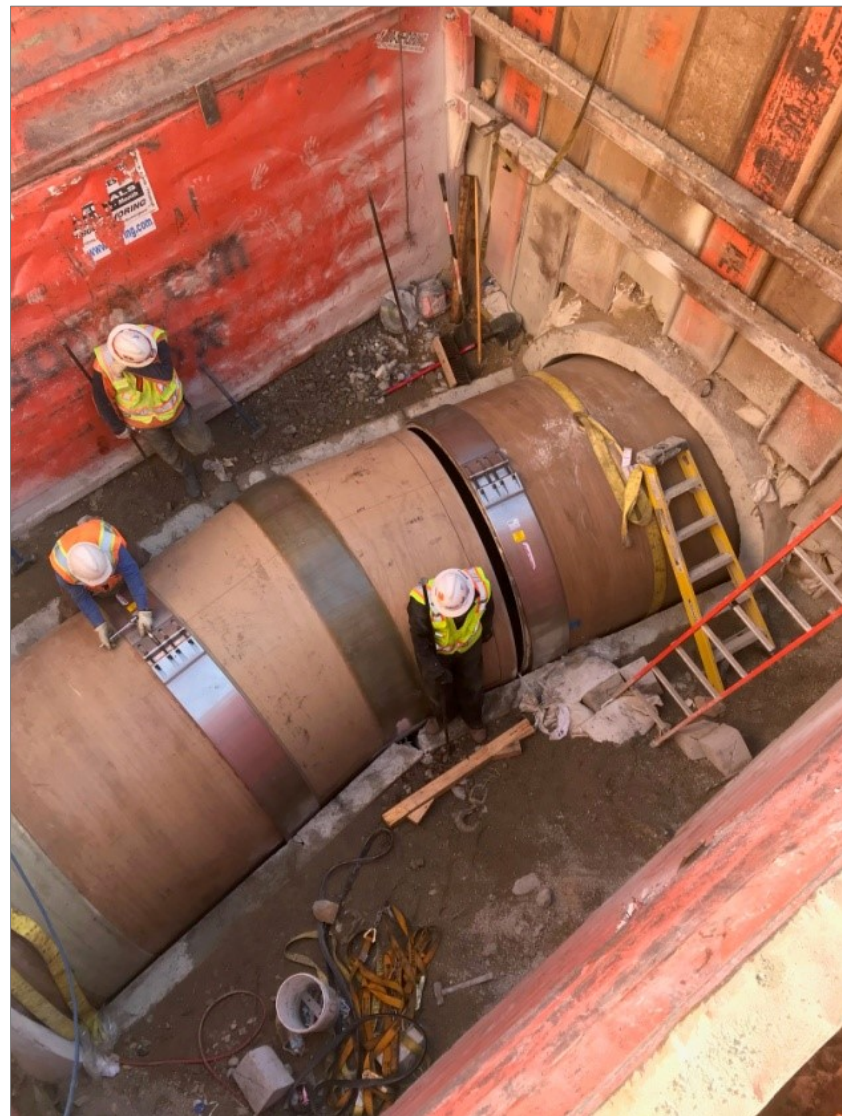
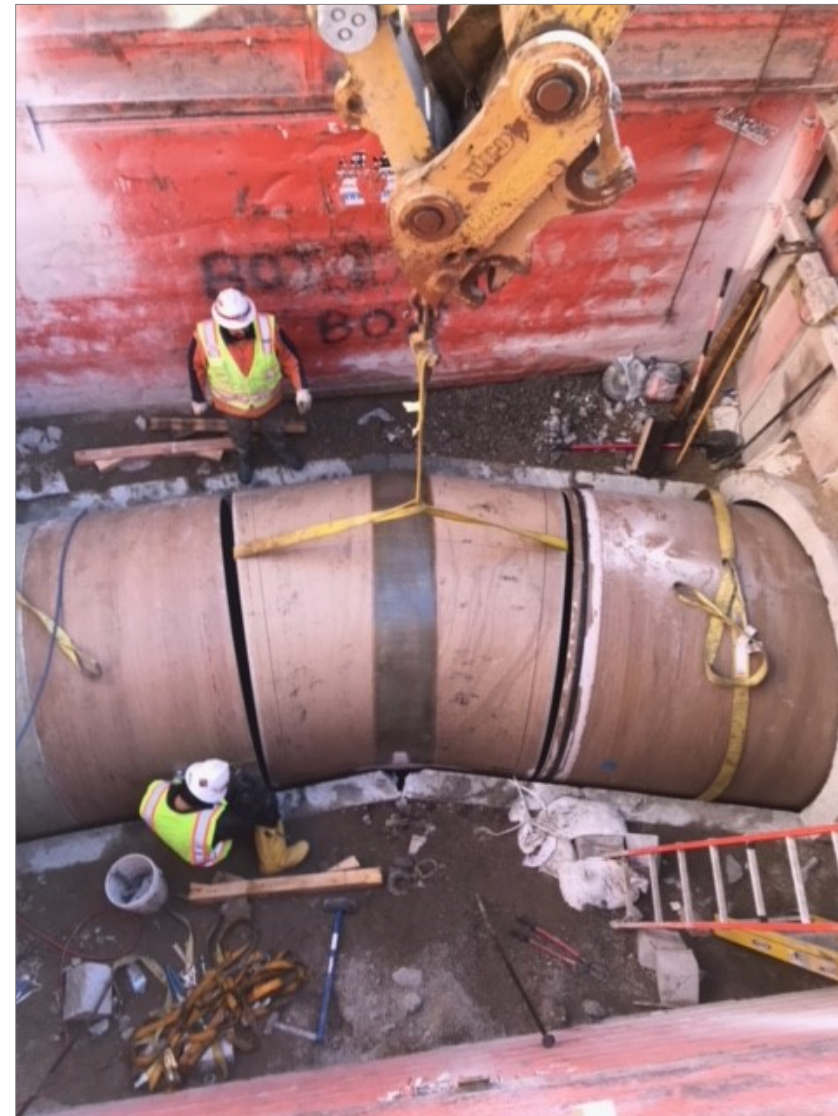
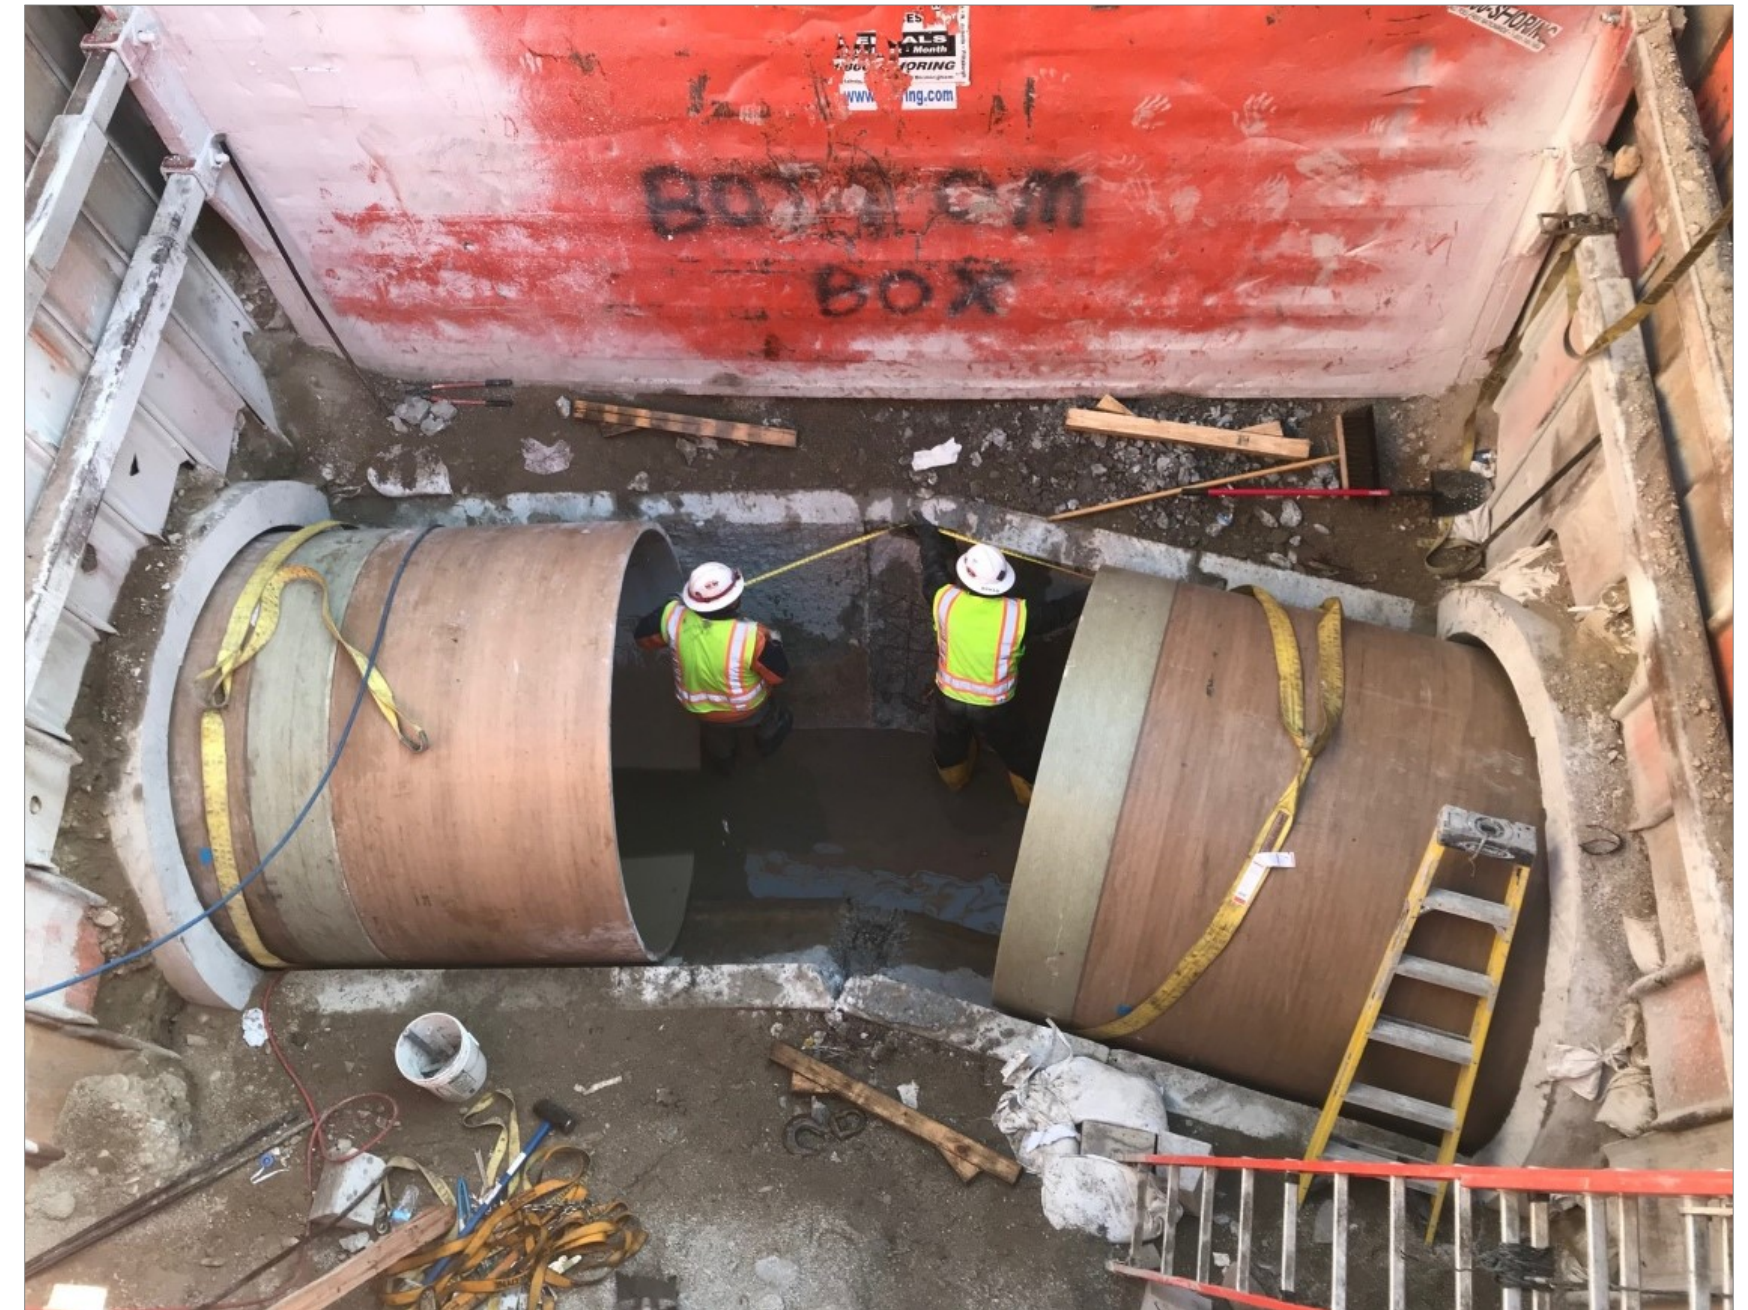
Influent Structure Rehab Custom Liner Installation

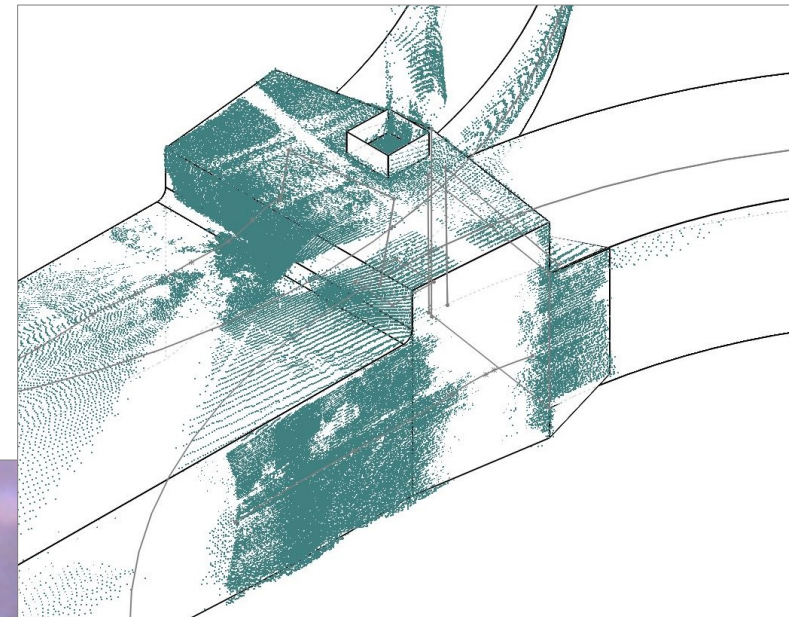
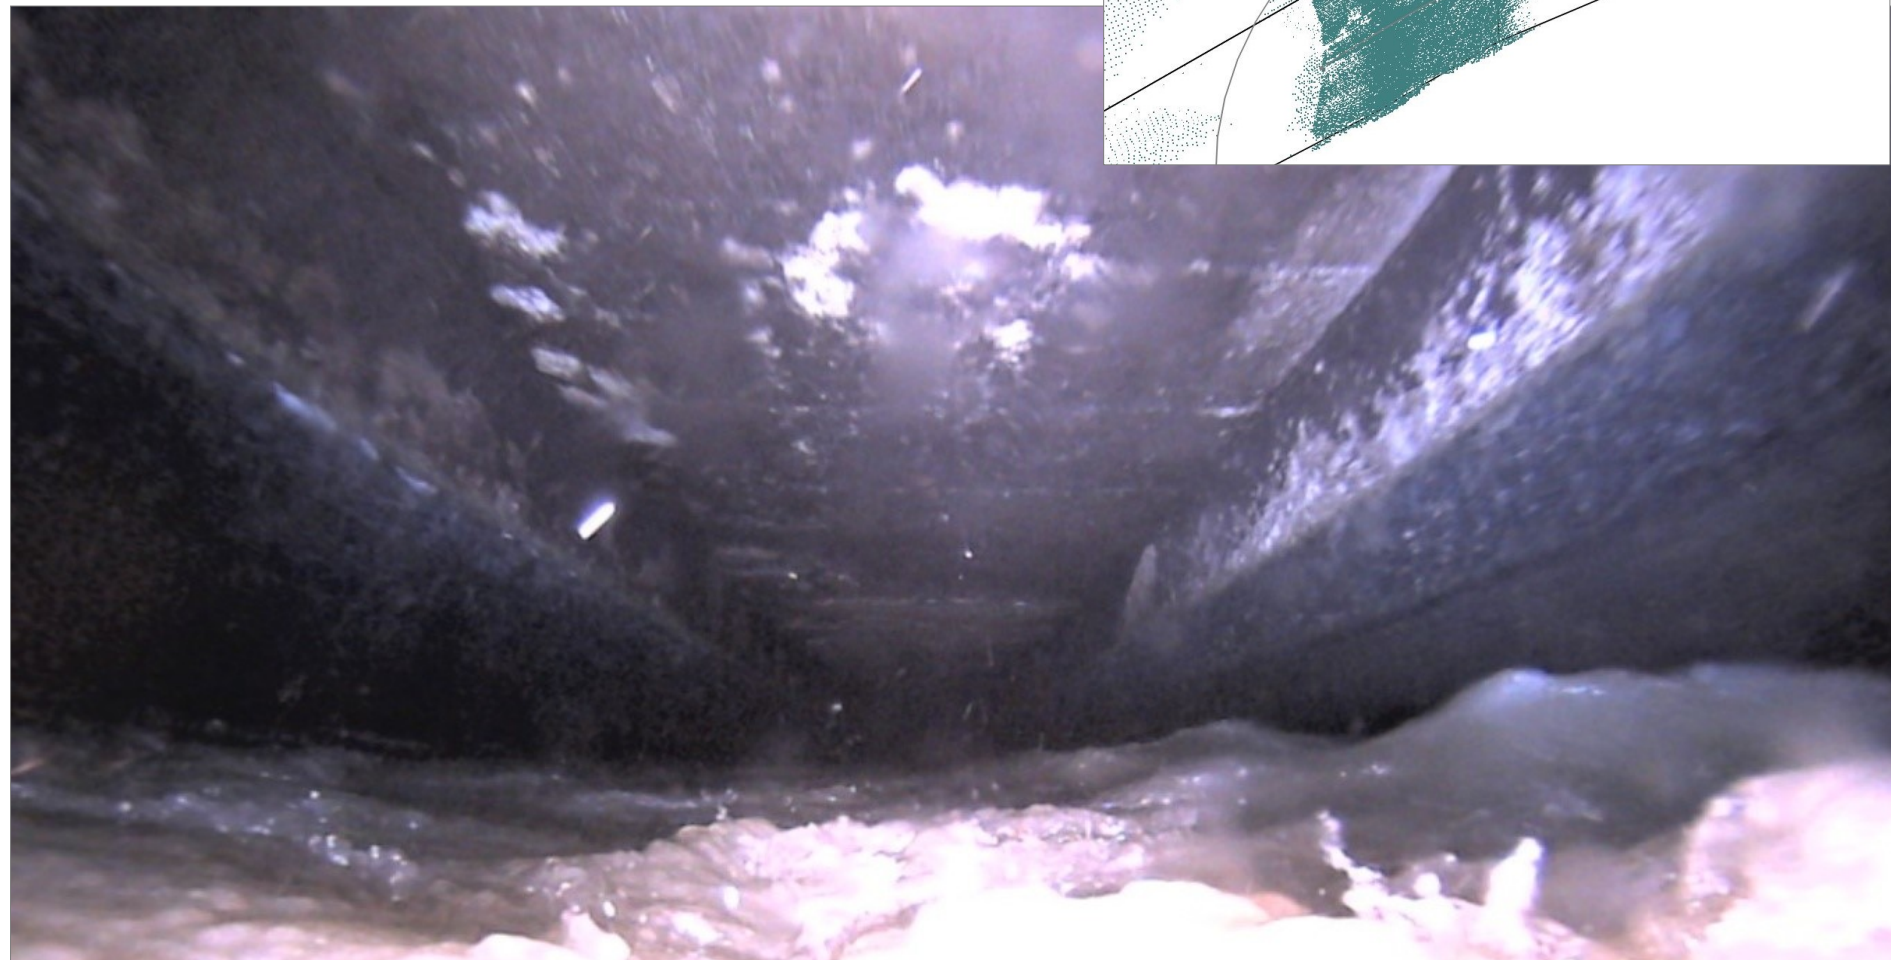
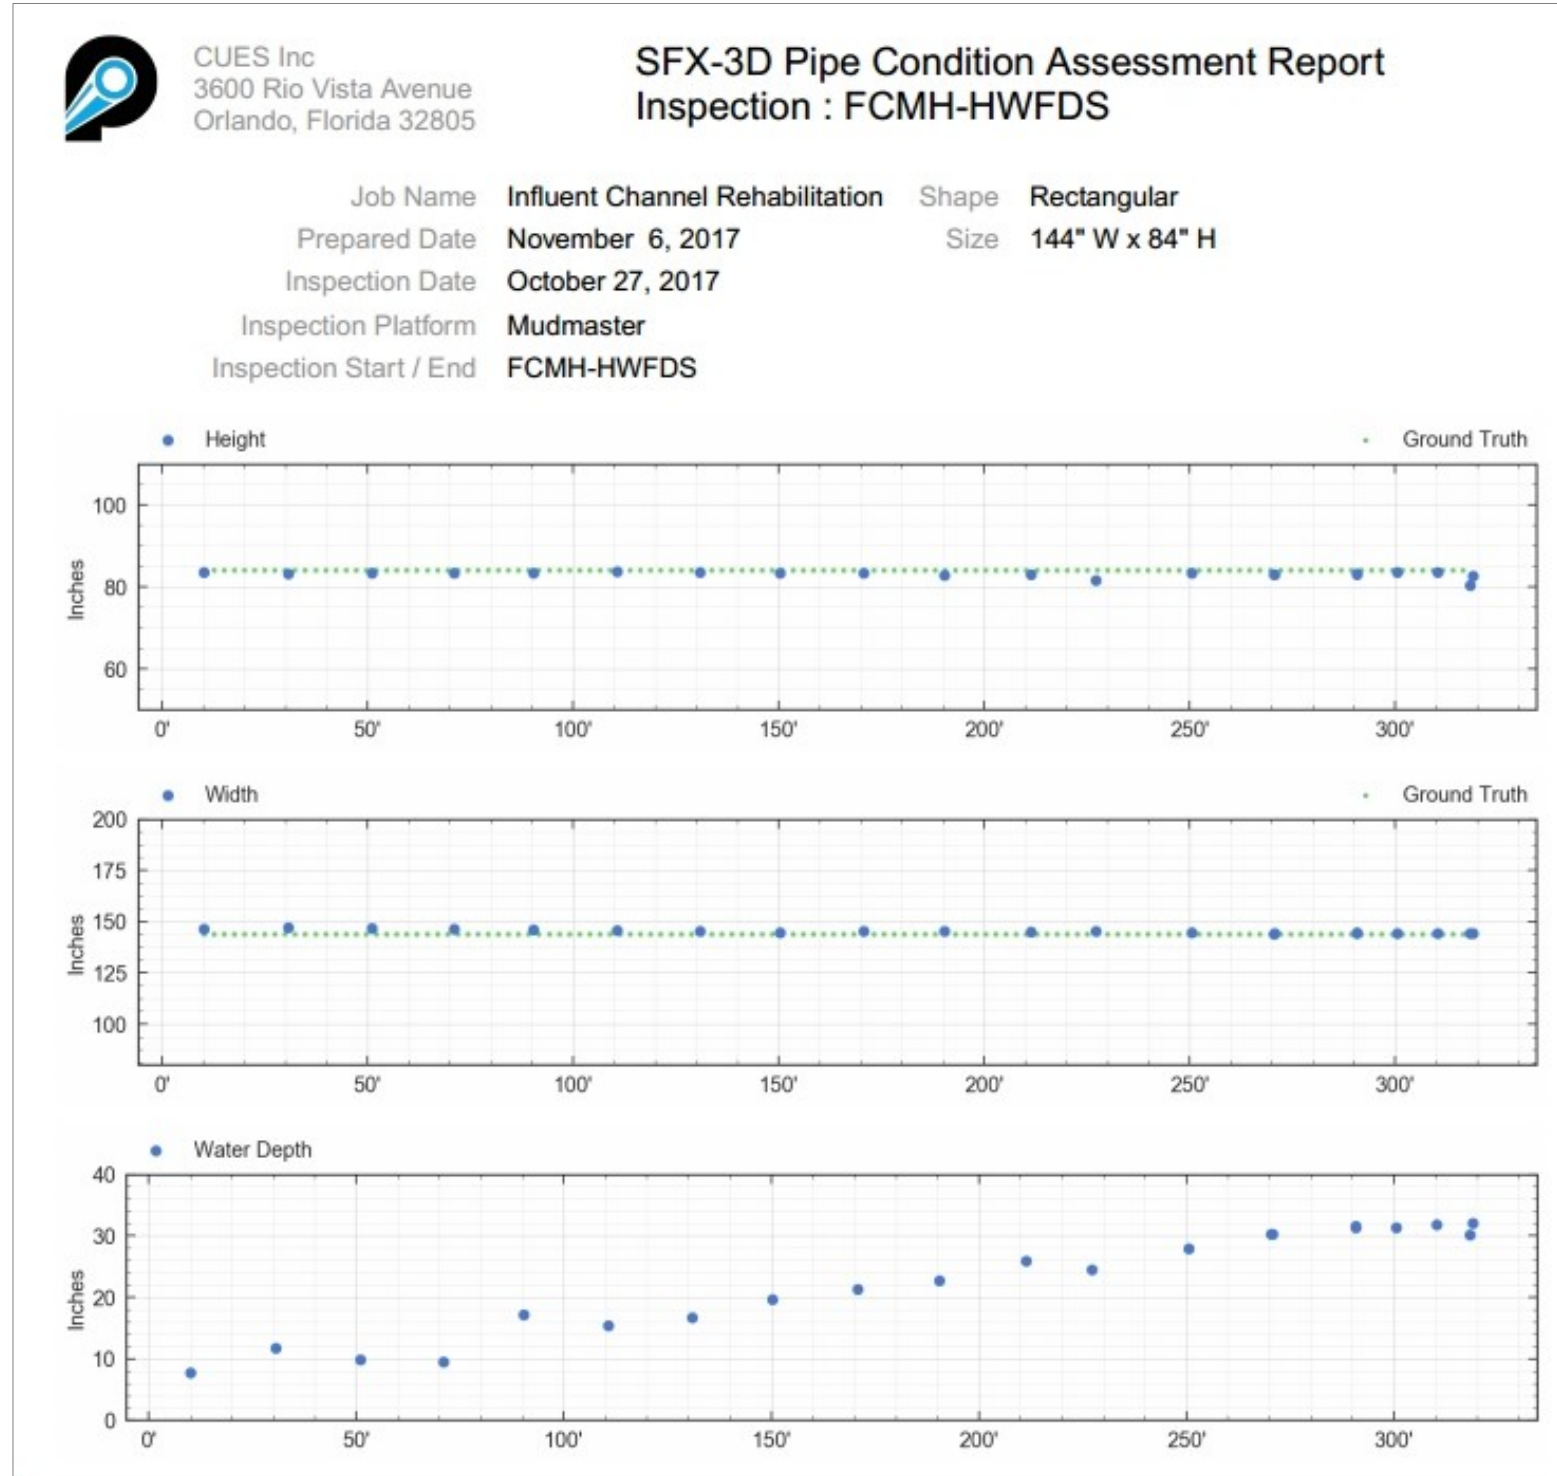
Influent Structure Rehab
 Influent Channel Size?
 Does the height change?
