Multi-Sensor Inspection: 2D LIDAR & 3D LIDAR

SolidFX MSI Equipment

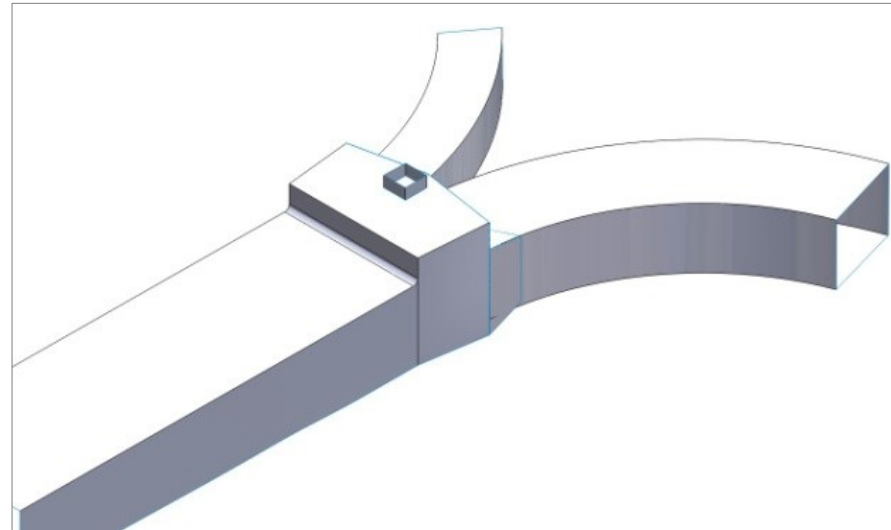
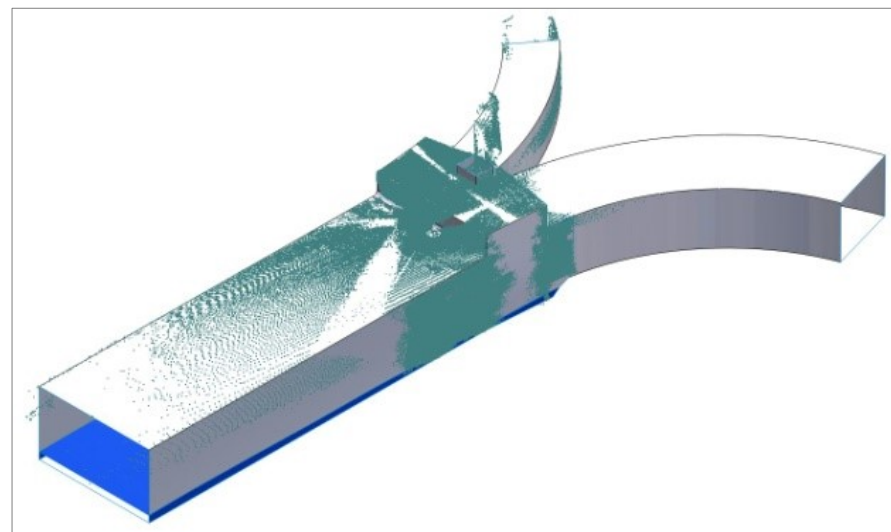
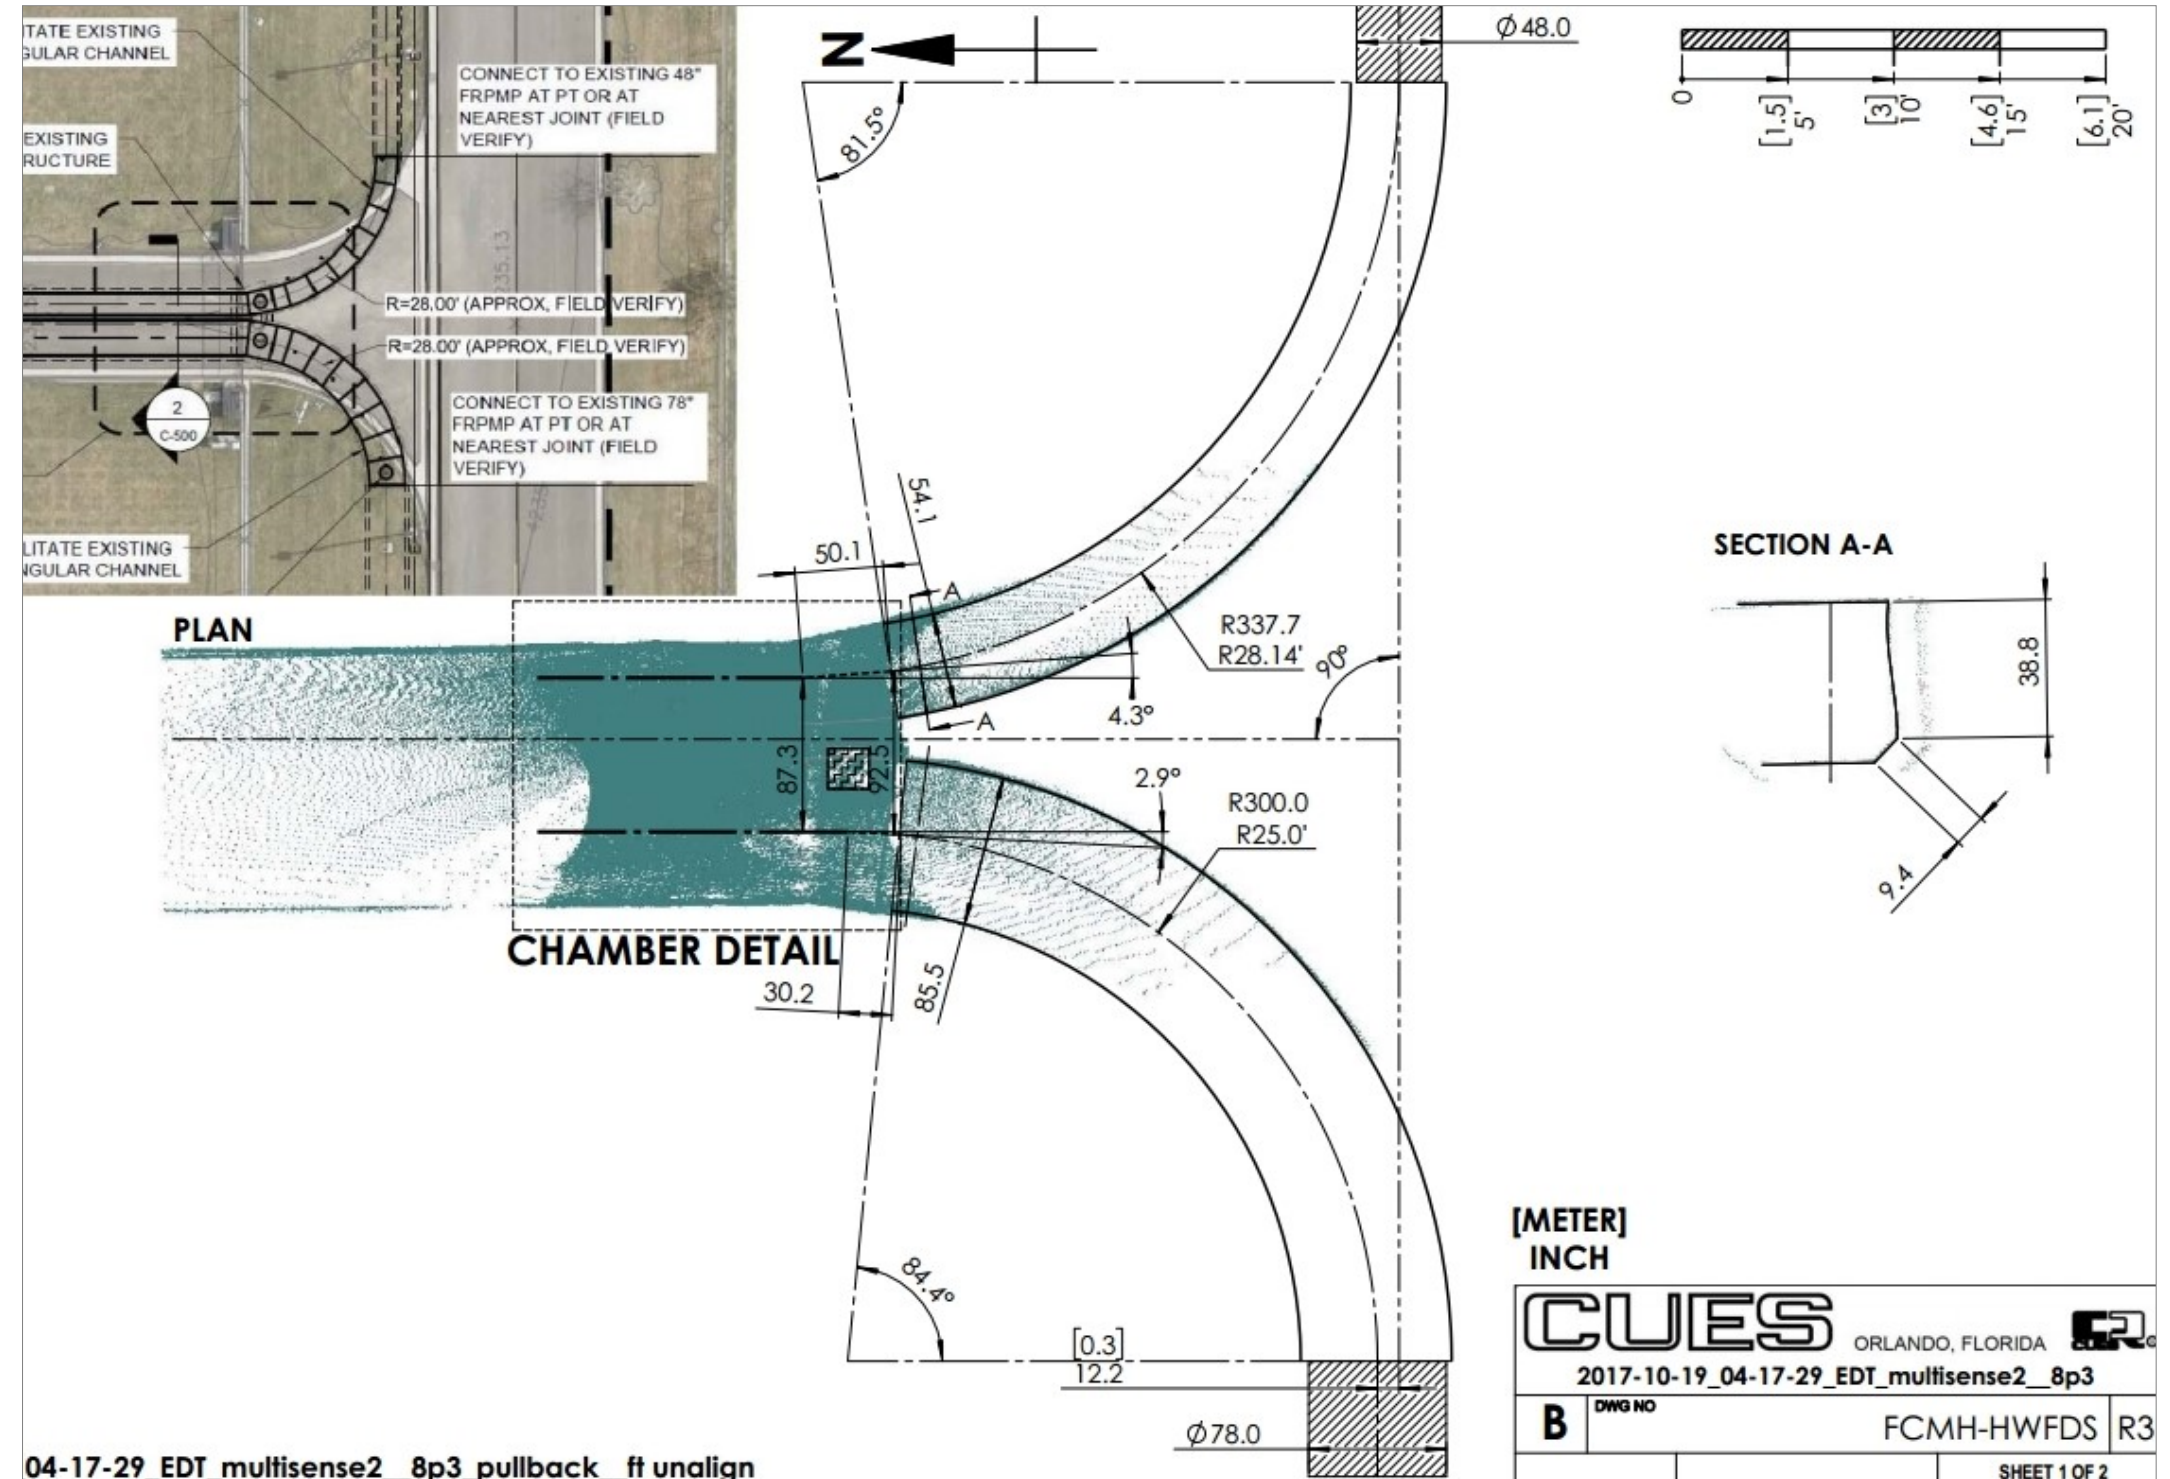
Influent Structure Rehab Combining Structure – Radii?

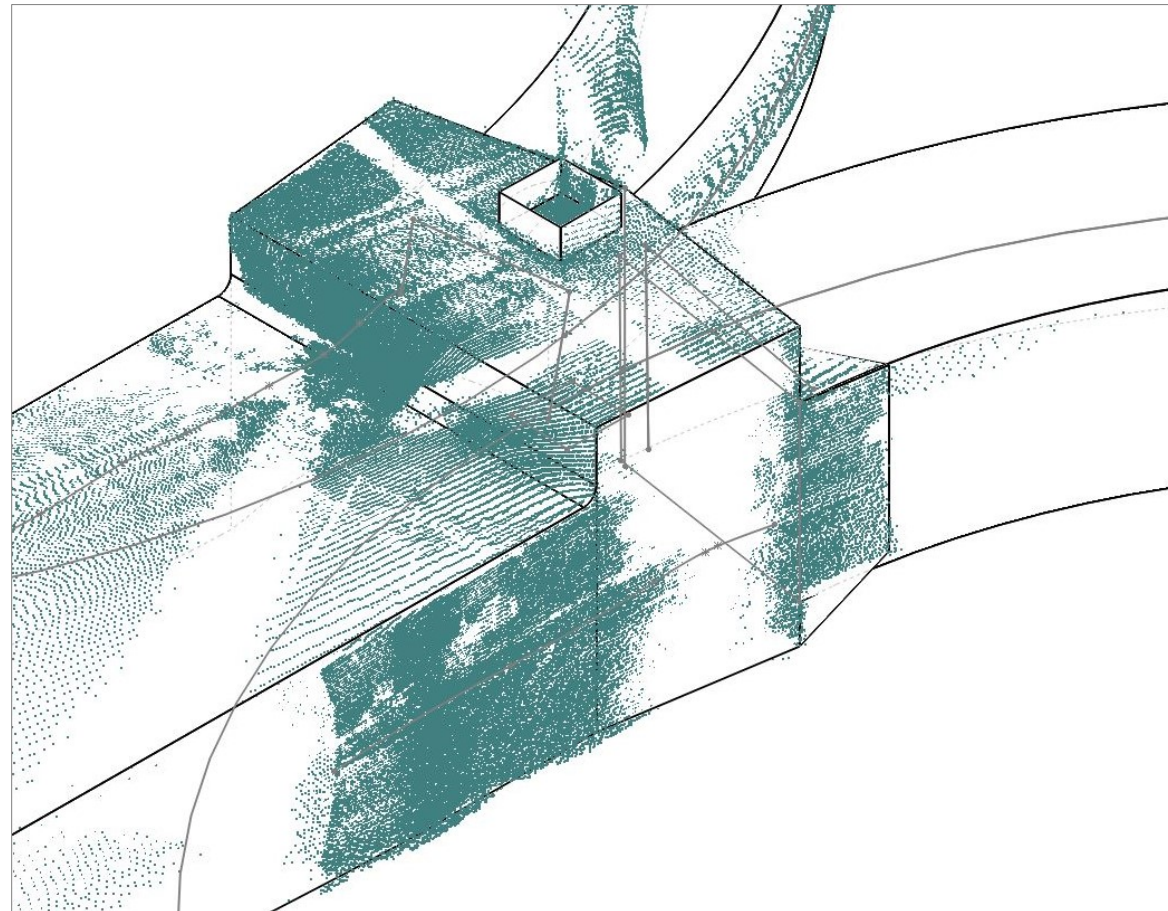
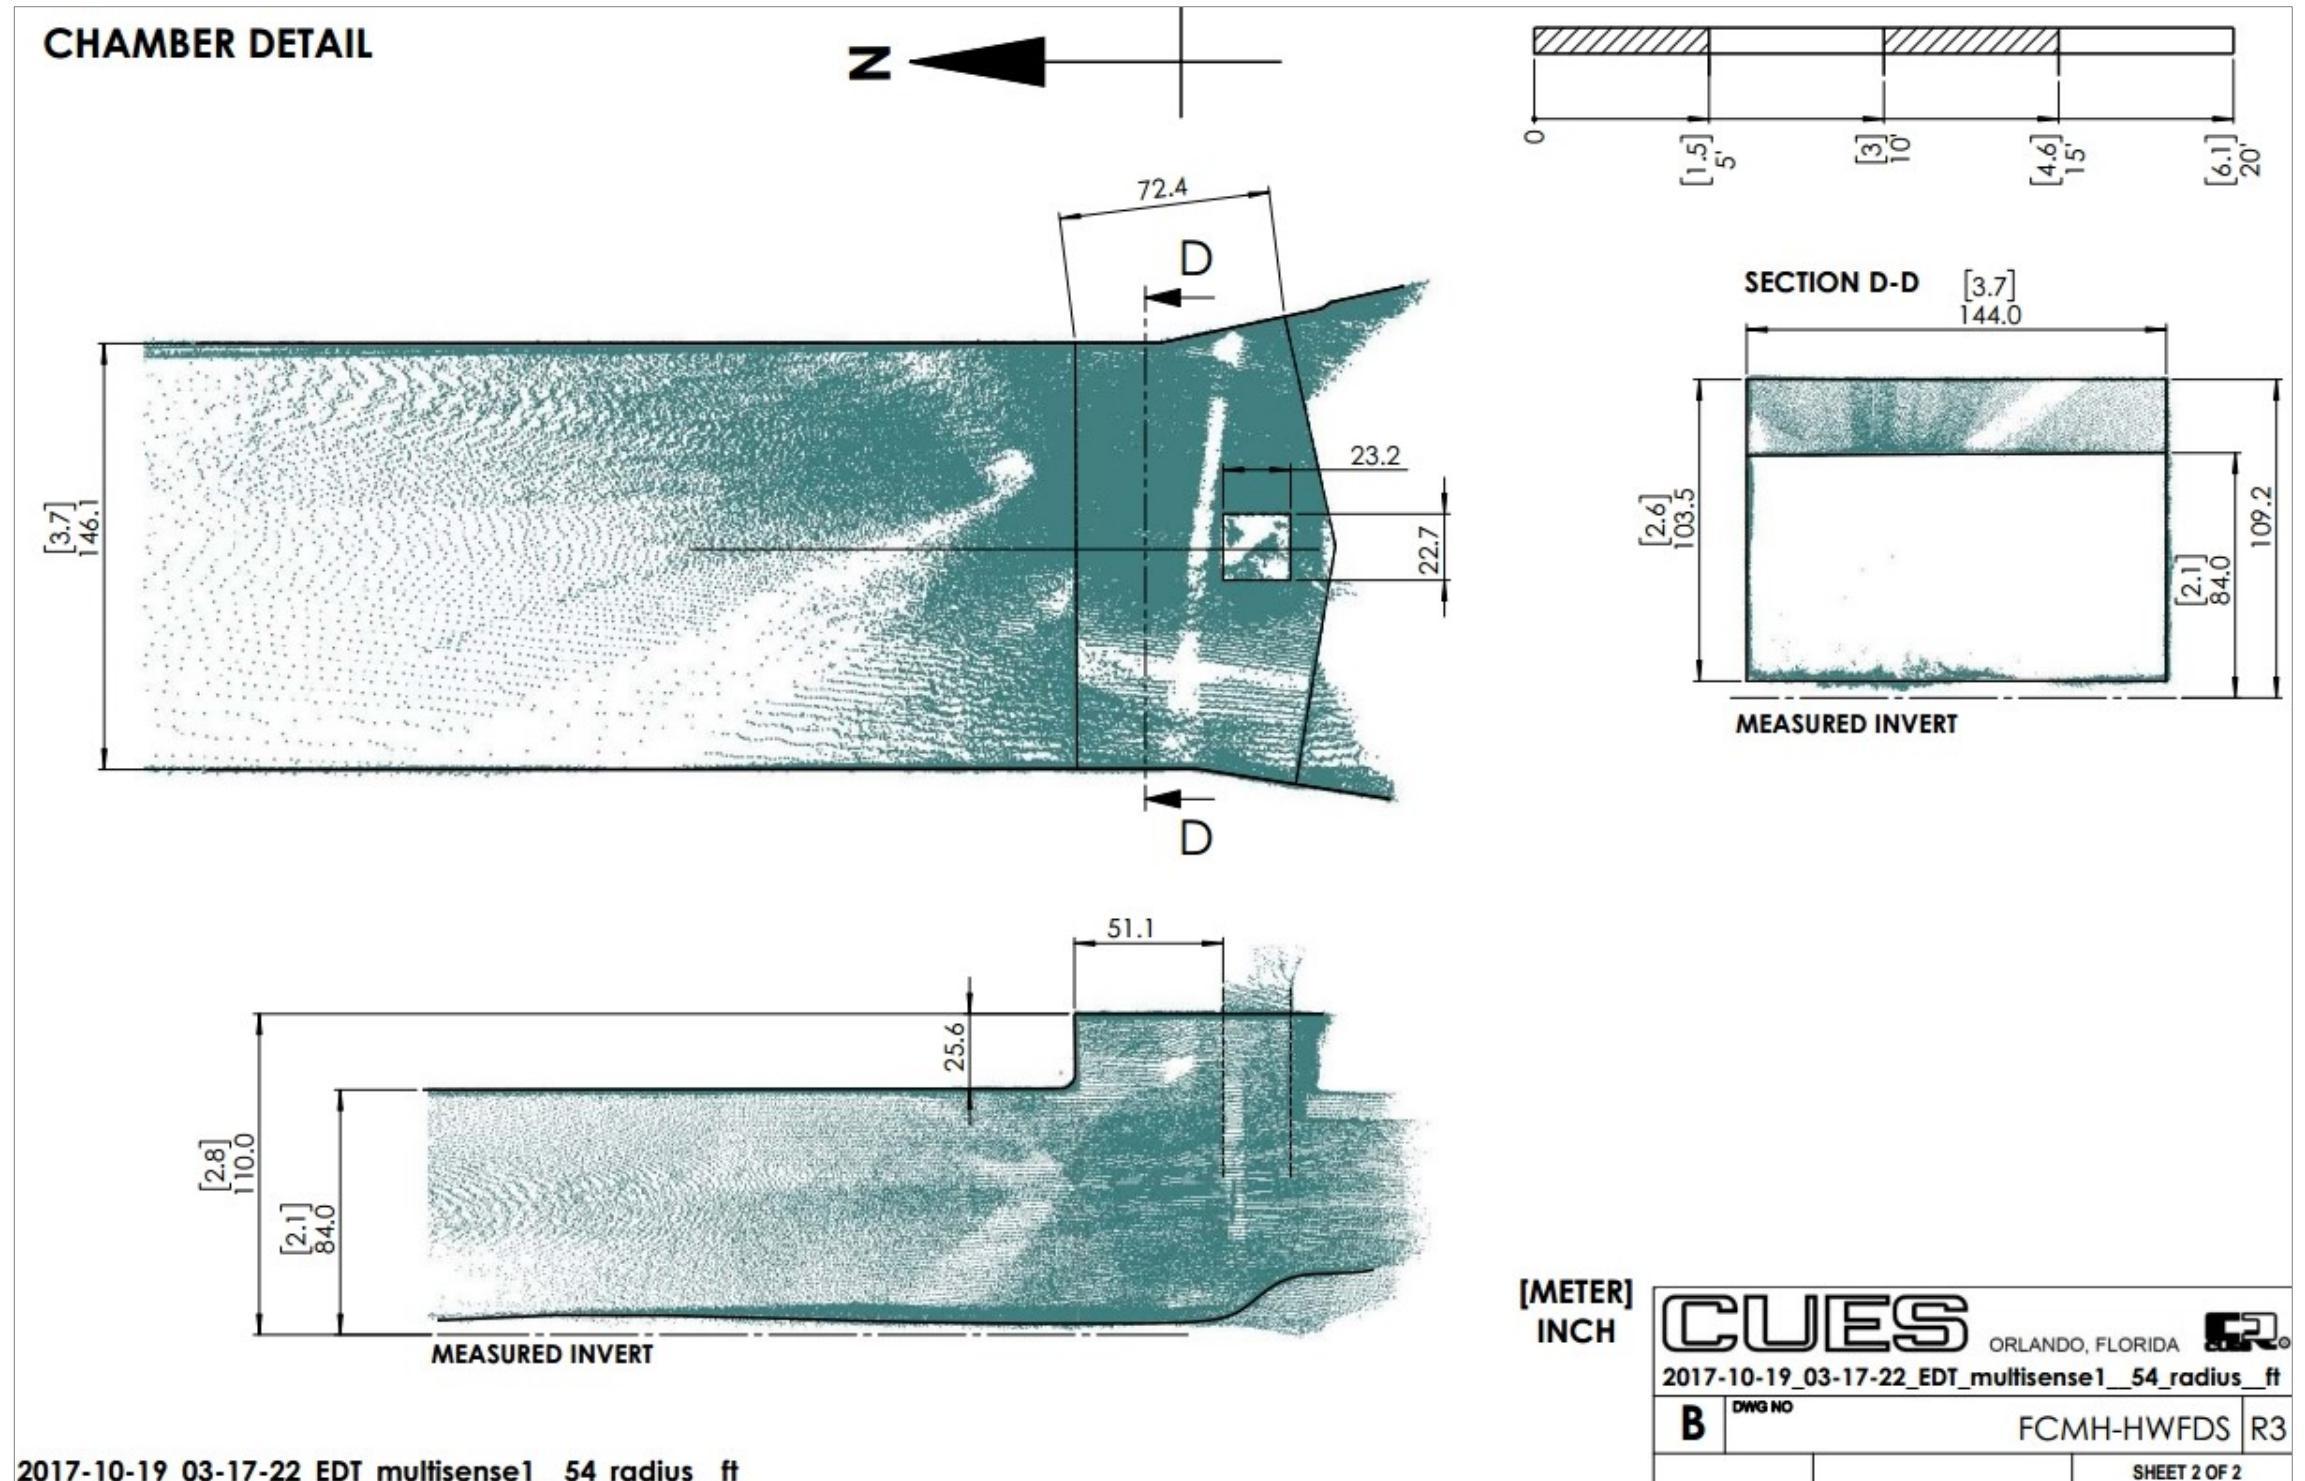
Influent Structure Rehab Chamber Detail

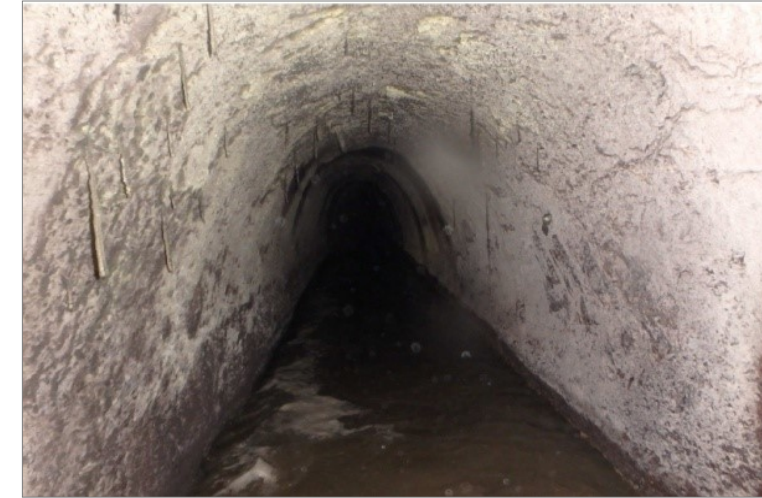
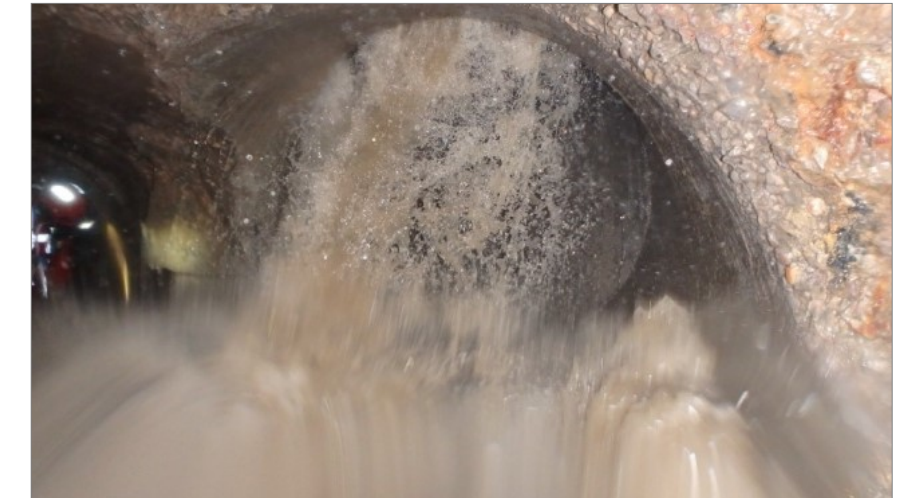
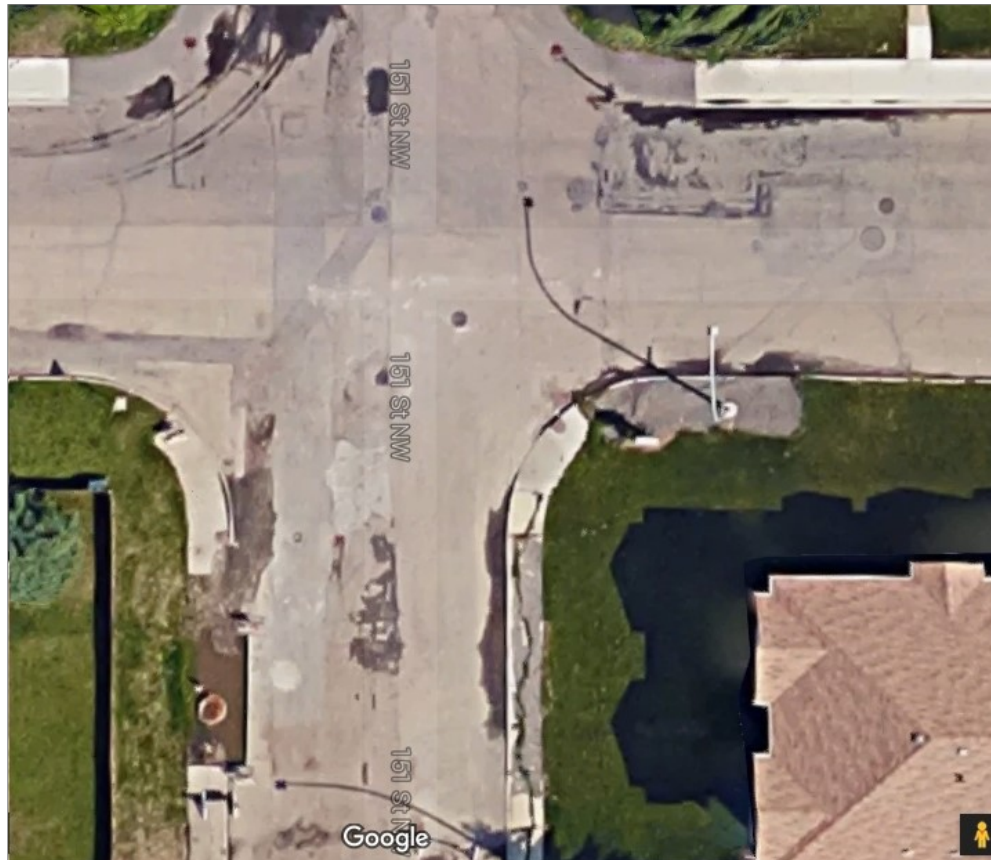
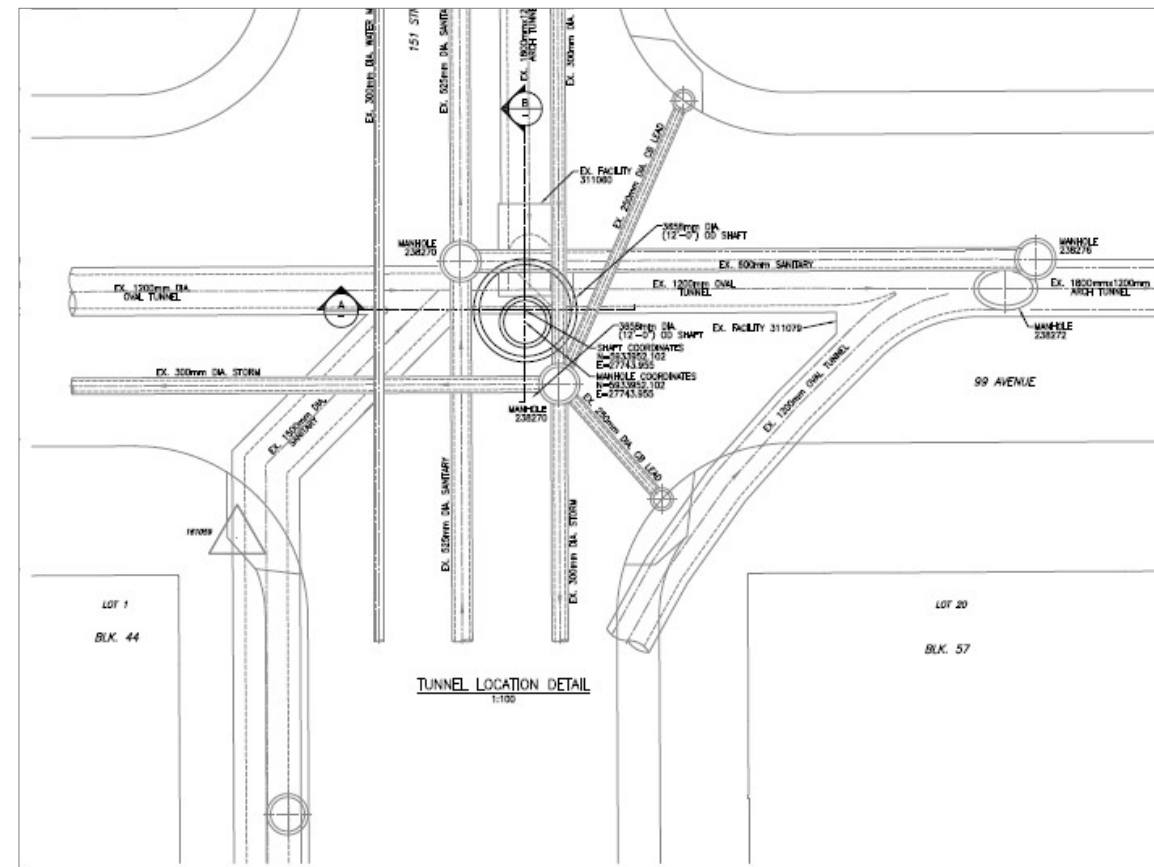
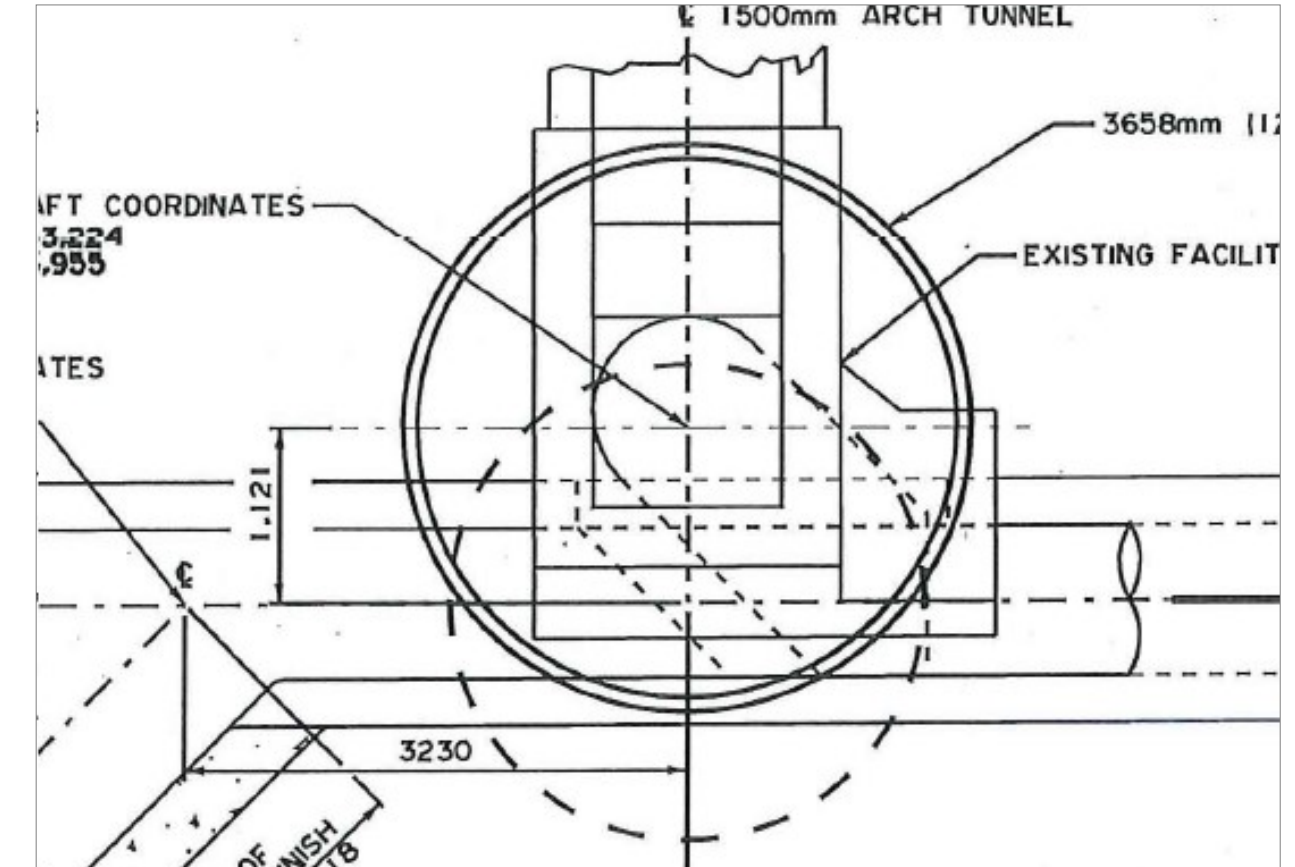
Drill and Rehab Project

Geo Location & Cross Section Report

- What is smallest cross section of the E-W tunnel?
- Where should be dig our 10' diameter, 100 ft. deep rehab/maintenance shaft?

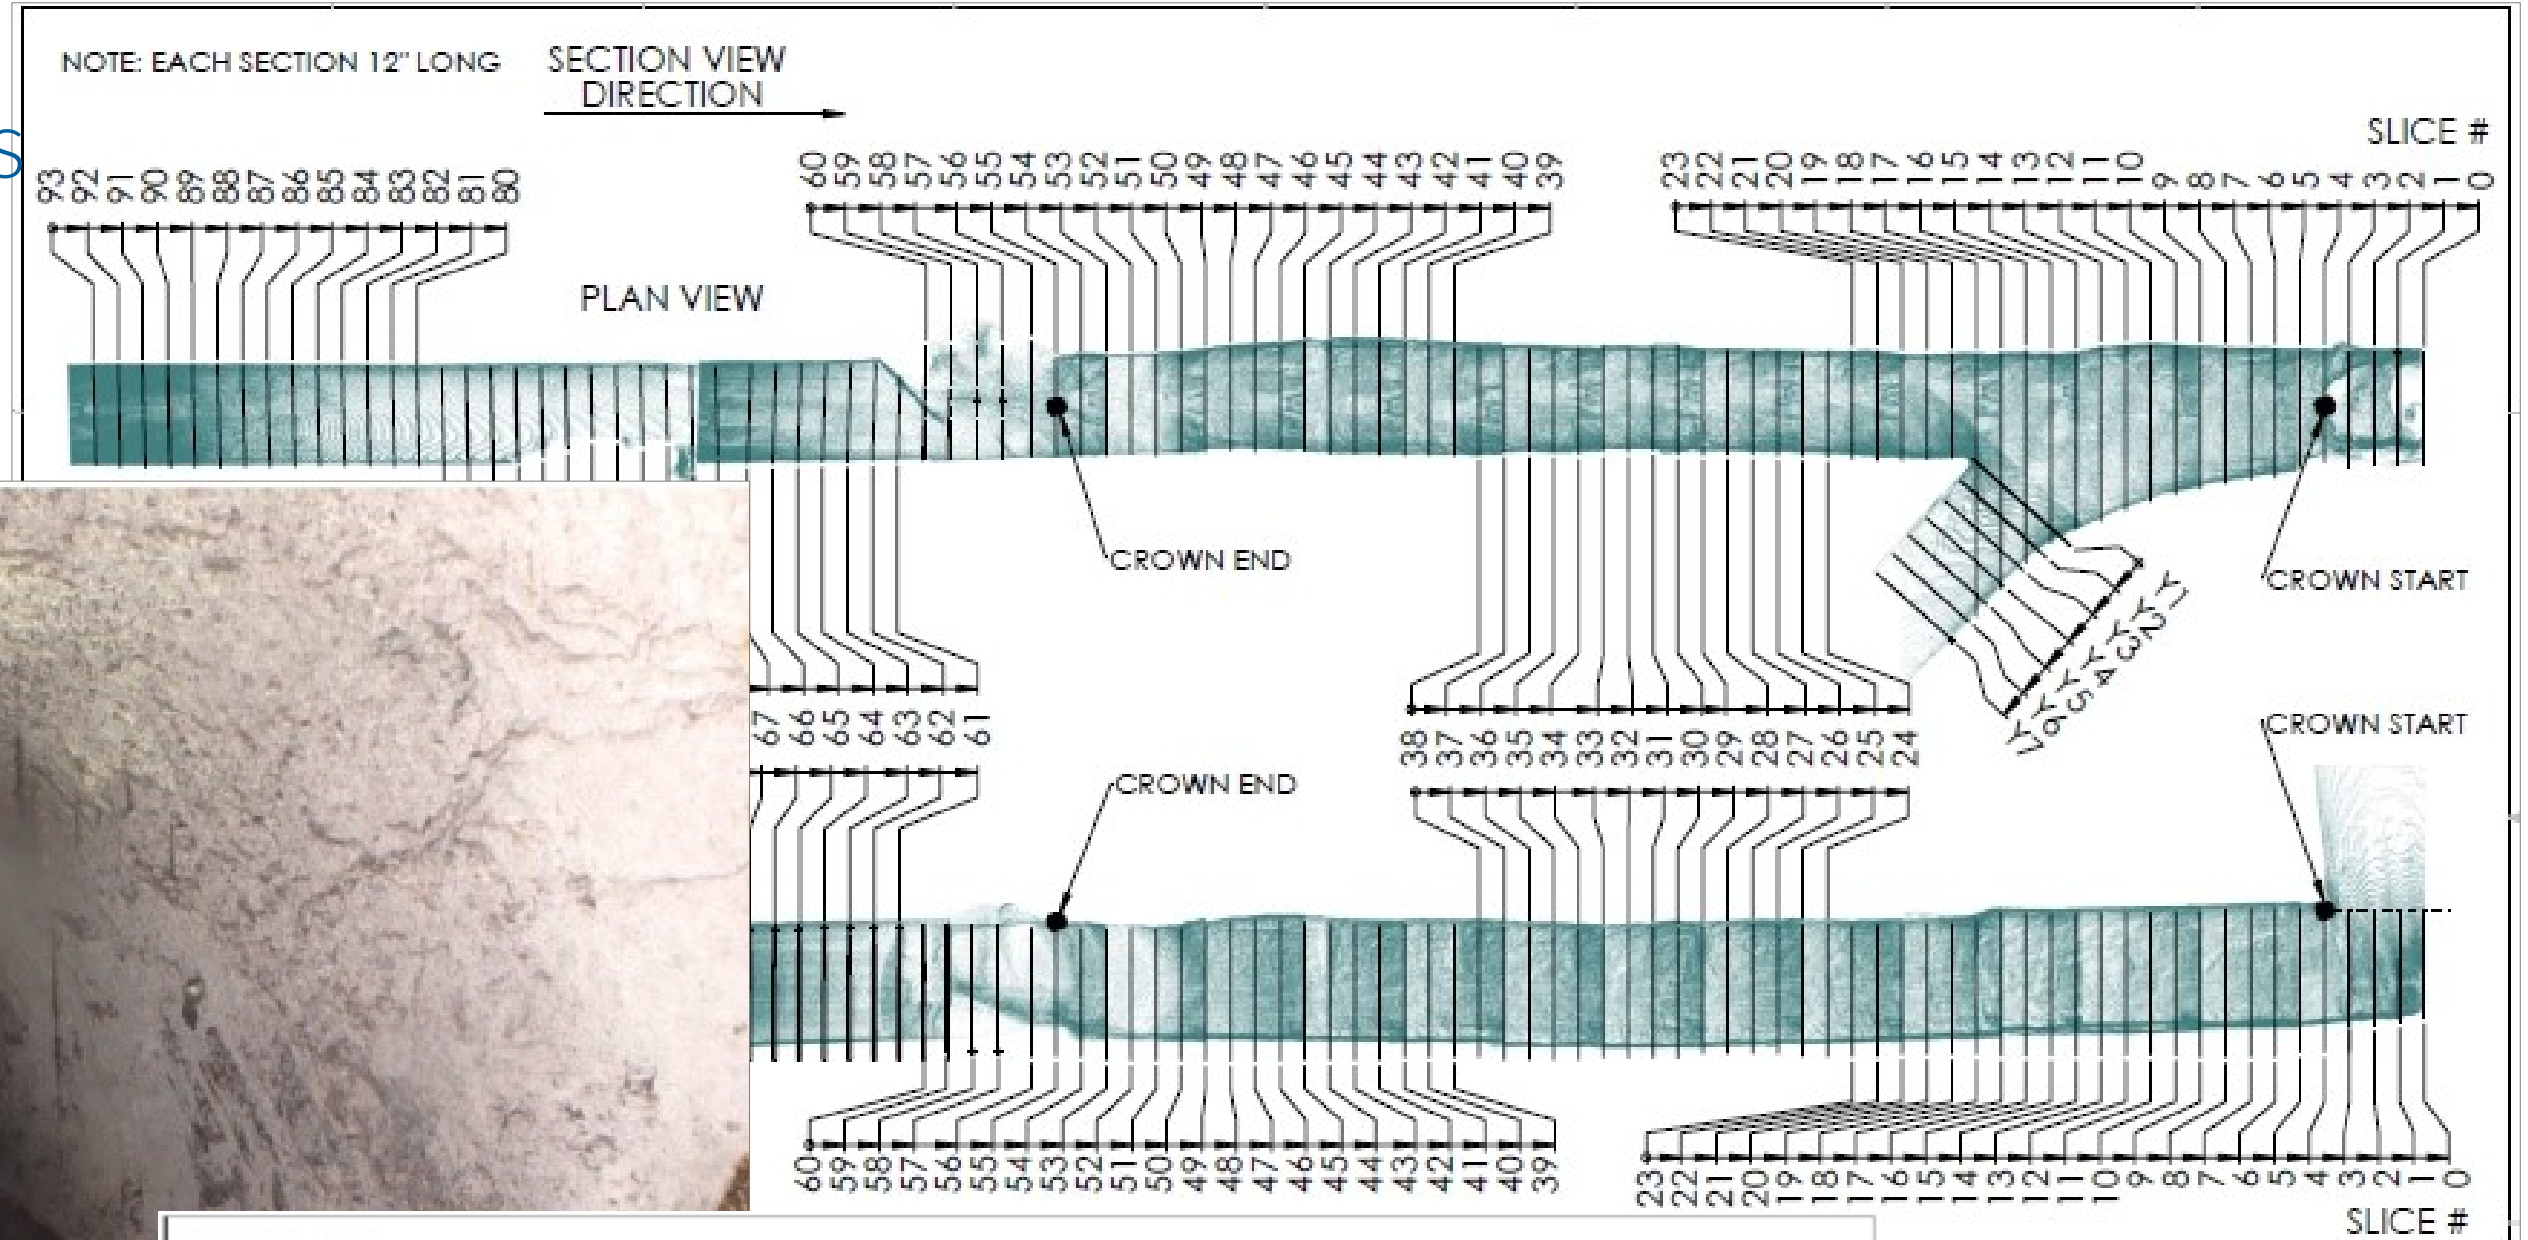
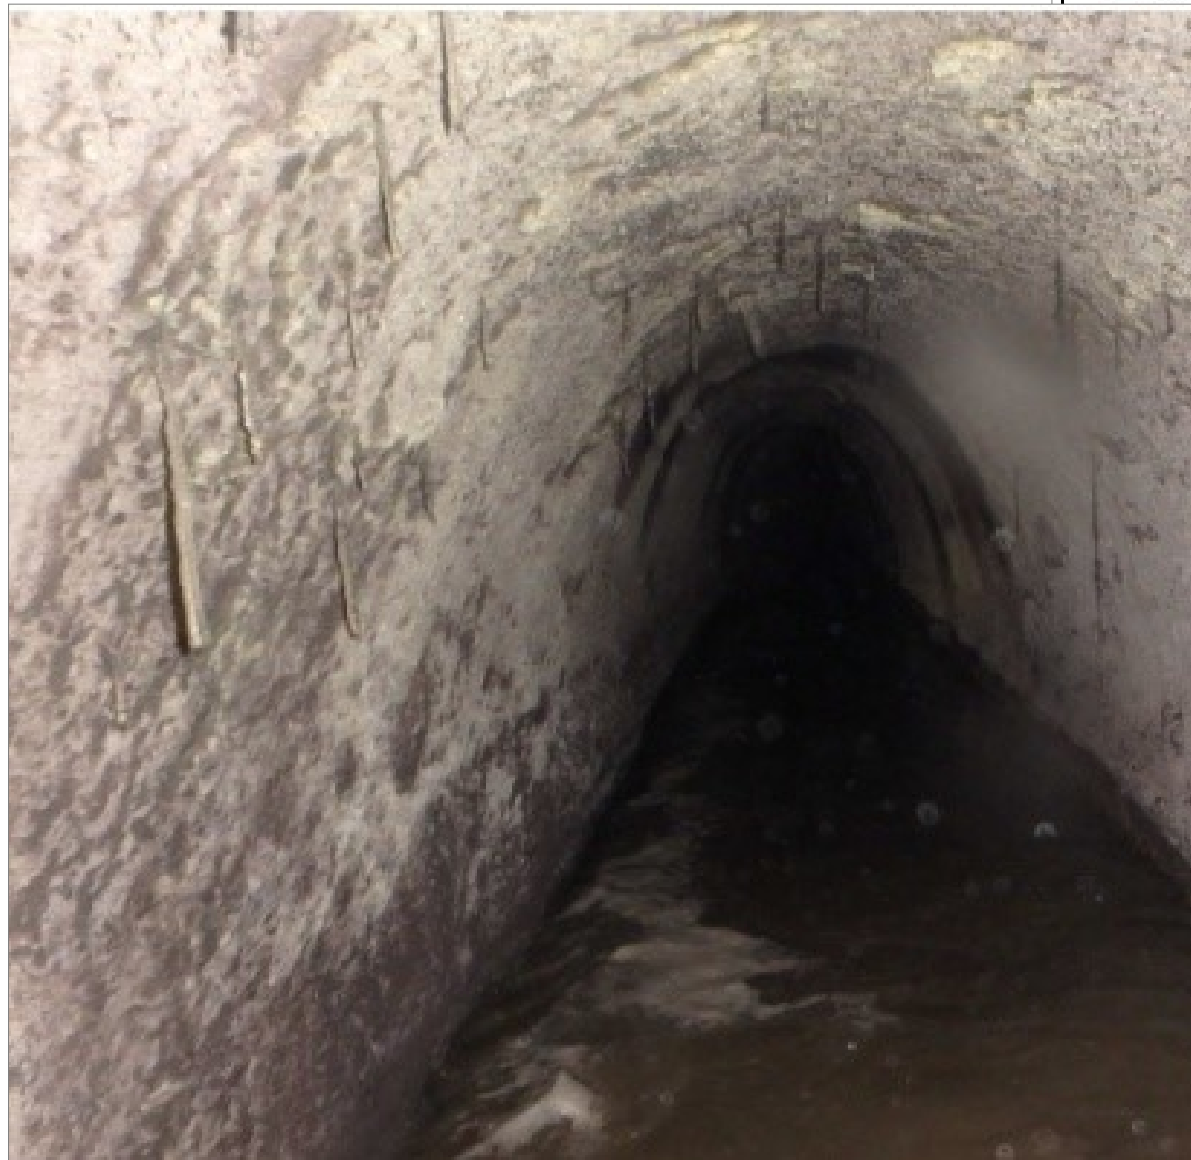
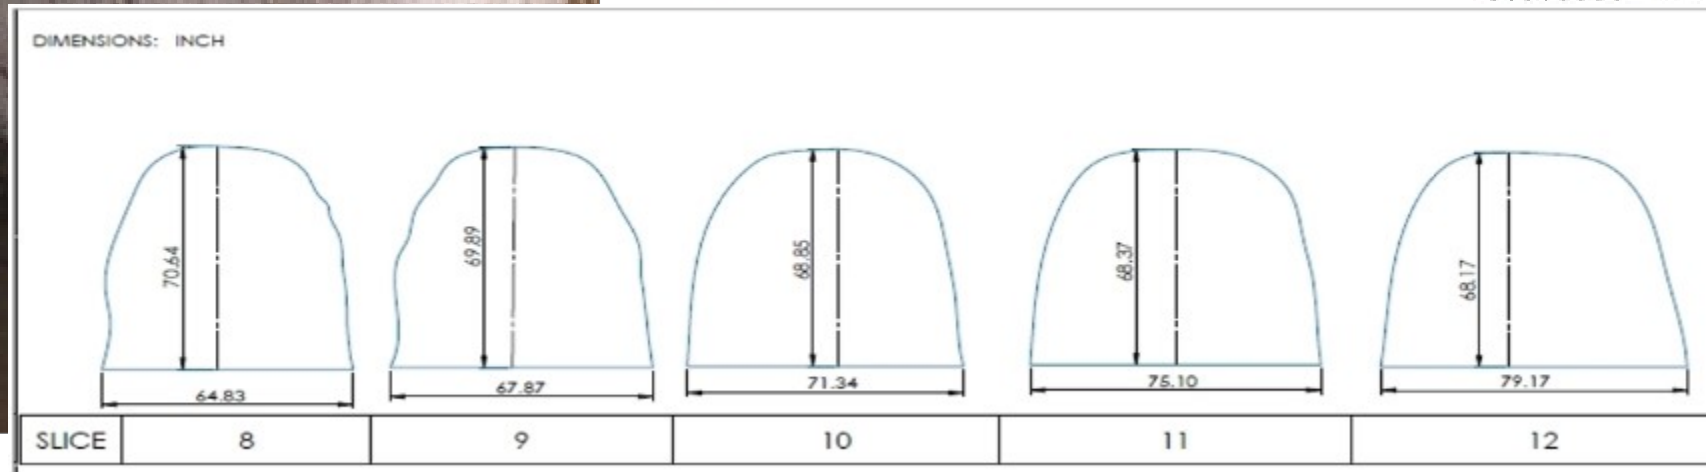
Cross Sections - Anytown USA

Drill and Rehab Project Deliverable - Cross Sections

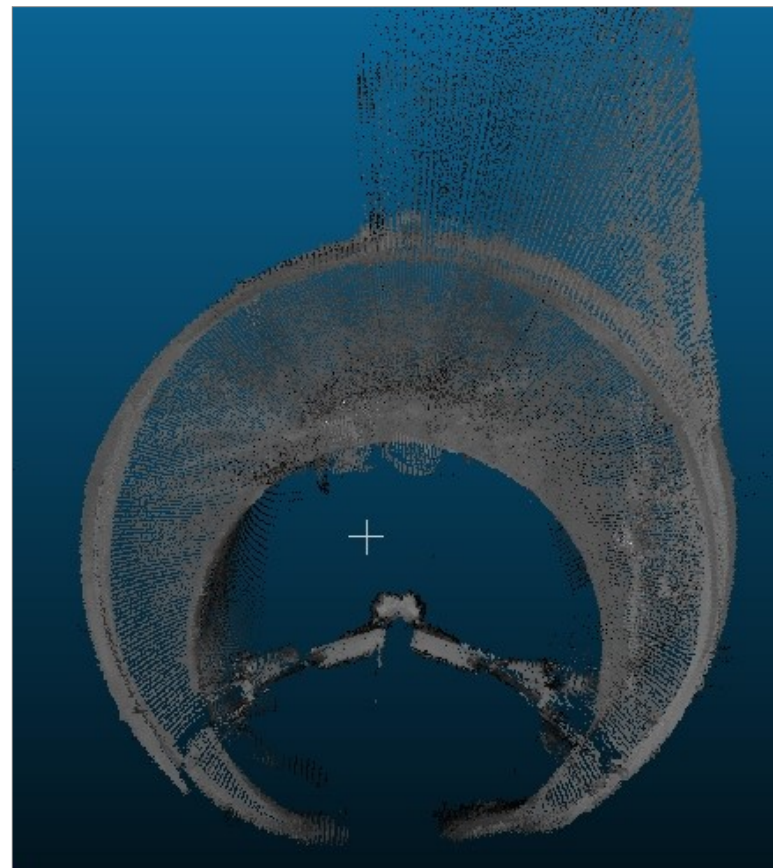
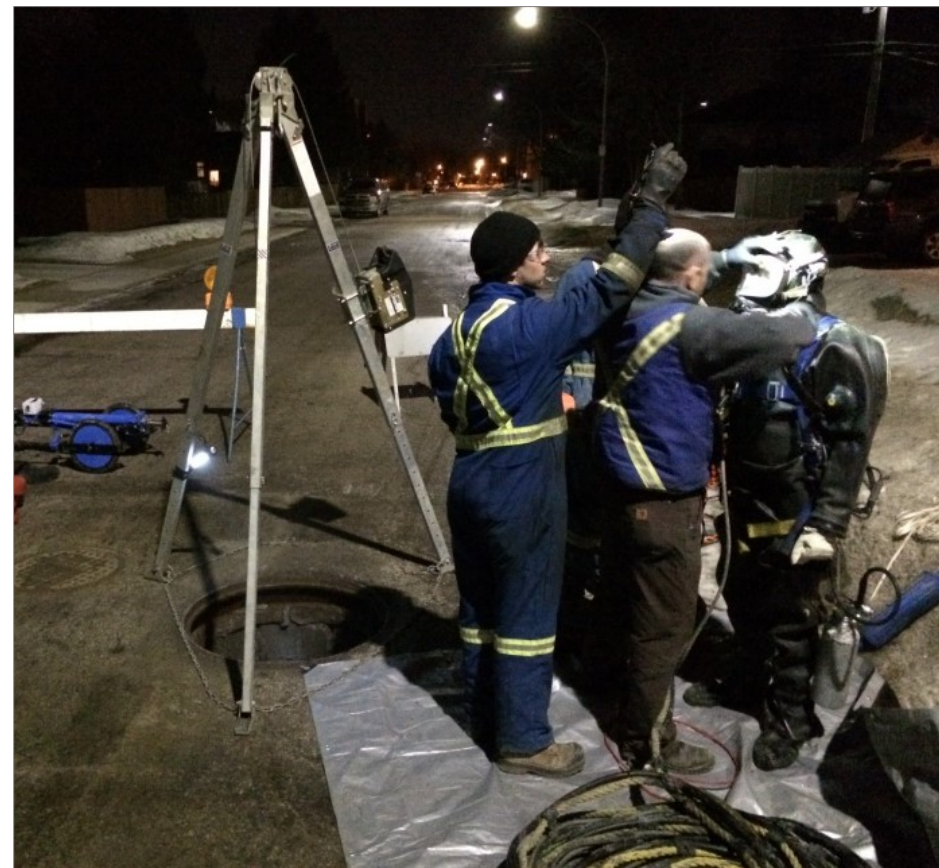
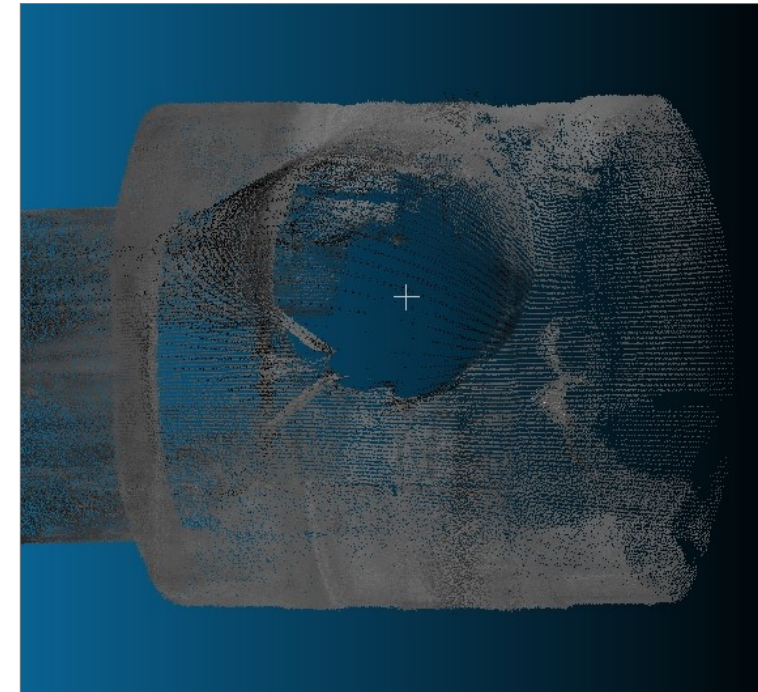
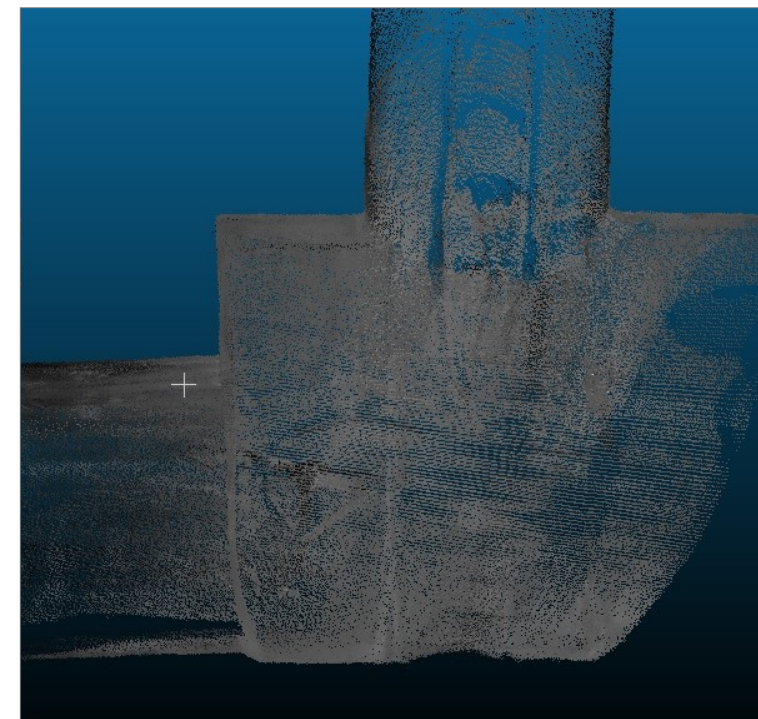
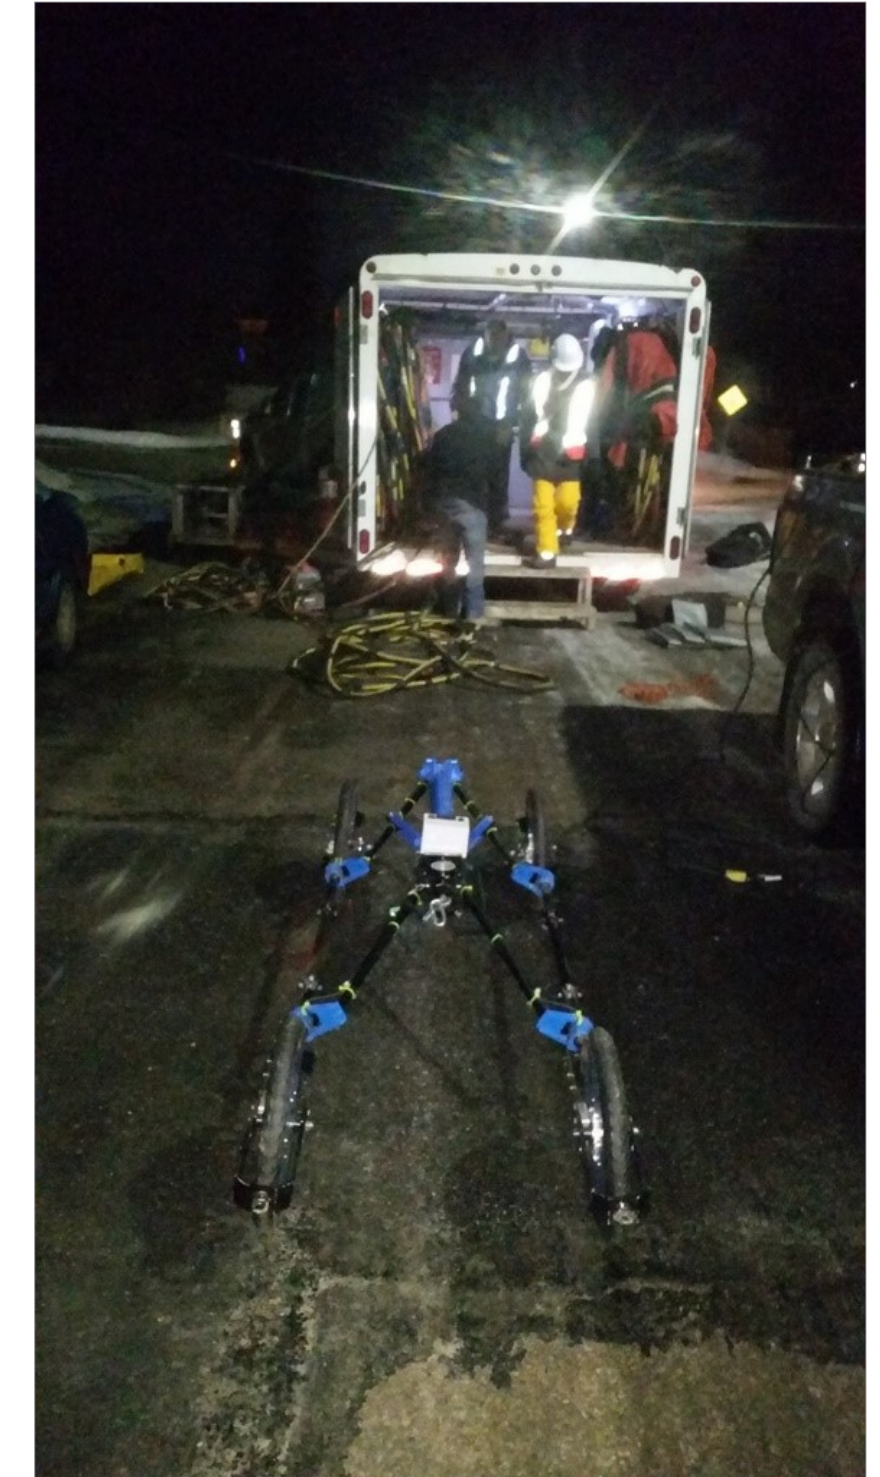
Deployment Into N-S Bypass Pipe
Scans At Bottom of 100' Deep MH
