Multi-Sensor Inspection: 2D LIDAR & 3D LIDAR

SolidFX MSI Equipment

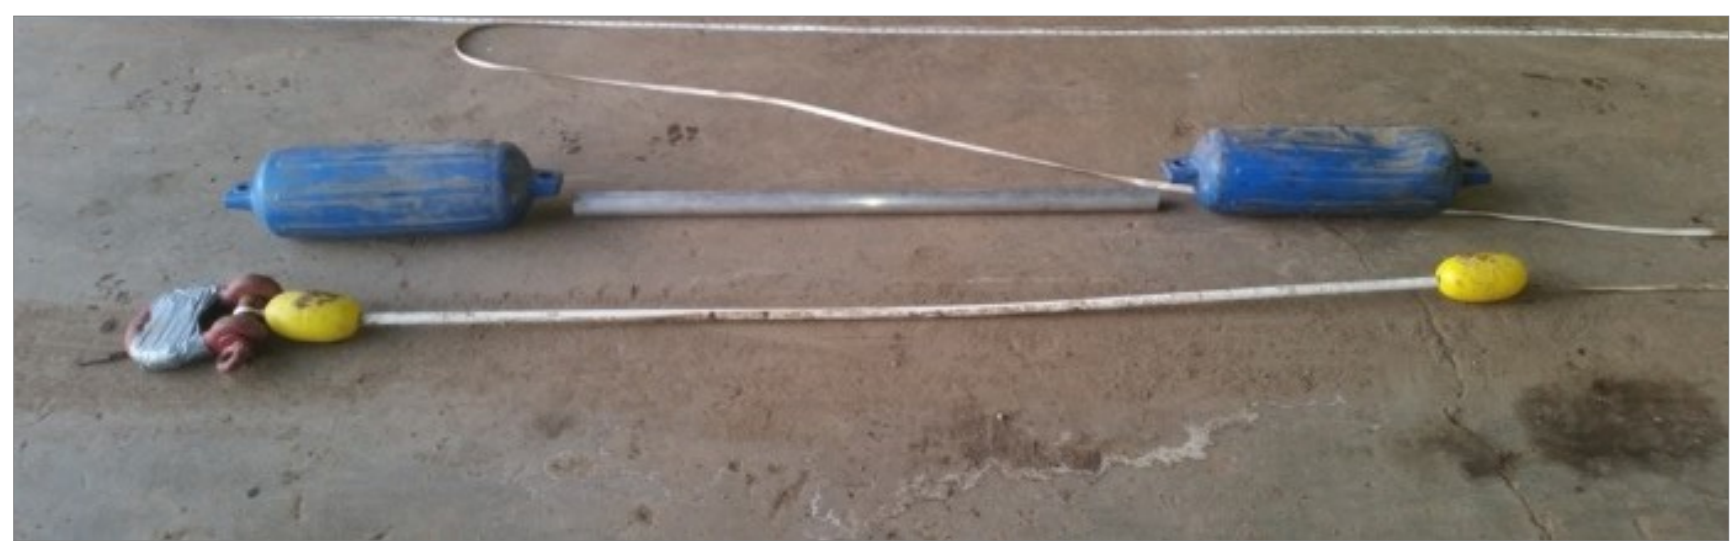
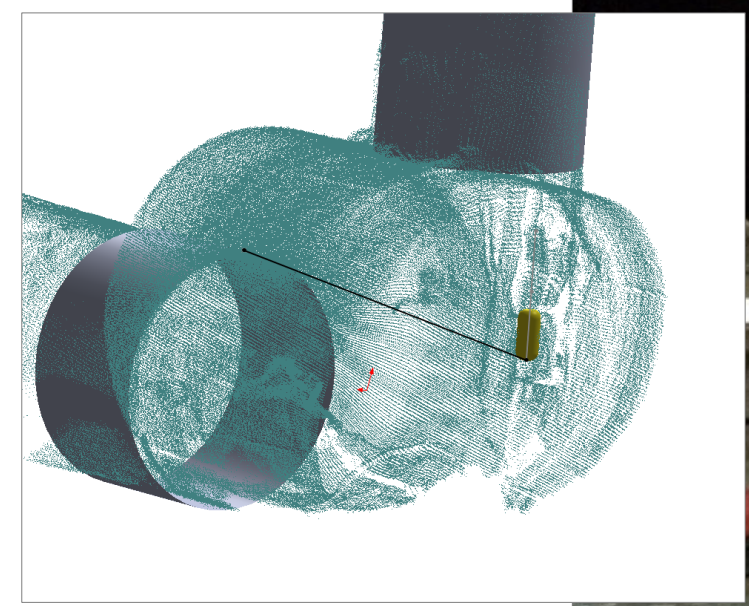
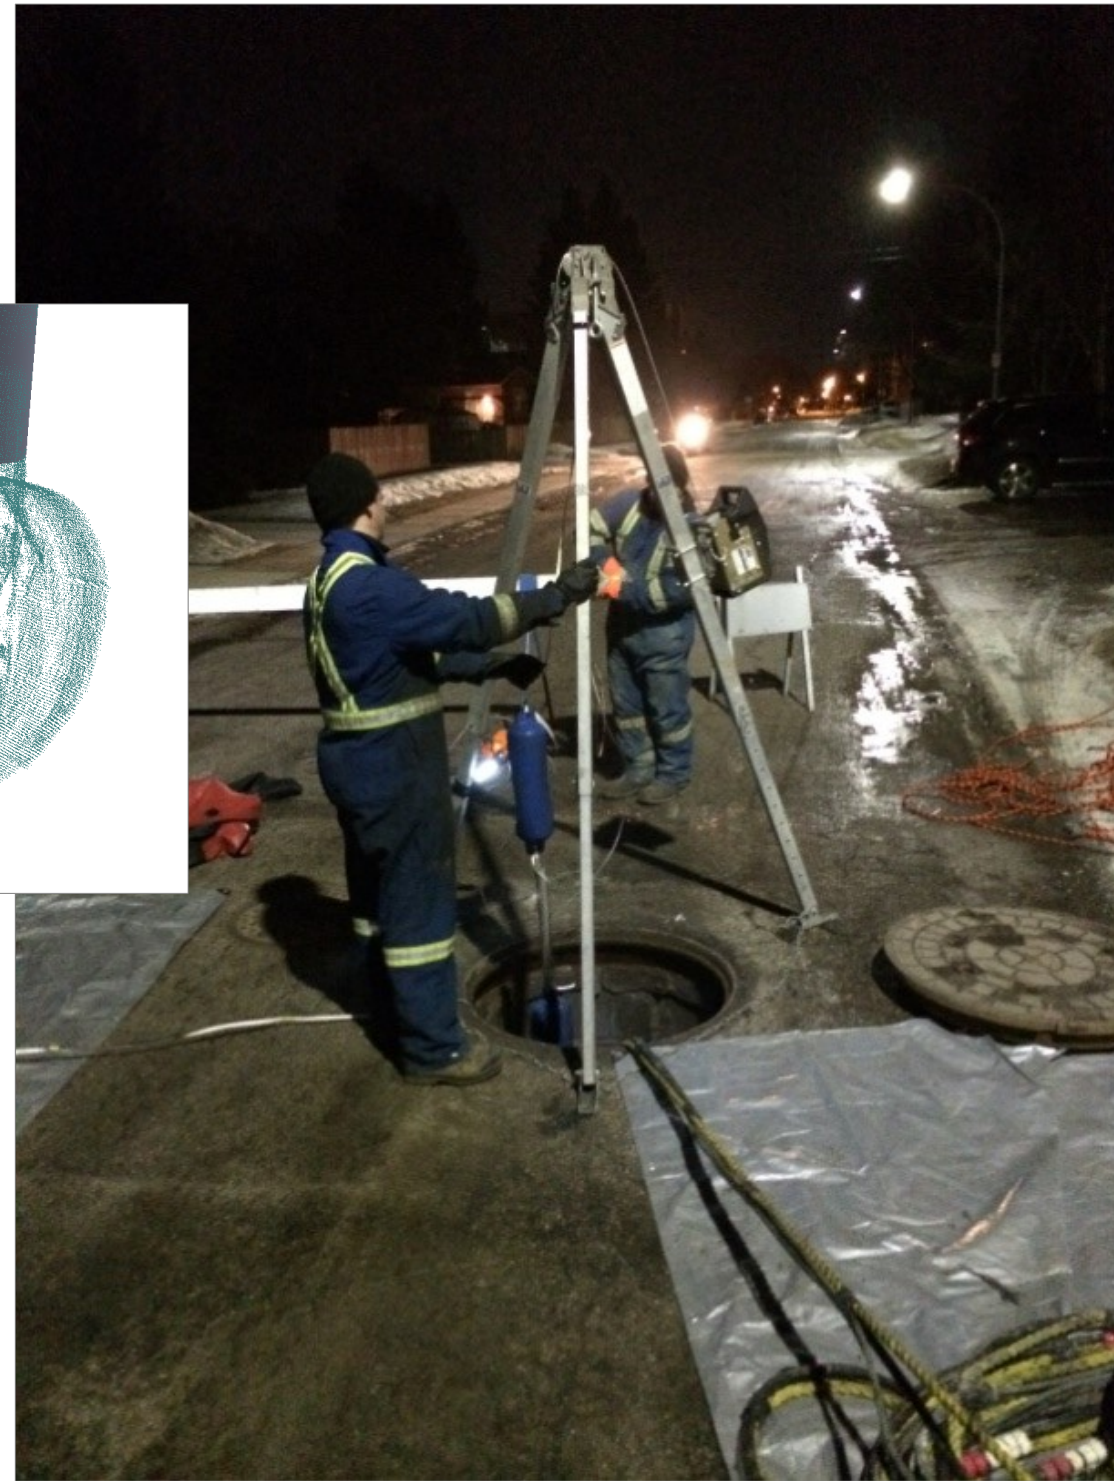
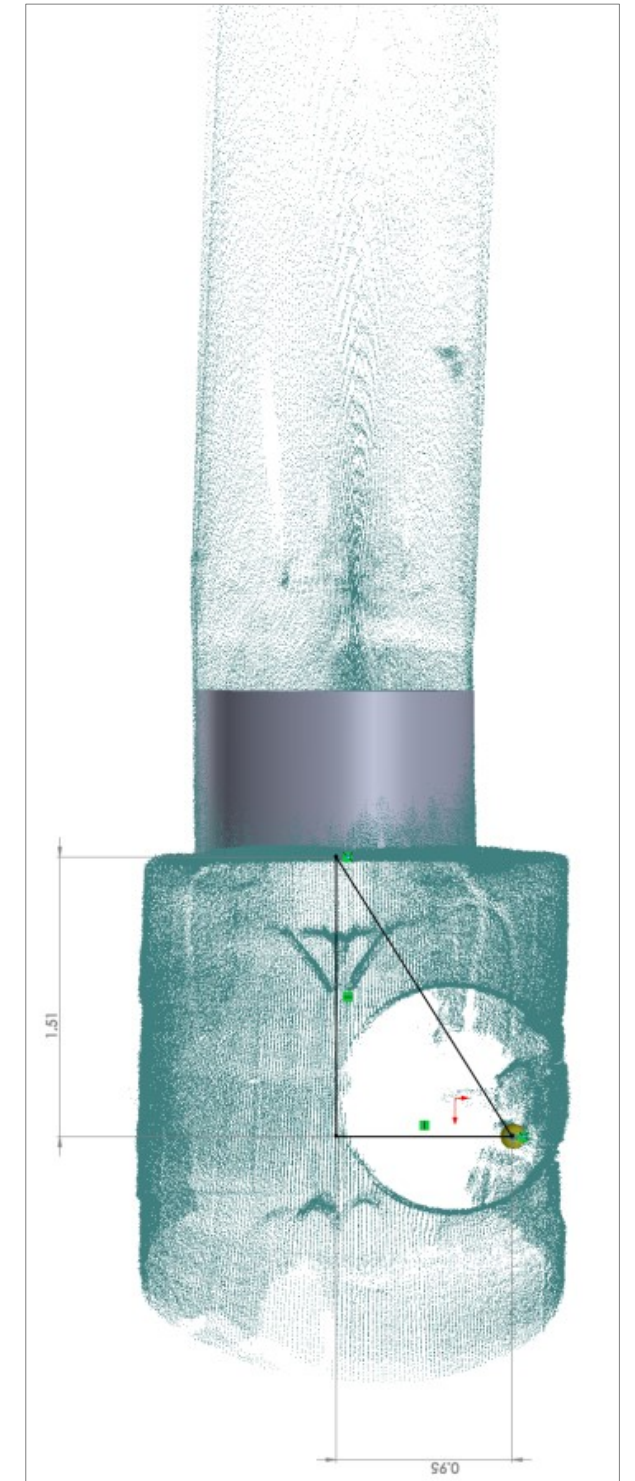
Drill and Rehab Project Offset MH

- Drop plumb line
- GPS coordinate transfer

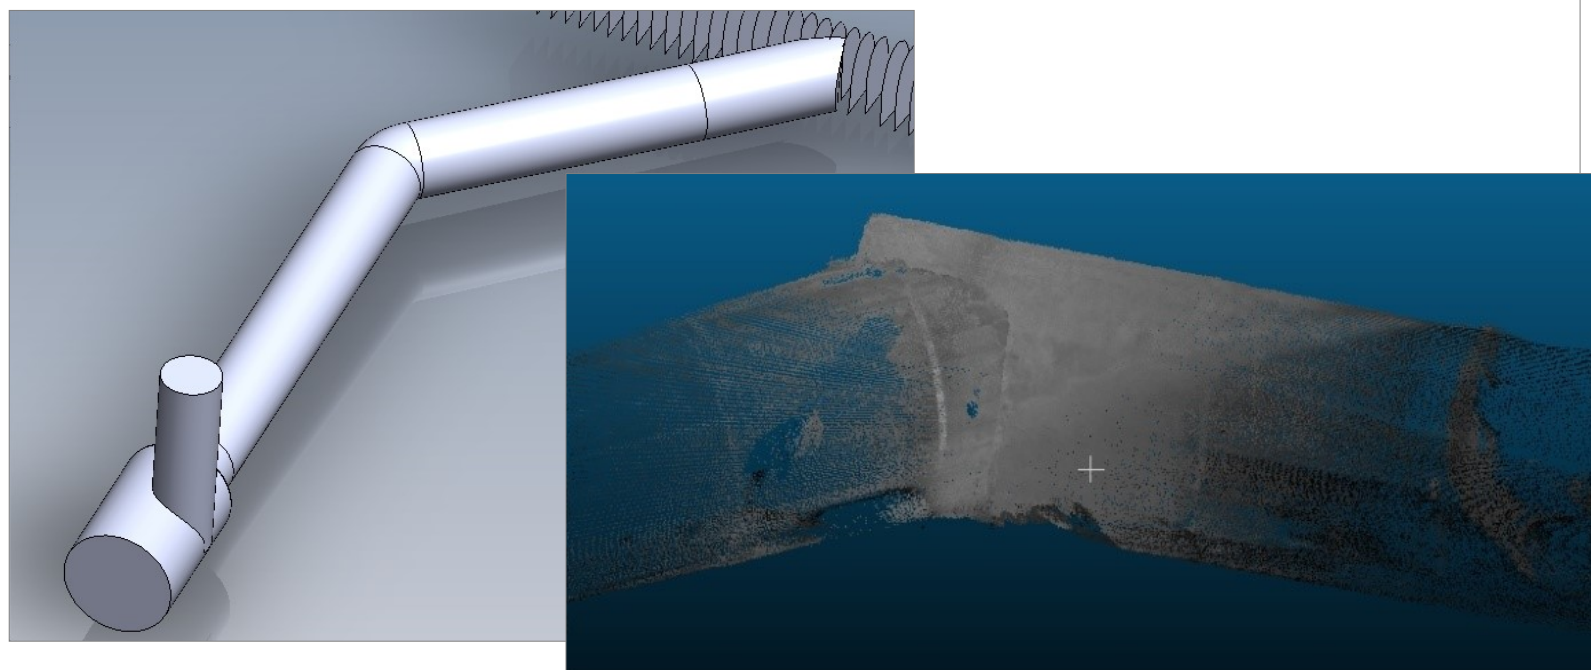
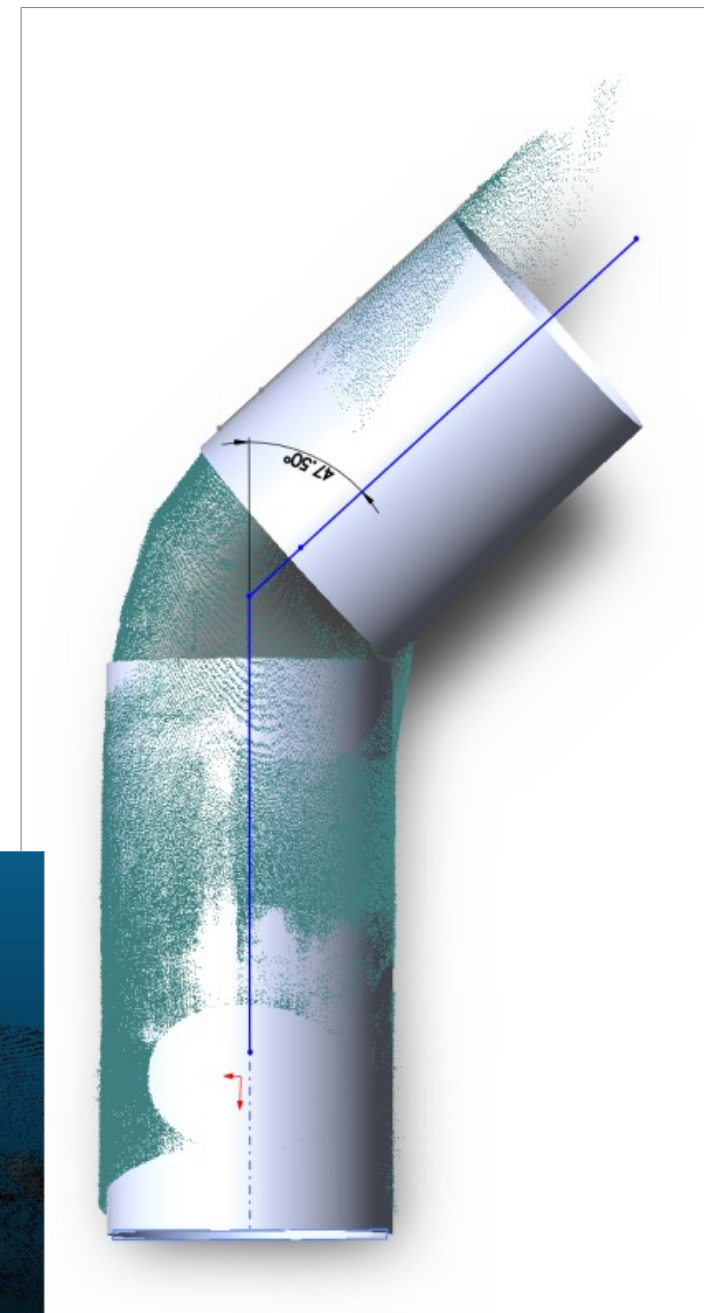
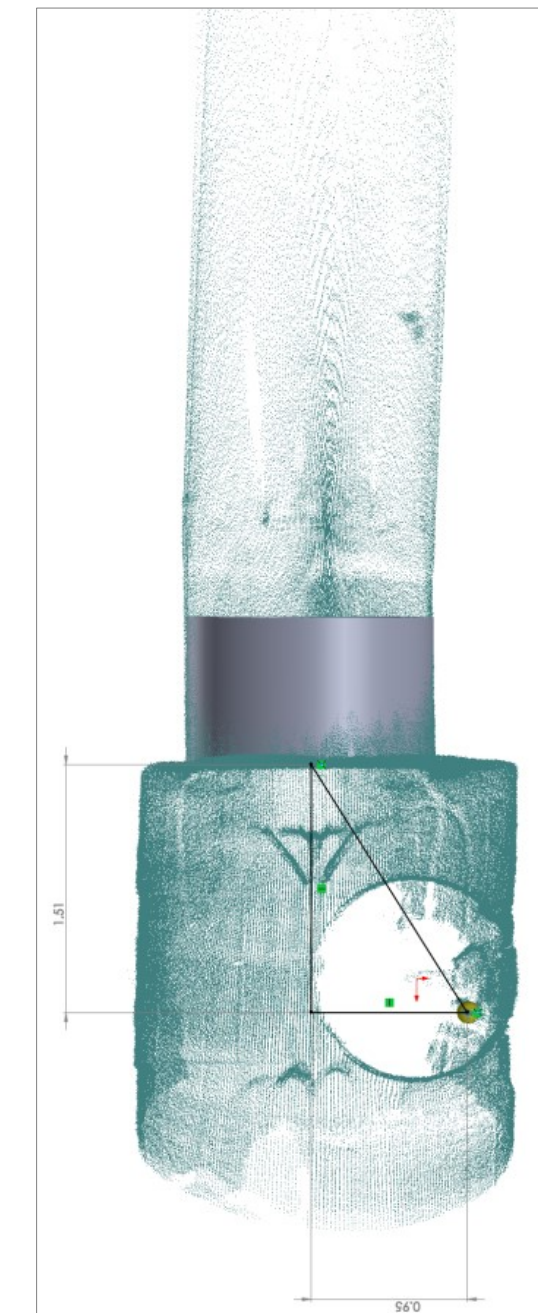
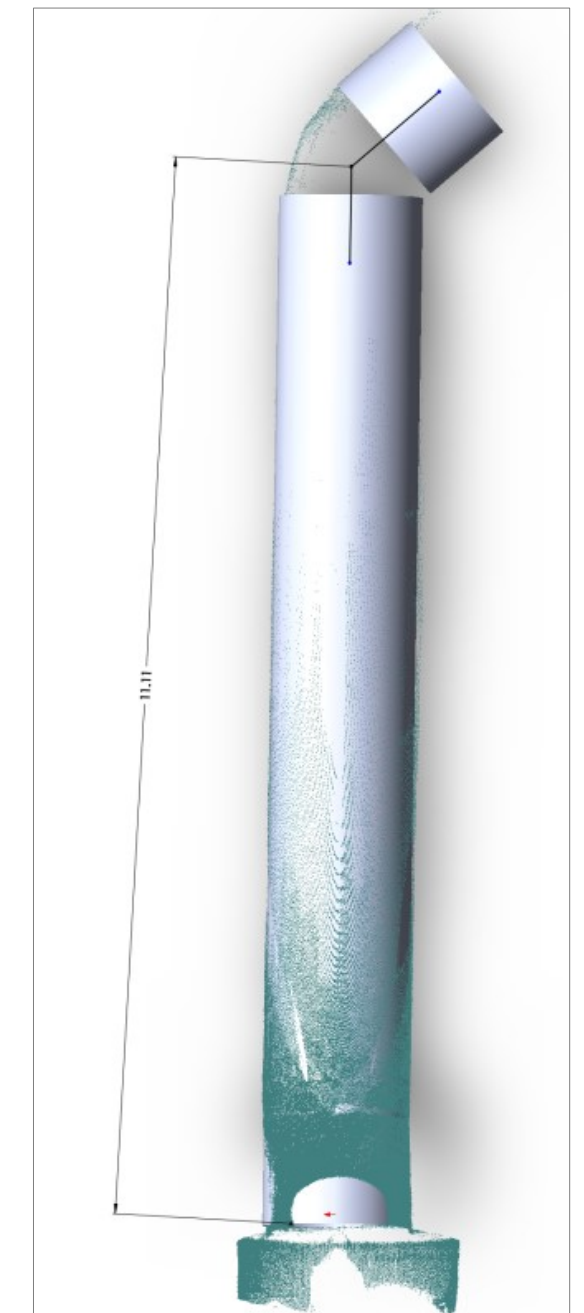
N-S Bypass Pipe – Bend Analysis

- Import point clouds into CAD
- Define pipe wall and CL
- Measure angles
- Update 3D model

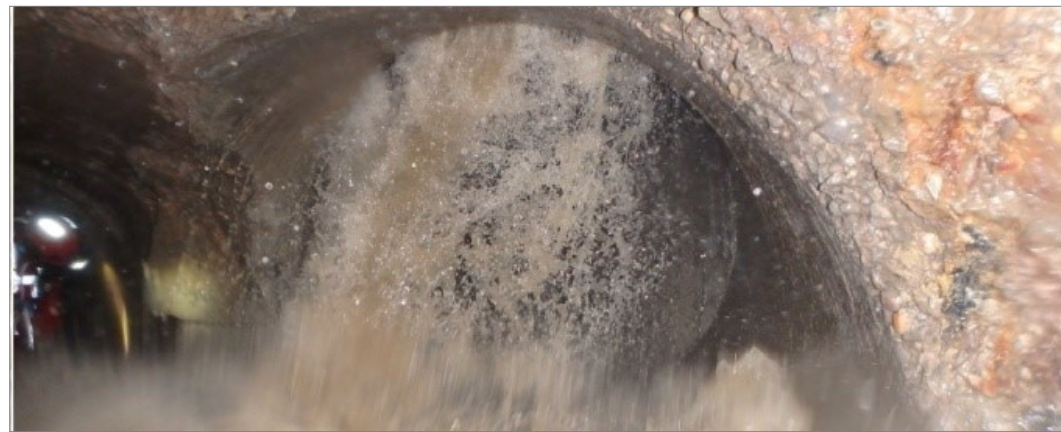
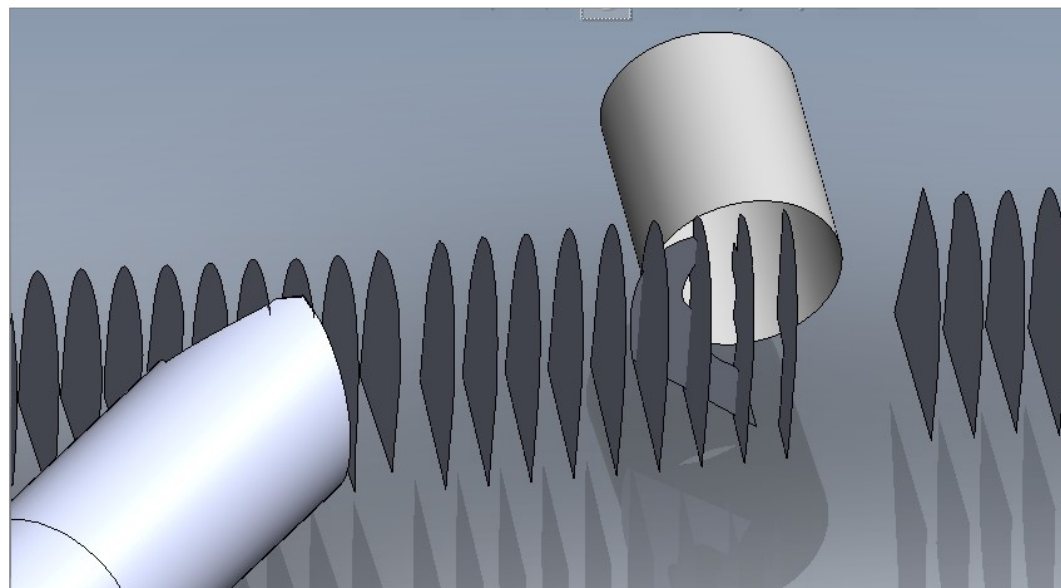
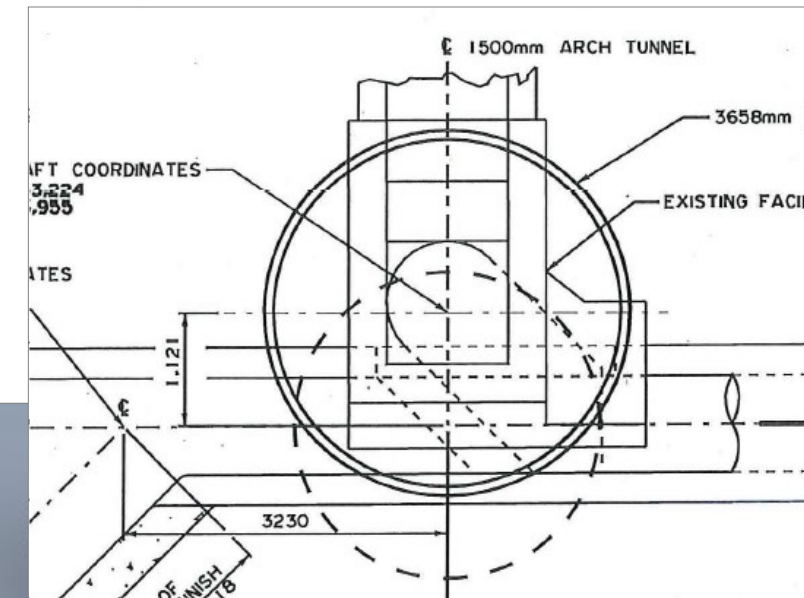
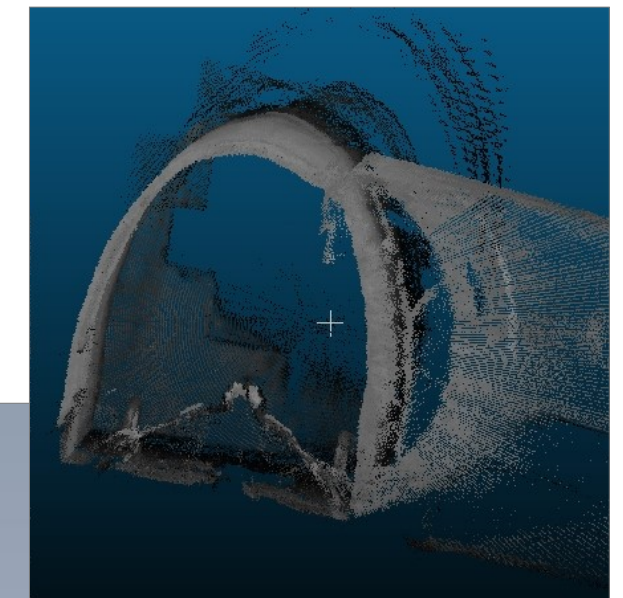
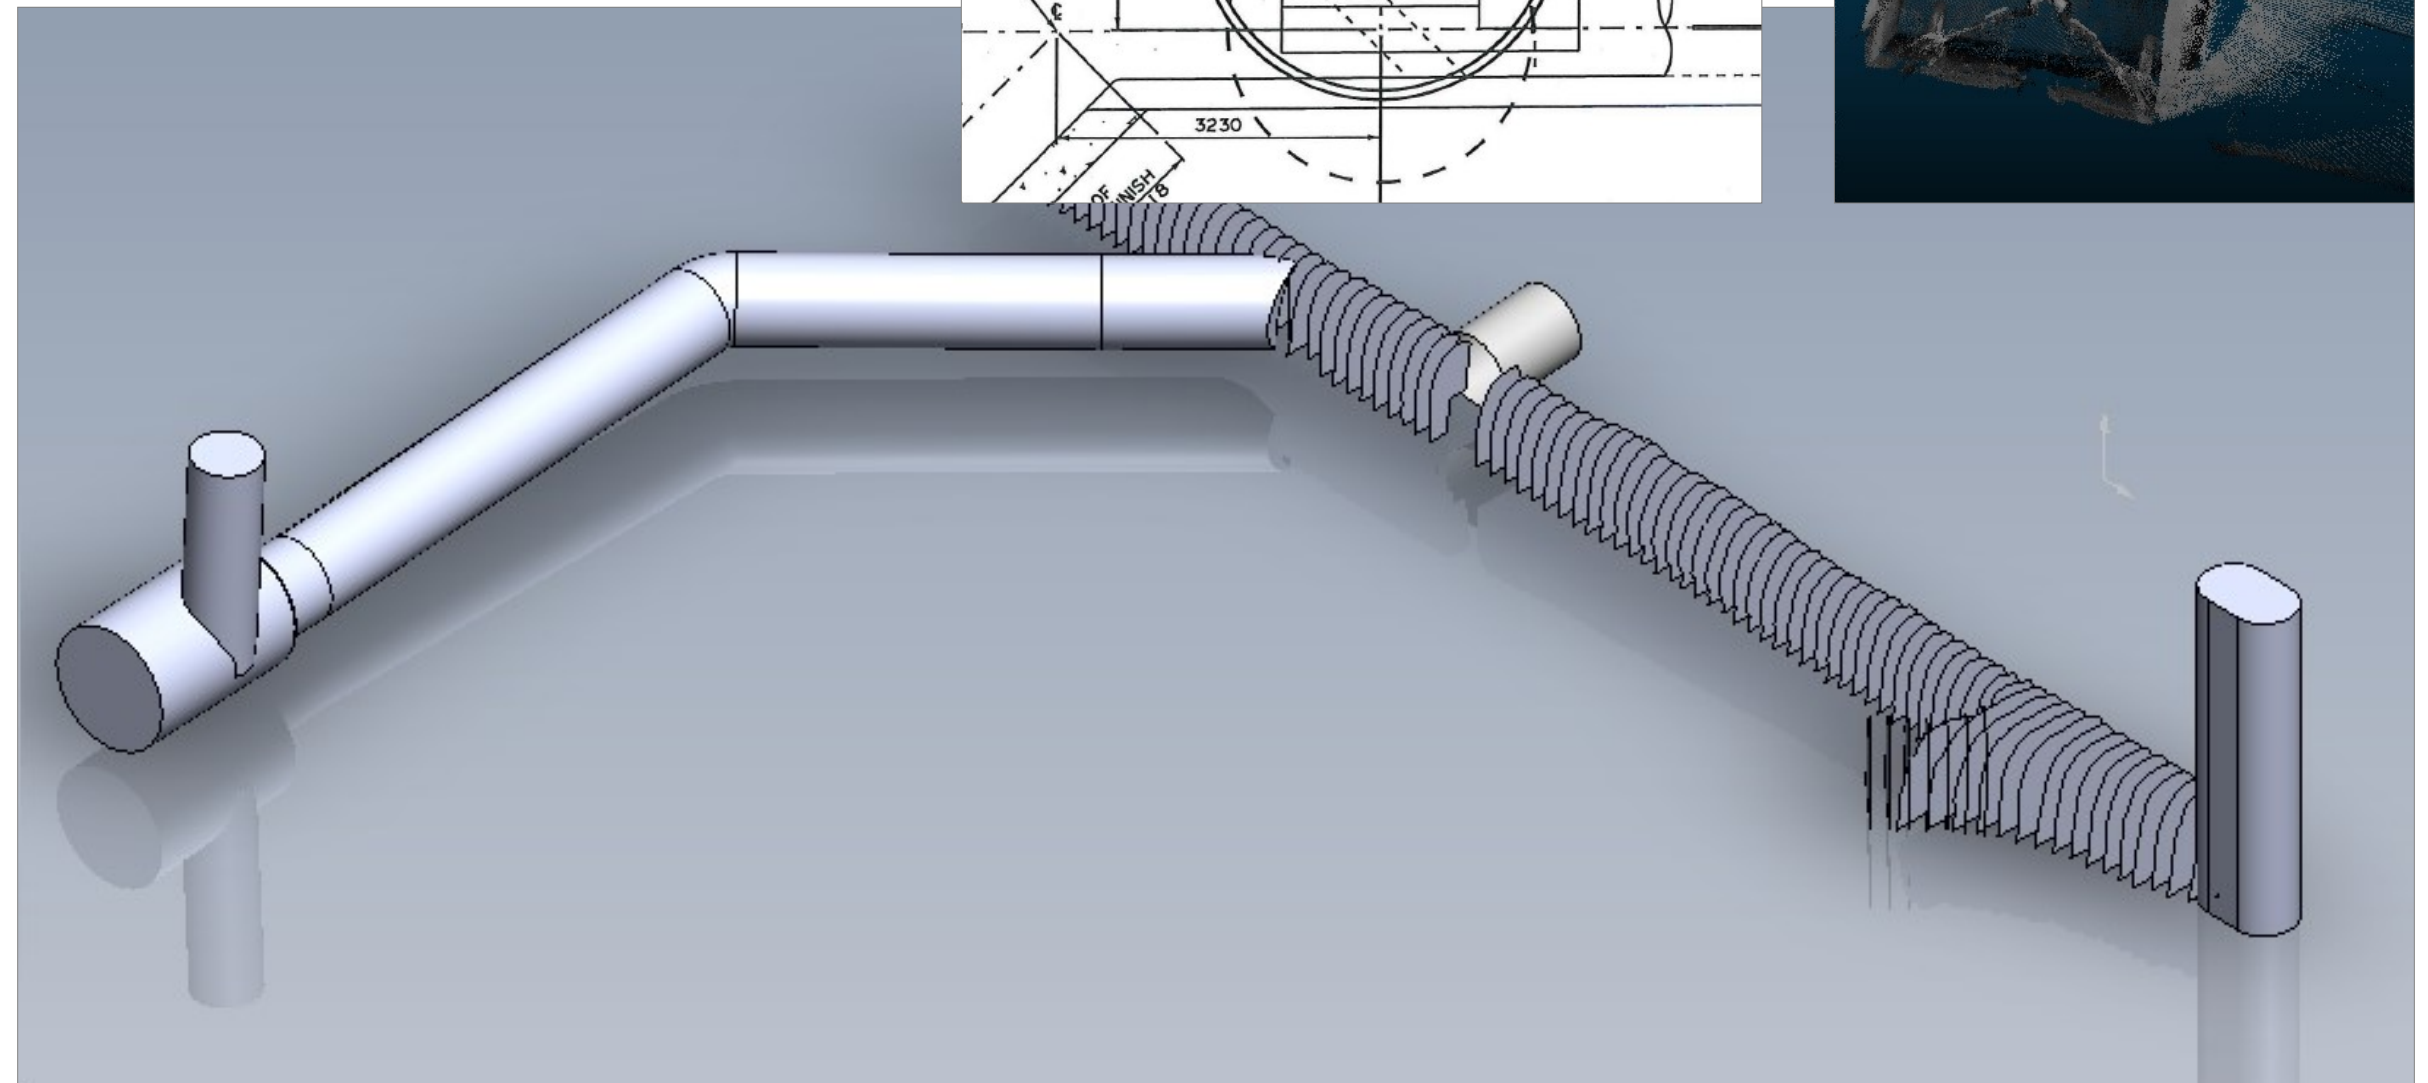
Tie The Pipe And Tunnel Together

Drill and Rehab Project

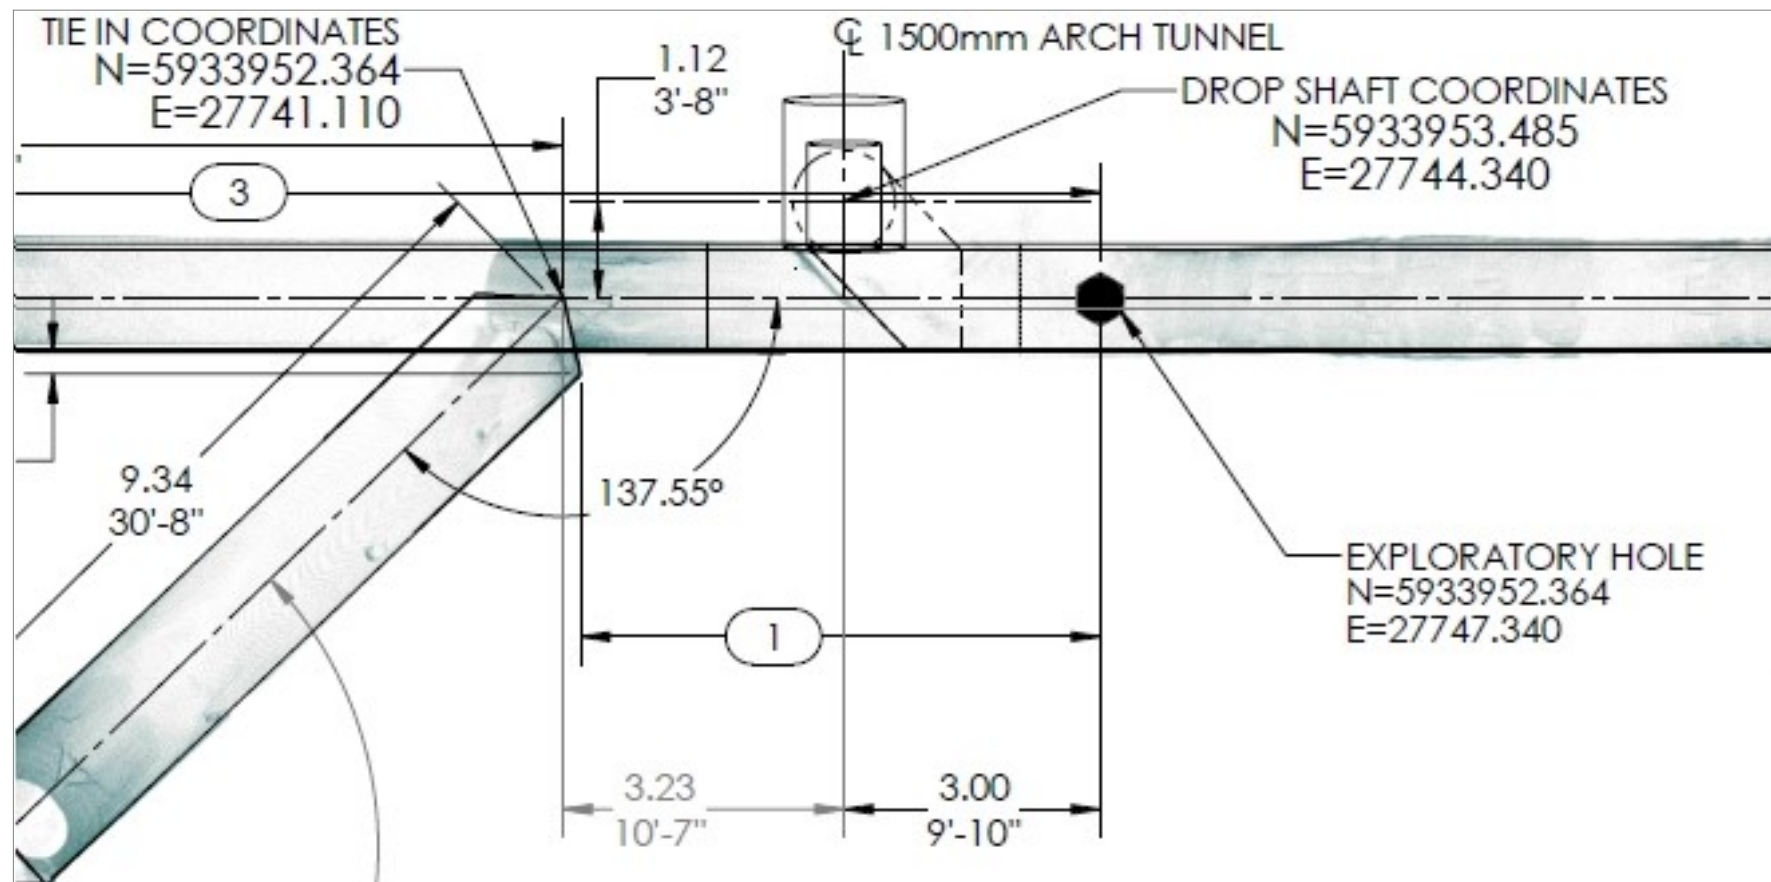
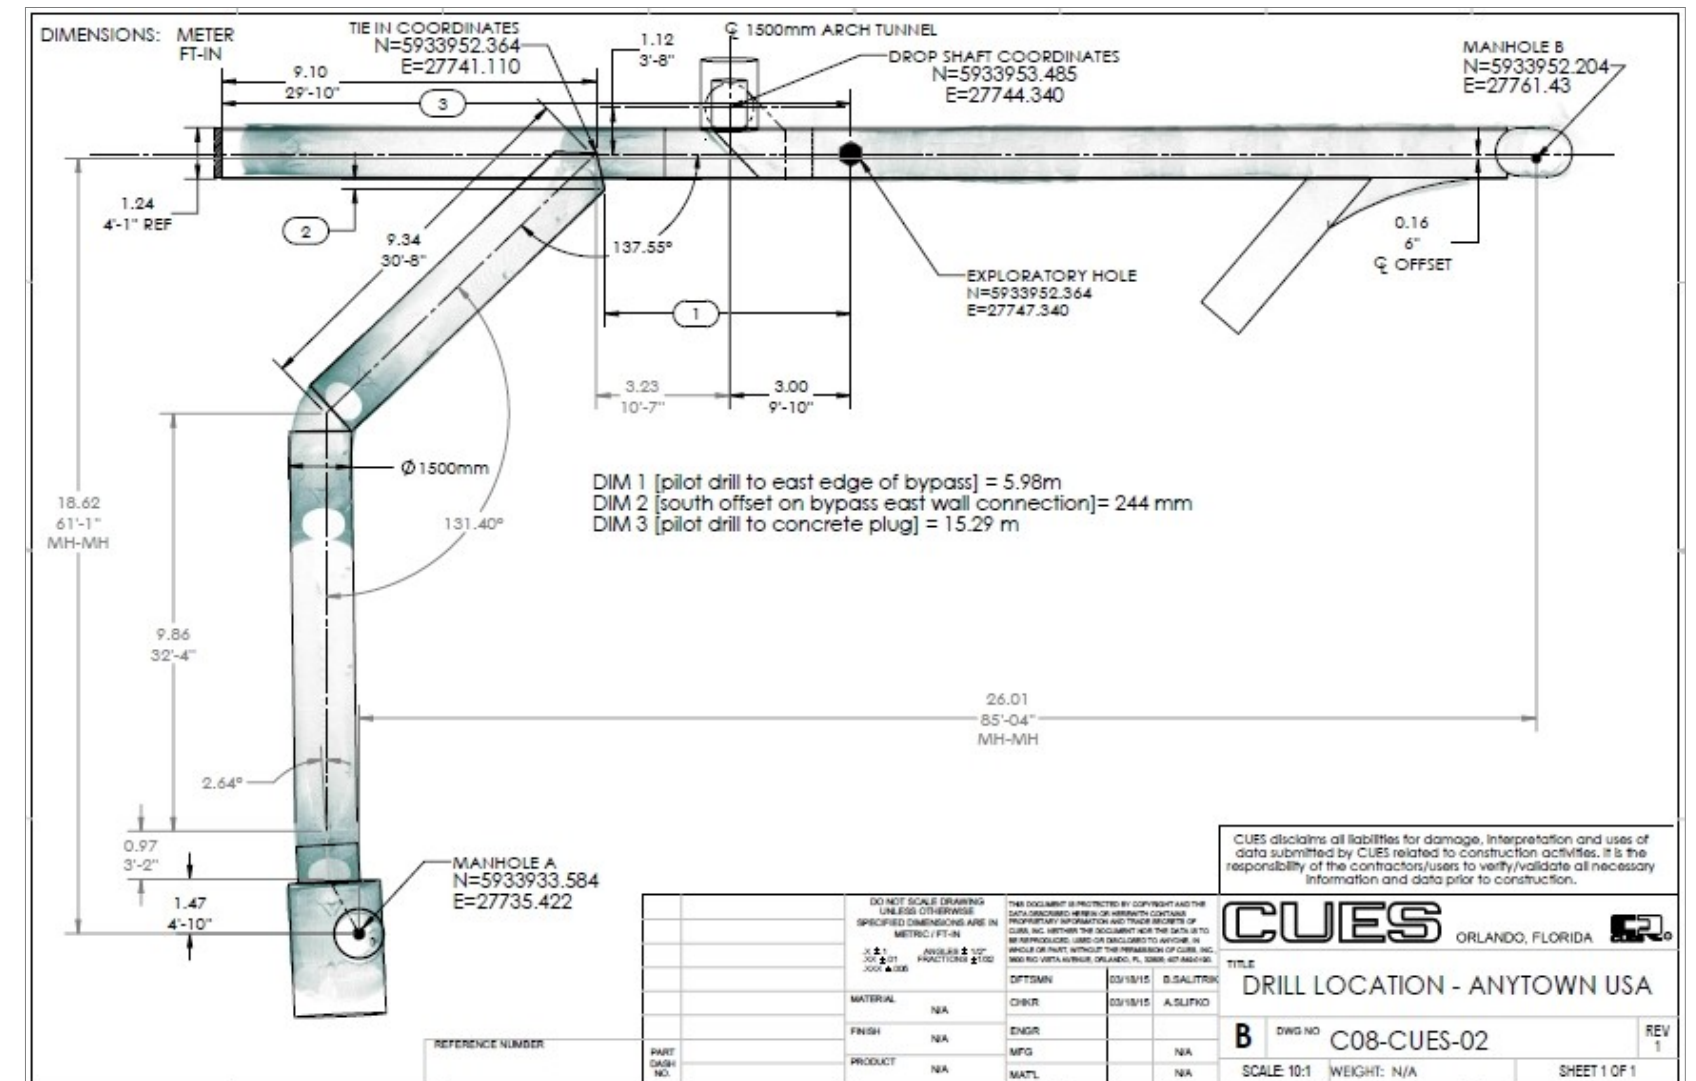
Deliverable – Access Shaft Dig Coordinates

Drill and Rehab Project

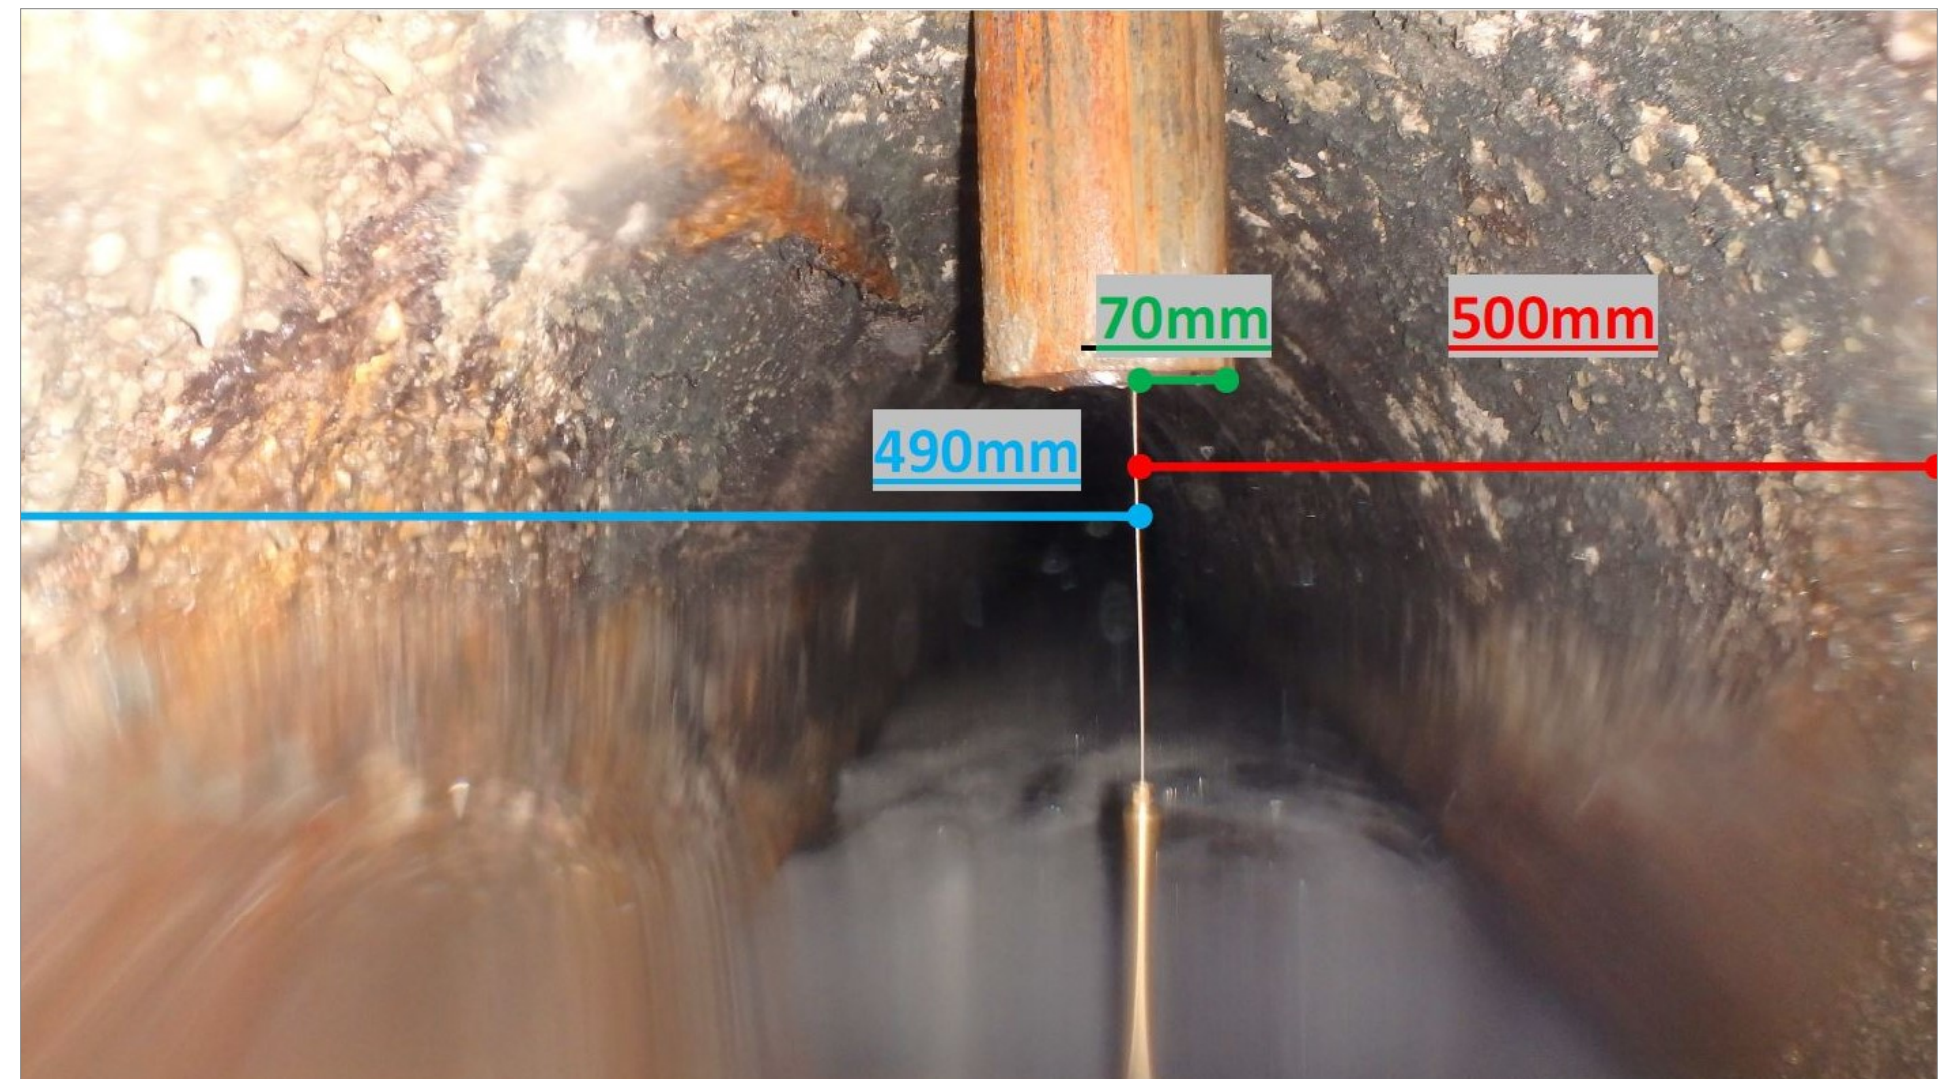
Results – Exploratory Hole For Shaft

- String line to South wall – 500mm
- String line to North wall – 490 mm
