MPlus⁺ Field Firmware Update

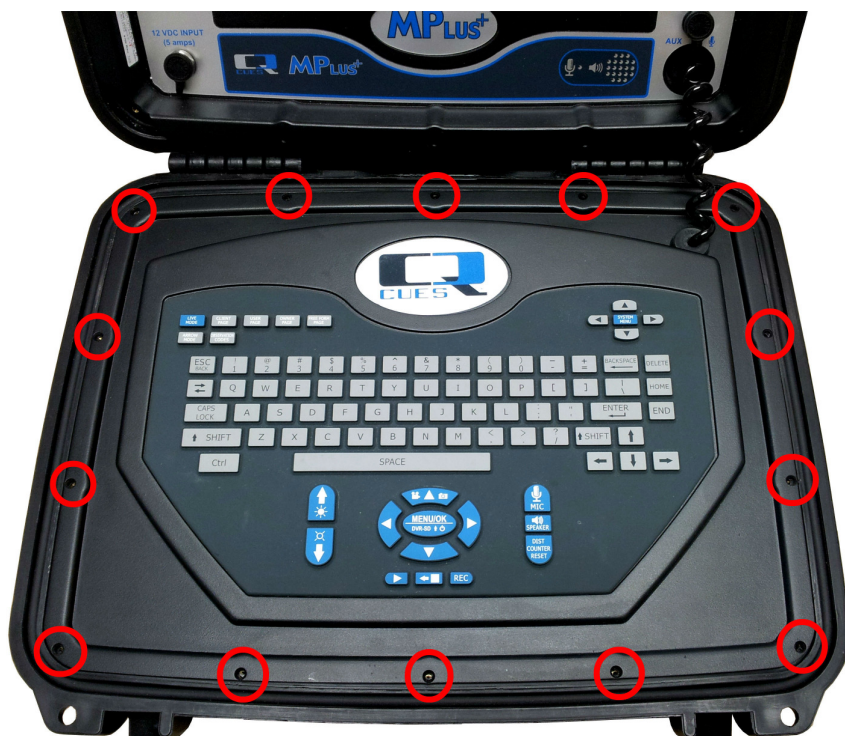
2. Power-down the MPlus⁺, if necessary, by pressing the power button.
3. Using the Phillips screwdriver, unscrew the 14 screws that secure the keyboard panel to the fold-down portion of the MPlus⁺ Control Unit.

11. Set the keyboard panel back in place into the fold-down portion of the MPlus⁺ Control Unit, and, using the Phillips screwdriver, reinstall the 14 screws to secure it. Be careful to not over-tighten the screws.

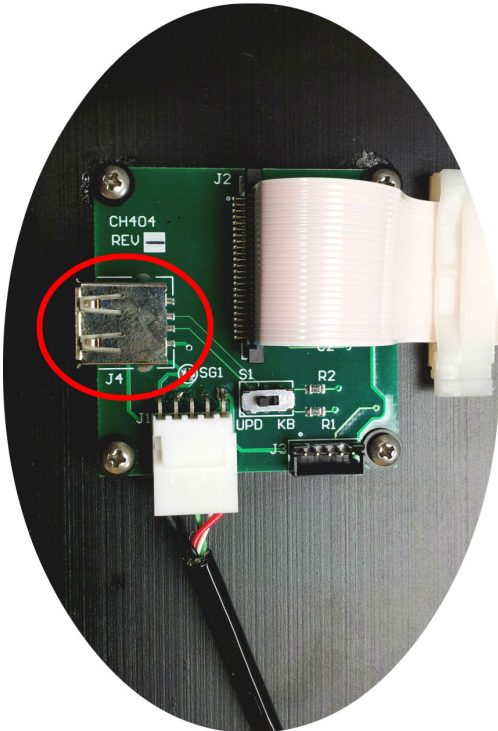
4. Locate the circuit board attached to the underside of the keyboard panel. Insert the USB Flash drive into the USB port, J4, on top of this circuit board.

- A USB device is not plugged into the USB port, J4, on the circuit board attached to the underside of the keyboard panel.

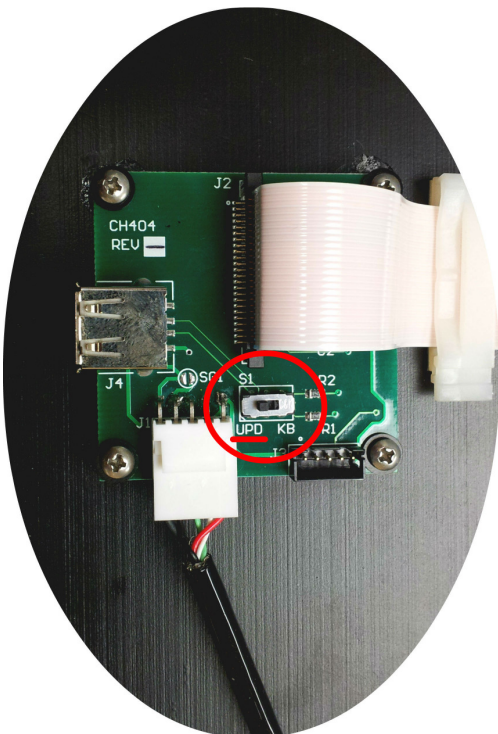
5. Move the sliding switch, S1, on the circuit board to the 'UPD' position.

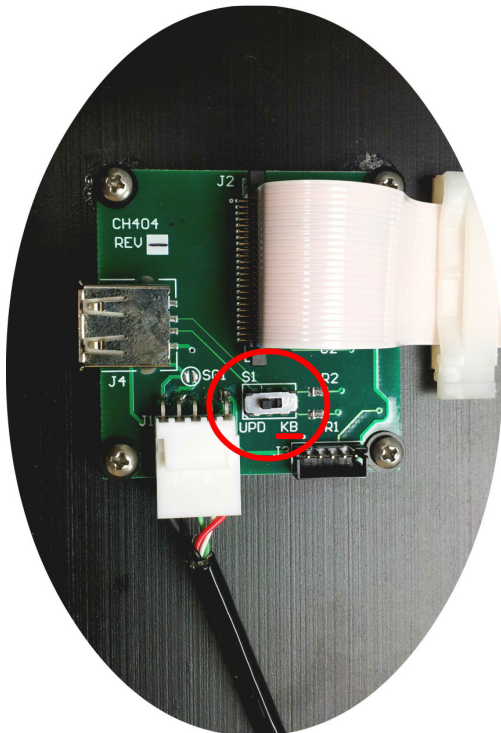
Please refer to the Troubleshooting section if the system displays an error message.
8. Wait until the MPlus⁺ system automatically powers-down; this occurs approximately 8 – 10 seconds after the firmware update completes.
9. Remove the USB Flash drive from the circuit board.
10. Move the sliding switch, S1, on the circuit board back to the 'KB' position.
